# SPECIAL PROJECT INTERIM REPORT

MARCH 5, 2020

## SILVER LINE PHASE 2 REVIEW

## **OIG Interim Report of Findings & Recommendations**

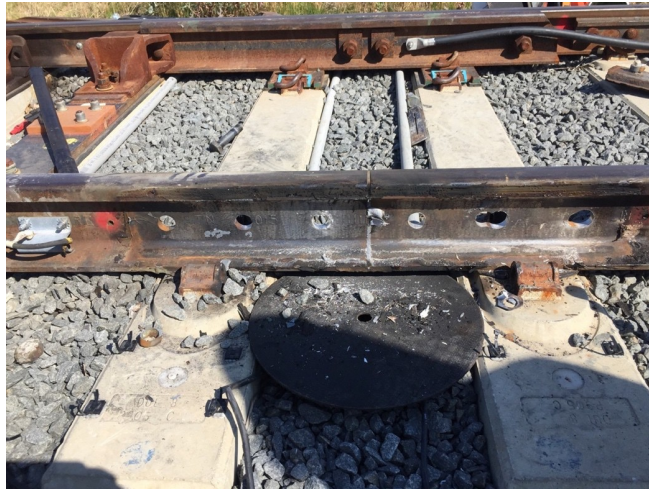
## Insulated Joint

A failure of the joint, resulting in two sections of track being uninsulated, poses a significant risk to personnel safety and operational efficiency. Insulated rail joints are continuously subjected to dynamic loads generated by rolling stock, stresses due to thermal expansion, and electrical potential. Insulated rail joints are regarded as safety-critical sections of the rail network; therefore, the rail joints must be installed, inspected, and maintained properly.

During early testing of the insulated joints in the Rail Yard, there was an abnormally high number of failures that the Contractor later attributed mainly to poor installation. WMATA Project staff attempted to confirm the Contractor's assertions and determine the frequency and extent of the failures. WMATA staff requested manufacturer information, installation method, all results of electrical isolation testing, replacement and/or remediation details, and results from the root cause analyses of the failures. Not all requested information was provided timely and Project staff is continuing to monitor the results of electrical testing conducted in December 2019. MWAA agrees with WMATA Project staff that no failed insulated joints will be accepted. The OIG was informed that resolution of the insulated rail joint issues is being currently discussed between MWAA and WMATA.

WMATA Project staff should request a more detailed failure chronology for all failed insulated rail joints, with accompanying root cause analyses and any other field or manufacturer's testing results. The manufacturer and installer should attest that the insulated rail joints meet all safety and performance requirements. The performance of the insulated rail joints should be closely monitored during Operational Readiness Testing to ensure no additional failures or anomalies occur during rail traffic and simulated normal operations.

6. Require MWAA and its Contractor to meet the five conditions in WMATA's February 26, 2020, letter for the remediation of the ballast;
7. Require MWAA, its Contractor, and the manufacturer and installer of insulated rail joints to provide all information relating to the frequency, root causes, and mitigations for resolving insulated joint failures, including all functional testing, and to attest that the insulated rail joints meet all safety and performance requirements;

8. Closely monitor the performance of the insulated rail joints during Operational Readiness testing to ensure no additional failures or anomalies occur during rail traffic and simulated normal operations;

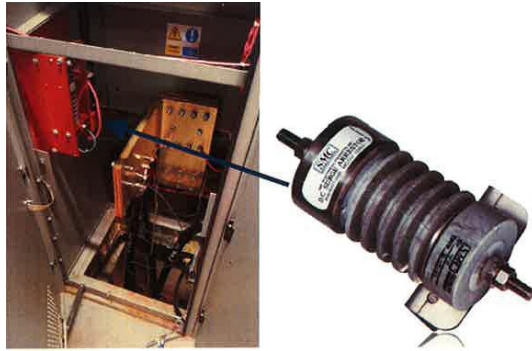
## Surge Arrester

The OIG was informed by WMATA Project staff there had been several surge arresters that failed testing early in 2019. WMATA Project staff inquired about the failures and were told that appropriate steps were being taken by the manufacturer to mitigate any problems, but staff was initially provided no further information despite making several requests. As more surge arresters were installed, it was reported that some arresters were continuing to exhibit undesirable voltage tolerances.

On April 3, 2019, MWAA provided WMATA Project staff with a copy of the lead electrical contractor's Surge Arrester Analysis Report.<sup>15</sup> The report included information provided by the surge arrester supplier about failures earlier in the year. The supplier had been notified on February 18, 2019, that four surge arresters had been activated on the Silver Line Phase 2 rail extension between February 9-15, 2019. The supplier was further advised that due to the critical nature of the issue, additional surge arrester testing should be conducted. The supplier conducted a forensics review of four activated (failed) arresters and six additional non-activated arresters. Among the six non-activated arresters, three passed the supplier's quality testing and three failed, with the failures being noted as "conducting below the test voltage." The supplier's forensic report concluded that the four activated units caused track arcing during rail polishing and Dynamic Testing.<sup>16</sup> The supplier attributed the other failures on other electrical transients that caused the reduced conduction voltage. An installed surge arrester is shown above.

reviewed subsequent arrester failures. Significantly, there were 23 surge arrester events reported through July 19, 2019, involving both positive and negative voltage conditions. The lead electrical contractor reviewed and found no anomalies with the System Configuration. They reviewed the specifications and the performance characteristics for the supplier's installed arrester and then compared data sheets with two other suppliers and those suppliers' compliance with the European surge arrester standard EN-50163.20. The lead electrical contractor concluded that the supplier's surge arrester was not appropriately rated for the 750v WMATA system and should not be used. In its place, the lead electrical contractor recommended using another supplier whose surge arresters were more tolerant of voltage changes.

Surge arrester failures were reported as early as February 2019 with the activation of four arresters and test failures of other installed and uninstalled arresters. Subsequent investigations by the lead electrical contractor were more in-depth, and its recommendation was to replace the arresters with a more voltage tolerant arrester, which it represents may be the correct solution to arrester failures. In both the lead electrical contractor and subcontractor analyses there were inconclusive findings as to root causes; however, there were potential causes cited that related to exposure during 'rail polishing,' DC Switchgear and TPS testing, and indeterminant track arcing. Identification of root cause in arrester failures is important to WMATA to ensure that this matter has been resolved and that future incidents do not occur.

Given the frequency of failures and criticality of this component, WMATA should very closely monitor surge arrester performance during the upcoming testing and commissioning, and later System Acceptance, to ascertain whether or not the root cause(s) for electrical transients can be more clearly identified. There are several internal and external potential causes for voltage fluctuations and WMATA may be able to identify and mitigate those before revenue service.

WMATA should also review the impacts of using a higher rated surge arrester in this extension of the Silver Line within the context of surge arrester sizing and performance on the remainder of the system. As WMATA balances its trainset lengths and moves to increase line capacities, the power needs and devices to protect upstream and downstream devices will be more critical.

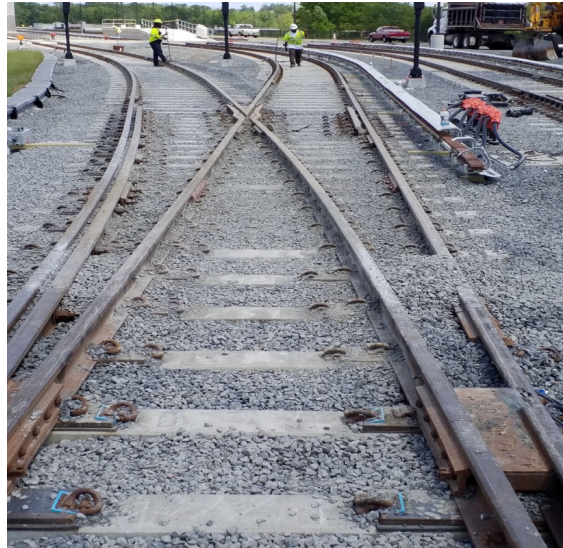
## Turn-outs/Switches (Package B)

On August 12, 2019 the OIG team met with the WMATA Project staff and contract Subject Matter Expert co-located at the Rail Yard. The staff and technical advisor expressed specific concerns about the chronic failures of turnouts (#8) failing to meet required track geometry standards and exhibiting ‘tight gage’ conditions.

When the rails leading into the switch cannot be properly aligned, the distance between the rails (gauge) may be adversely affected. In the Rail Yard, there have been repeated issues with a narrower than acceptable distance where the rails are too close together, called a tight gauge condition.

During an April 11-12, 2018 field inspection, MWAA documented improper placement of the concrete ties leading into the switch and turnout. When a train approaches a turnout, the distance between ties is reduced to provide further support for the rail as more loading forces are applied. Adequate space must also be allowed for movement of the rods that physically move the rail. MWAA noted that although the track construction was a “work in progress,” there were several locations where the tie spacing was too proximate to the moveable switch rods that this fact contributed to the problem.<sup>18</sup>

A tight gauge increases the strain on track fastenings and will cause the flange of the wheel to start grinding against the edge of the rail. This condition causes high flange forces to occur and the flange may ride over the rail, possibly leading to a derailment.

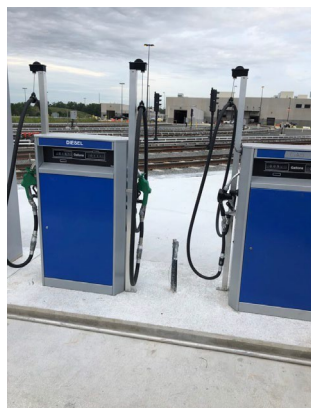
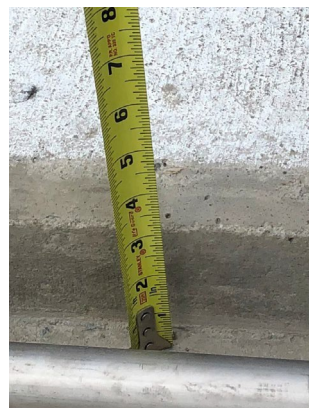
Without any responsive actions by the Design-Build Package B Lead Contractor, on August 13, 2019, a report from WMATA's Fire Marshal was sent to MWAA outlining possible safety and fire code violations with the work to date on the Fuel Center.<sup>22</sup>

The performance and technical specifications for the Fuel Center are straight-forward and should not have presented the Contractor with any significant challenges. For more than a year, the Contractor did not fully respond to WMATA's requests for design drawing details and did not demonstrate compliance with clear requirements; however, construction continued. MWAA made efforts to support the WMATA Project team, but for reasons that are not clear, MWAA did not issue any IRR for the Fuel Center.

WMATA should continue to demand that the final construction of the Fuel Center fully complies with all WMATA Design Criteria requirements and request that MWAA issue the appropriate IRR to document the known deficiencies.

11. Require MWAA and its Contractor to provide evidence that the final construction of the Fuel Center fully complies with all WMATA design criteria requirements and request that MWAA issue the appropriate IRR to document the known deficiencies; and
