**September 28, 2023**

## **A REPORT BY THE OFFICE OF INSPECTOR GENERAL**

**OIG 24-001**

# **Review of WMATA's 7000-Series Rail Car Cannibalization for Spare Parts**

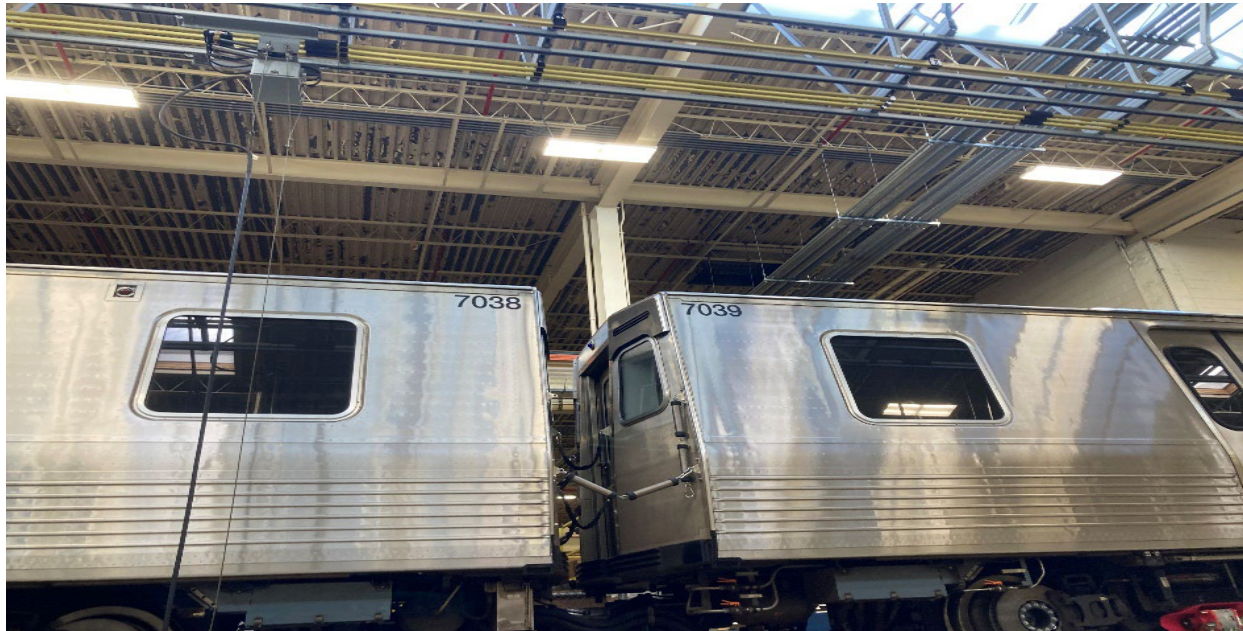
In June 2019, rail cars 7038 and 7039 were taken out of service for periodic maintenance. By July 2019, WMATA started removing parts from these two rail cars and replacing needed parts on other “recipient” rail cars, which were then returned to revenue service. As of January 2023, 45 parts had been removed from these cannibalized rail cars – see Appendix B.

**Picture 1: Cannibalized 7000-Series Rail Cars 7038 and 7039 at Brentwood Rail Yard**

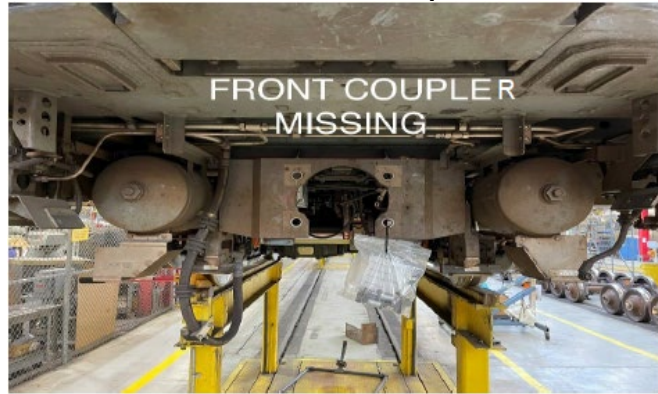
An example of a safety sensitive part is a front coupler. Picture 2<sup>2</sup> shows a coupler on a typical 7000-Series rail car, whereas Picture 3 shows the missing coupler from a cannibalized rail car. Officials designated this part as safety sensitive because it is used to connect one car to another. Rail Car Maintenance officials indicated it would take over 1.5 years for the couplers to be ordered and installed on rail cars 7038 and 7039. However, when OIG checked Maximo, the system of record, there were seven couplers in stock.

**Picture 3: Cannibalized Front Coupler**

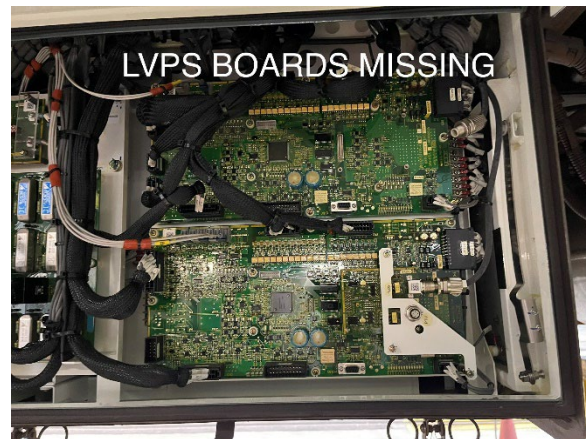
Another example of an electronic part designated as safety sensitive is a component called a “daughter board” on the low voltage power systems (LVPS) board. Picture 4 shows an LVPS board on a typical 7000-Series rail car, whereas Picture 5 depicts the missing component on the LVPS board from rail car 7039 after cannibalization.

**Picture 5: Cannibalized LVPS Boards**

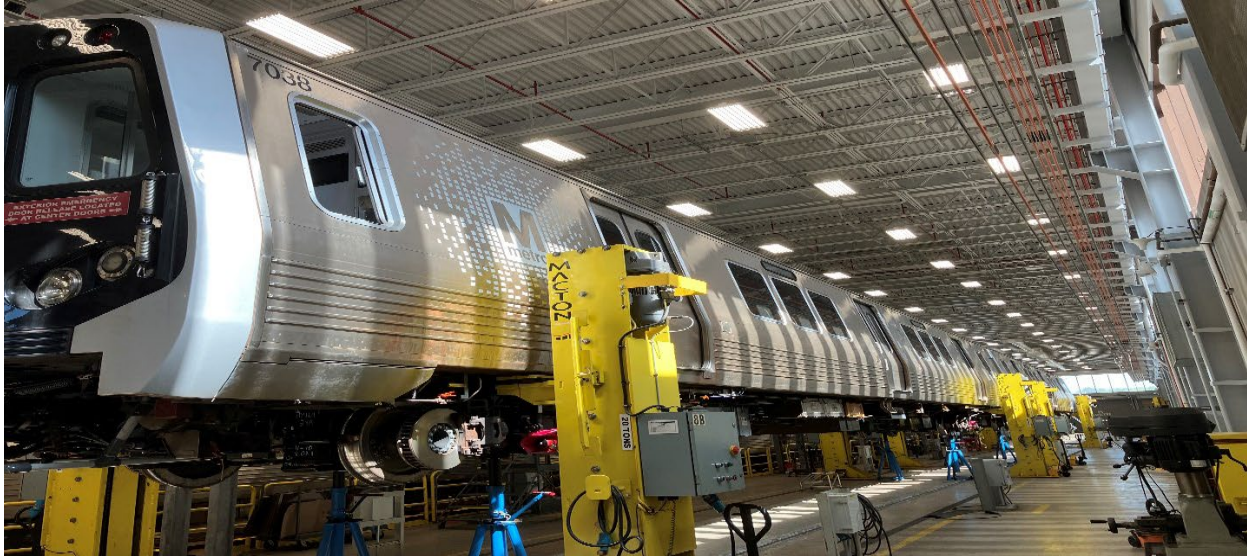
For over 4 years, rail cars 7038 and 7039 were stranded assets<sup>4</sup> as parts were cannibalized to use on other rail cars. As of April 18, 2023, OIG observed both cannibalized rail cars were located at the Greenbelt Rail Facility and Yard. Furthermore, OIG sampled 15 individual cannibalized parts and found all of them reinstalled on the rail cars. WMATA returned rail cars 7038 and 7039 to revenue service on August 7, 2023.

**Picture 6: Parts Restored on the Cannibalized Rail Cars**

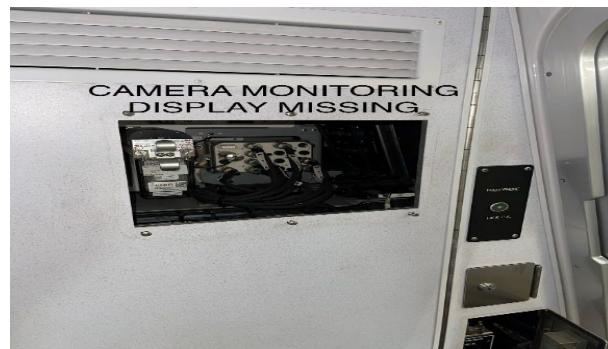
Picture 8: Cannibalized Monitor

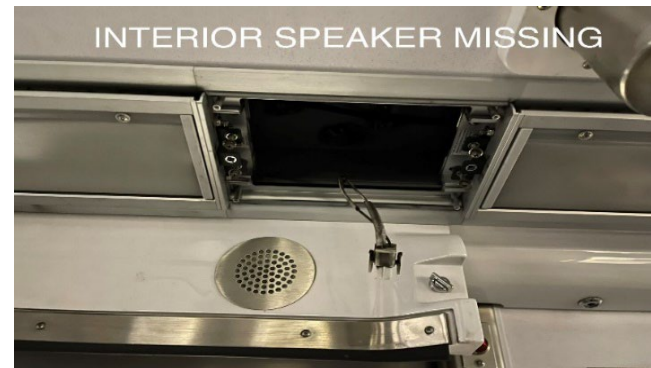
Picture 10: Cannibalized Speaker

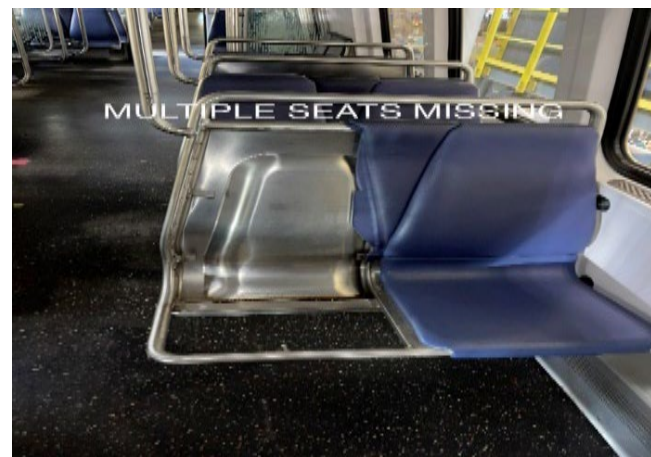
Picture 12: Cannibalized Seat

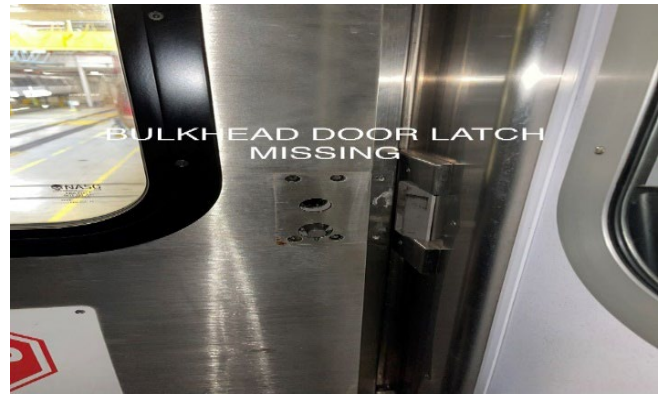
**Picture 14: Cannibalized Door Latch**
