SPECIAL PROJECT REPORT

September 4, 2020

**Dulles Silver Line Project
(Phase II)**

Evaluation and Analysis of Precast Concrete

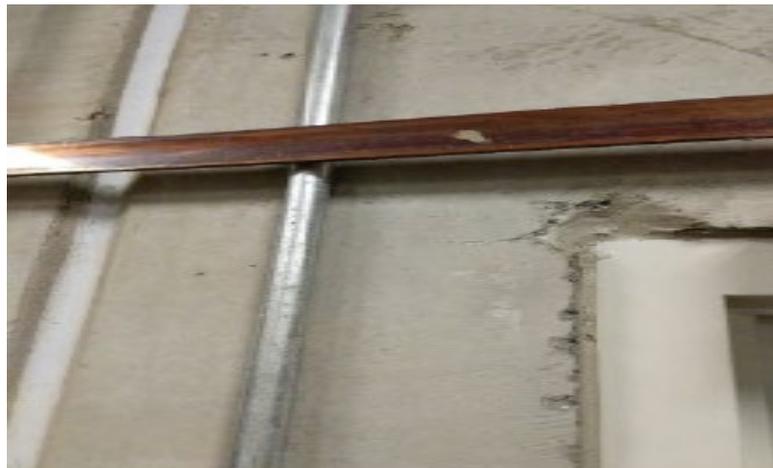
Herndon - Figure 16: Crack at Panel 2539. Source: DeSimone

WMATA OIG's inspection consultant identified 184 panels with one or more cracks. In addition, the consultant noted other issues including but not limited to spalling, corrosion and efflorescence. Below are examples. Additional pictures of the 184 panels are contained as exhibits in this report. These panels must be repaired prior to acceptance by WMATA.

9. If not already repaired, instruct MWAA and CRC to repair panels identified in the section entitled, "*Other Identifiable Issues with Panels*".

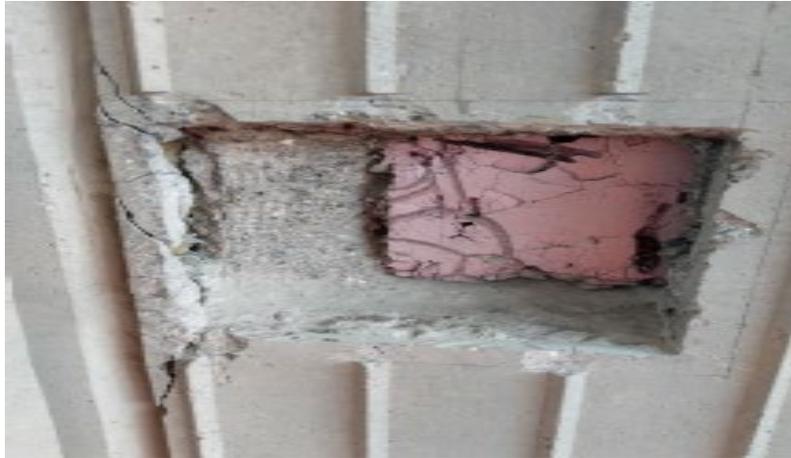
Ashburn: Figure 8: Piece of precast concrete panel cut-out at panel 5125. Source: DeSimone

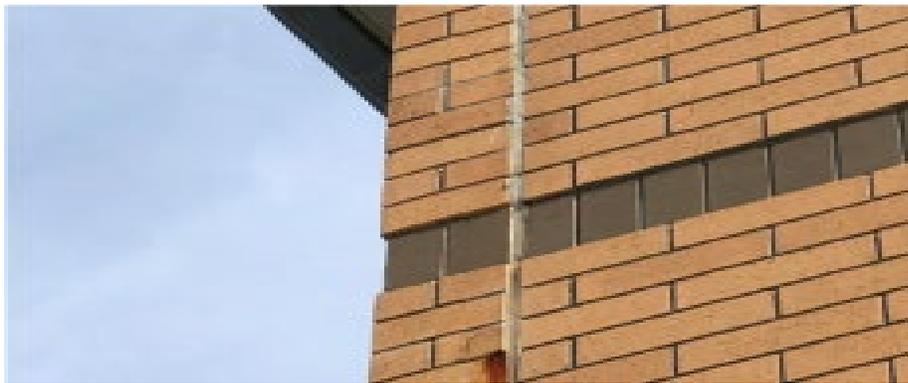
Reston: Figure 14: Corrosion observed at the exterior of Panel 3321. Source: DeSimone

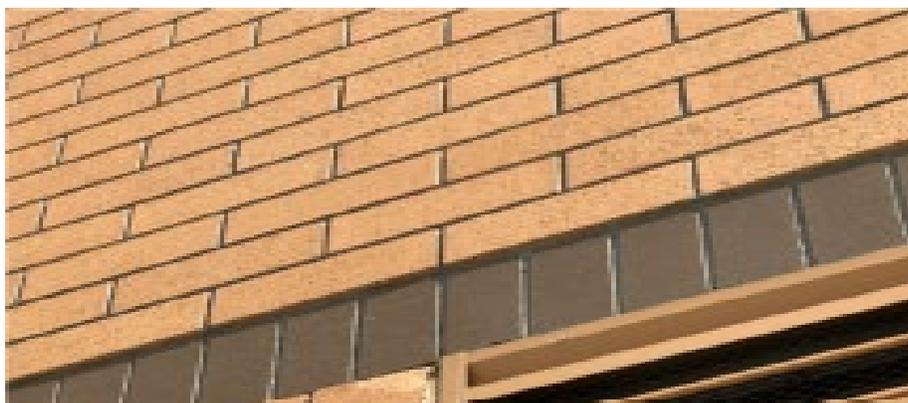
Reston: Figure 15: Spalling of brick masonry noted at Panel 3322. Source: DeSimone

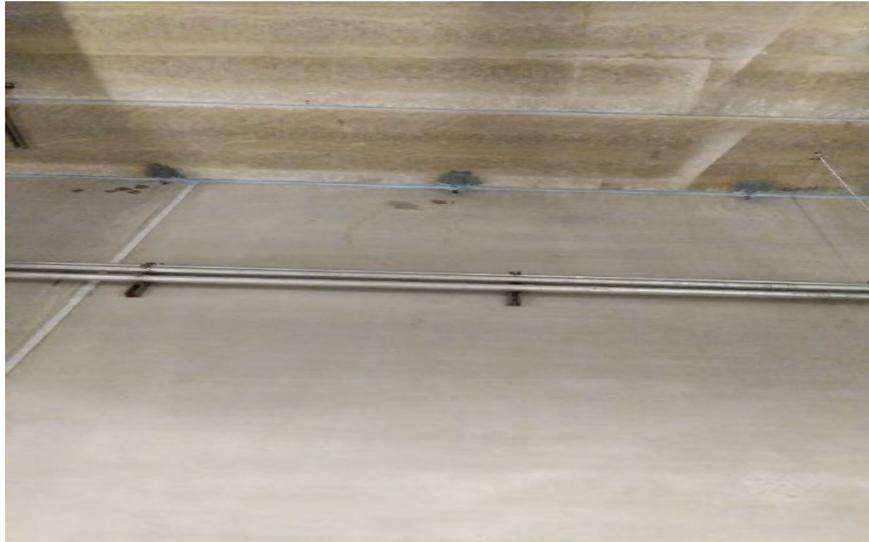
Herndon: Figure 11: Efflorescence at Panel 2538. Source: DeSimone

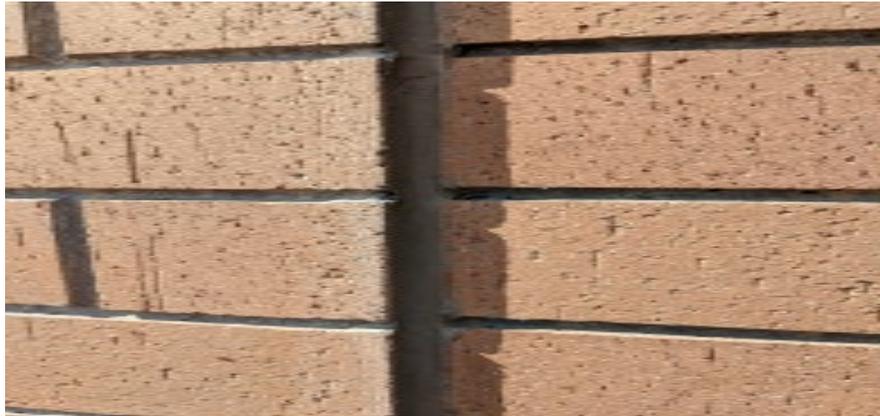
Innovation: Figure 7: Edge of panel outboard and not flush with adjacent panel at Panels 200, 201. Source: DeSimone

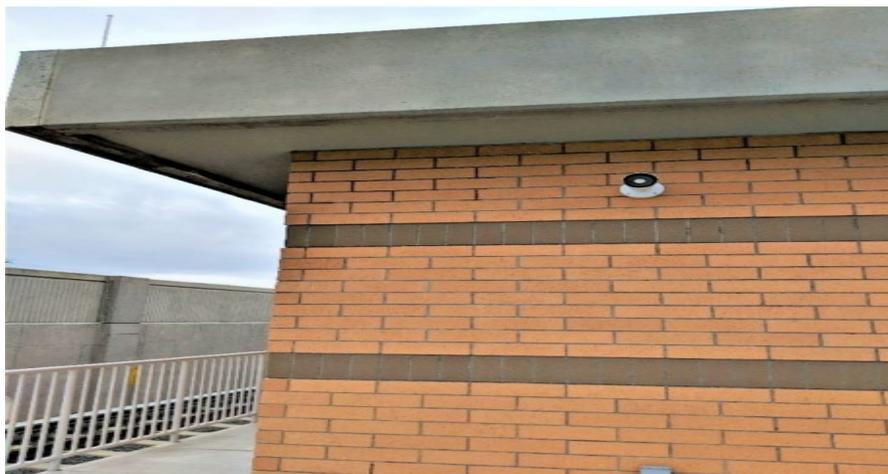
Ashburn: Figure 5: Voids in the brick mortar at Panel 5209. Source: DeSimone
