OIG 18-07
April 6, 2018

Evaluation of the Rhode Island Avenue - Brentwood Station (RIABS) Incidents

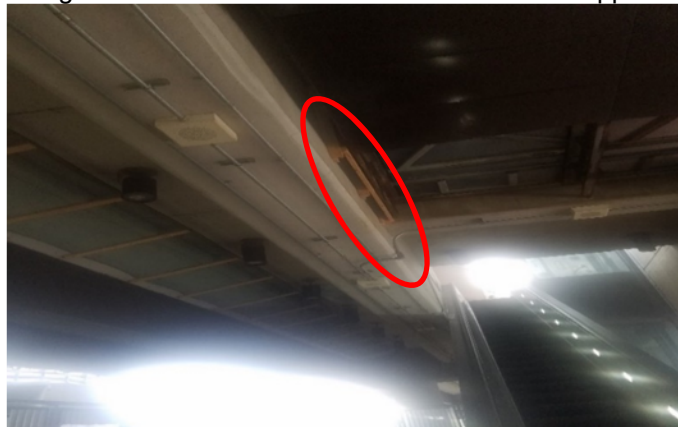
Figure 2: Previous Location of Steel Bracket Support

The inspection process did not identify the conditions leading to the steel bracket support falling on August 31, 2016. The steel bracket support between the escalator and the structure could not be easily examined as it was 16.9 feet above the mezzanine level in a hard-to-reach area (Refer to Figure 2).

The supporting elements of tilework were in a secluded position, and the failed anchor bolts, which caused the RIABS steel bracket to fall, were hidden from view.

1. Develop and implement policies and procedures to inspect non-visual components and hard-to-reach areas. (Action: Chief Operating Officer) (*Risk – High*)
2. Establish accountability for the area between the escalator and the platform structure ensuring it is included in the appropriate inspection process. (Action: Chief Operating Officer) (*Risk – High*)

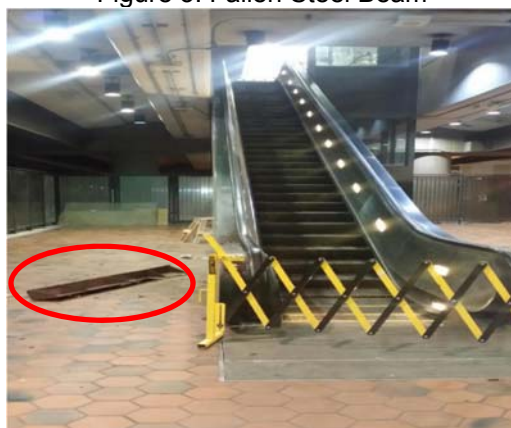
Figure 3: Fallen Steel Beam

Having a more robust inspection process may have prevented the steel bracket support located between the escalator and platform structure from falling to the mezzanine area (Refer to Figure 3). This incident created a potential safety risk had an individual been standing in that area.

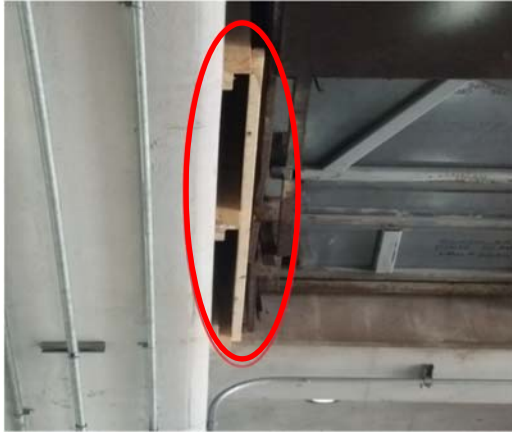
Figure 6: Incident 1 Temporary Repair

- Subsequent to the August 31, 2016 incident, TRST reinforced the area where the steel bracket support fell with a temporary structural falsework, or a wooden stabilizer (Refer to Figure 6). In addition, similar reinforcement was performed on the other side of the escalator. On September 1, 2016, the Office of Plant Maintenance met with ENGA and developed a repair plan for the permanent repair.
- Subsequent to the September 1, 2016 incident, to mitigate future risk, TRST reinforced the area where the concrete fell with safety/debris netting at the site of the incident. In addition, the same netting was installed on the remaining underside of the deck areas on both sides to prevent additional concrete from falling to the ground (Refer to Figure 7).

In April 2017, approximately eight months after the two incidents occurred, the OIG visited the RIABS and found the temporary structural falsework and safety netting were still in place. The OIG conducted site visits at RIABS in September 2017 and January 2018, and found that they were still in place.

4. Develop procedures to conduct post-incident structure inspection repairs and monitor them to completion. (Action: Chief Operating Officer) (*Risk – High*)
5. Periodically inspect the condition of the temporary structural falsework and safety netting at RIABS for continued safety. (Action: Chief Operating Officer) (*Risk – High*)
6. Complete permanent repairs related to the two incidents. (Action: Chief Operating Officer) (*Risk – High*)
