SUBJECT: Management Assistance Report
WMATA Crane Purchase
(MAR-23-0001)

DATE PUBLISHED: November 17, 2022

FROM: OIG – Rene Febles [REDACTED]

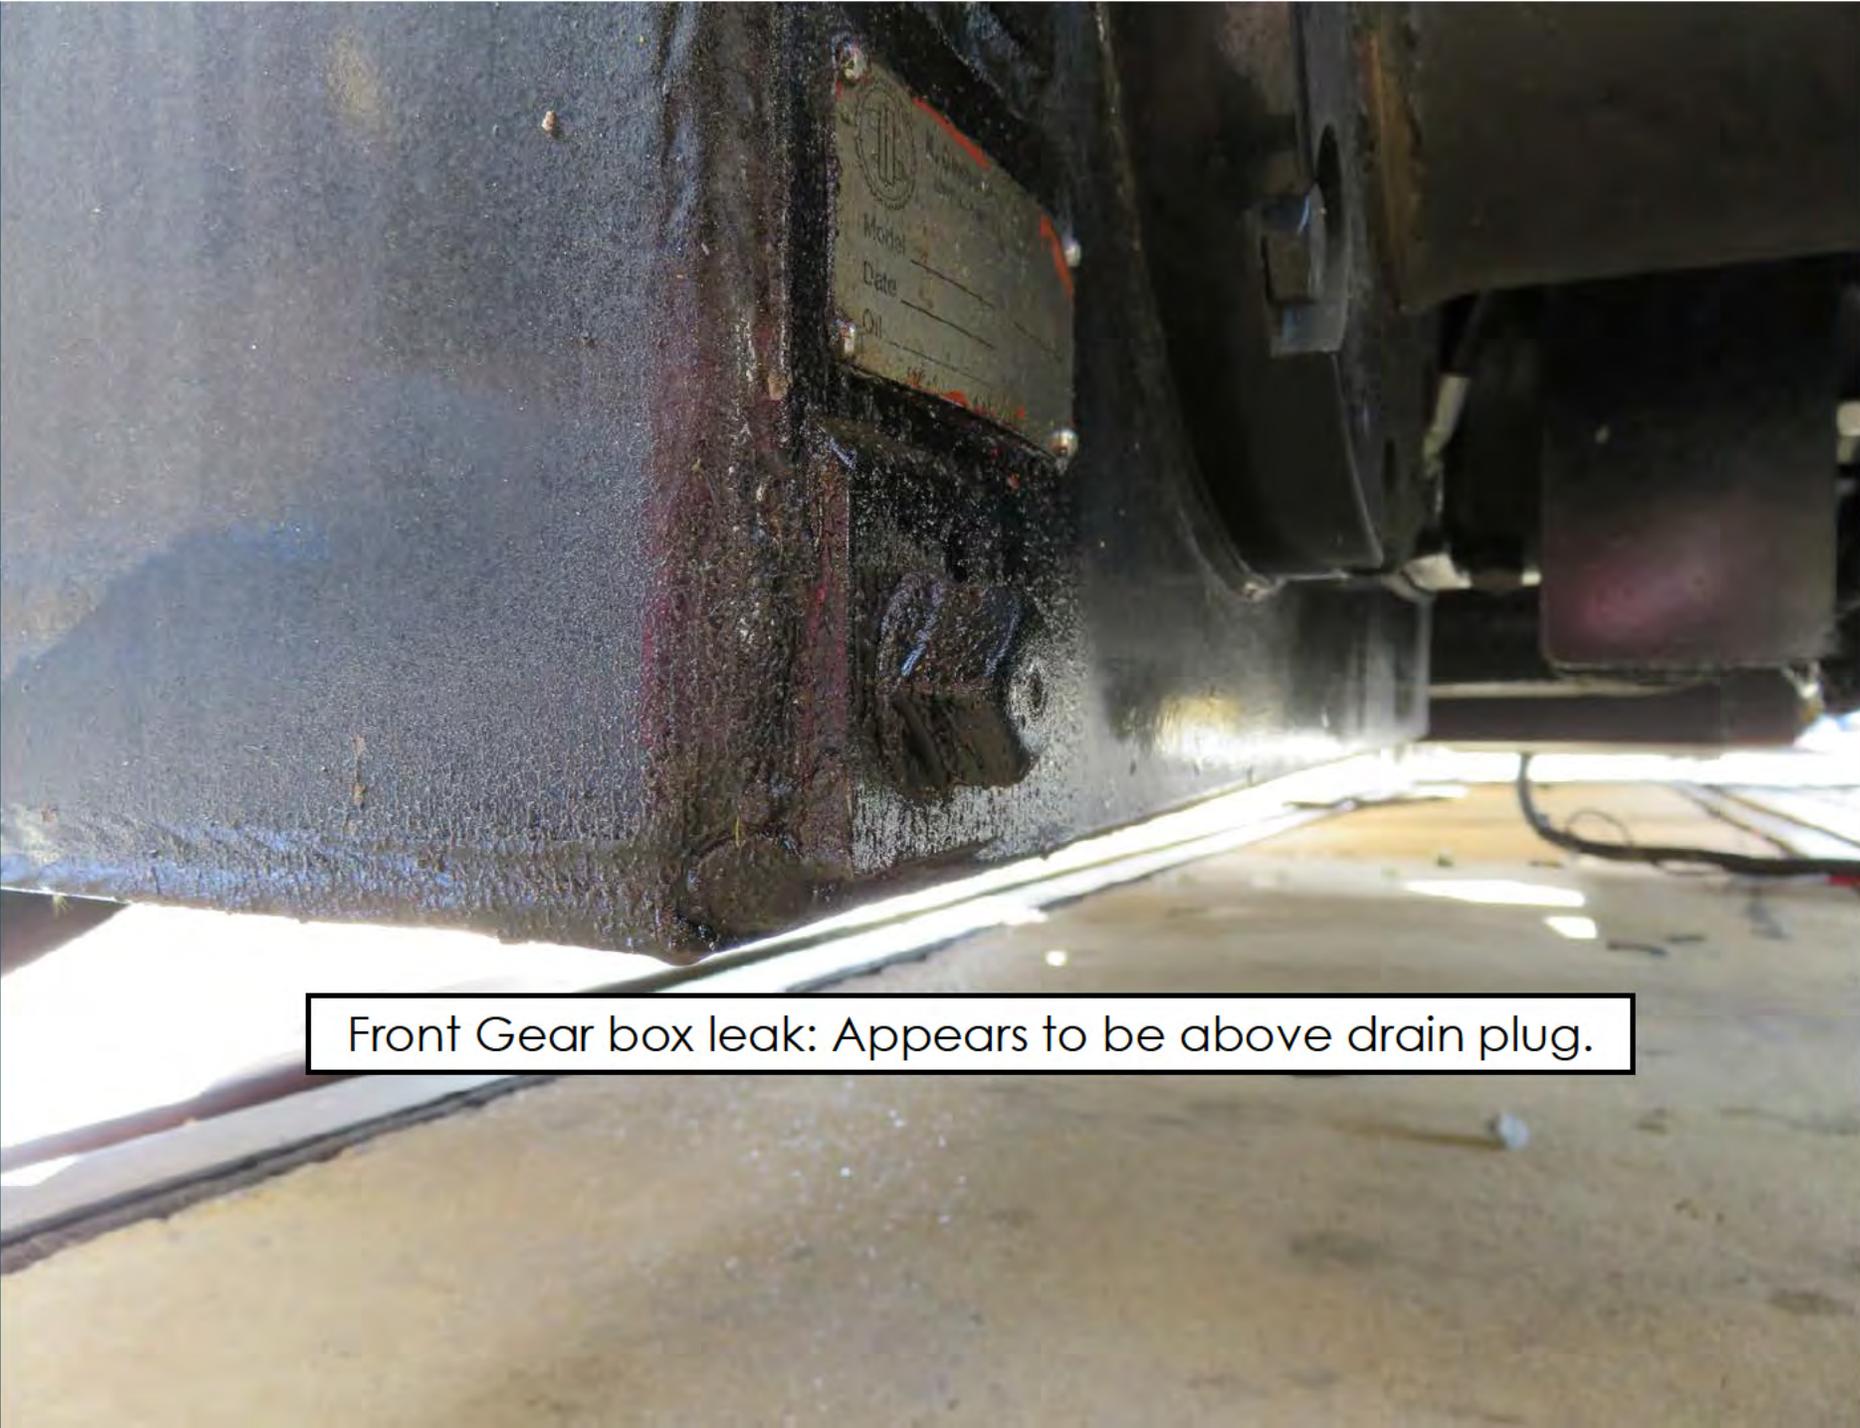
Front Gear box leak: Appears to be above drain plug.

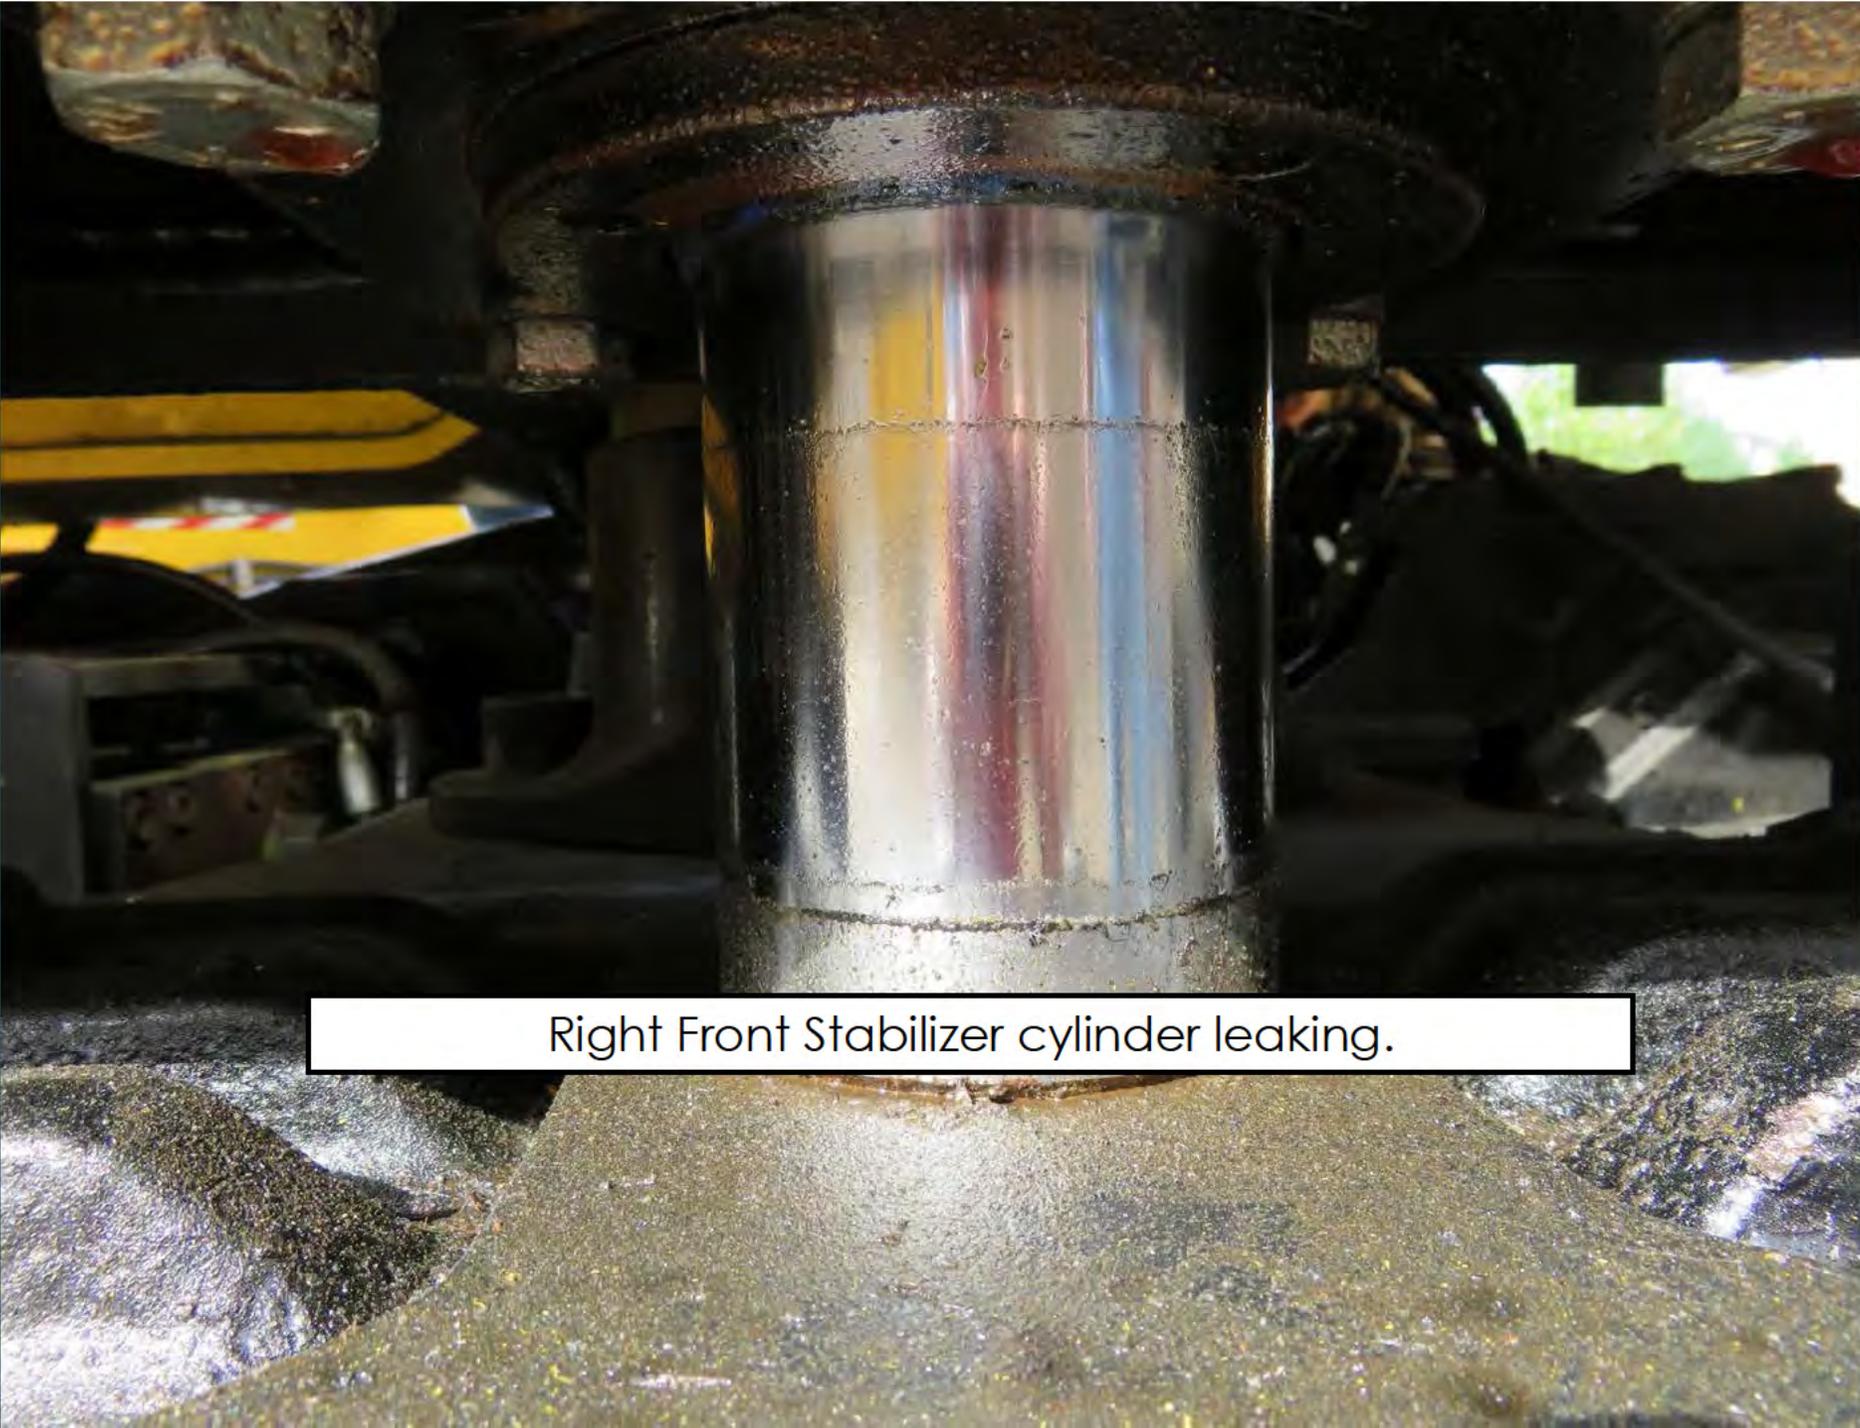
Right Front Stabilizer cylinder leaking.

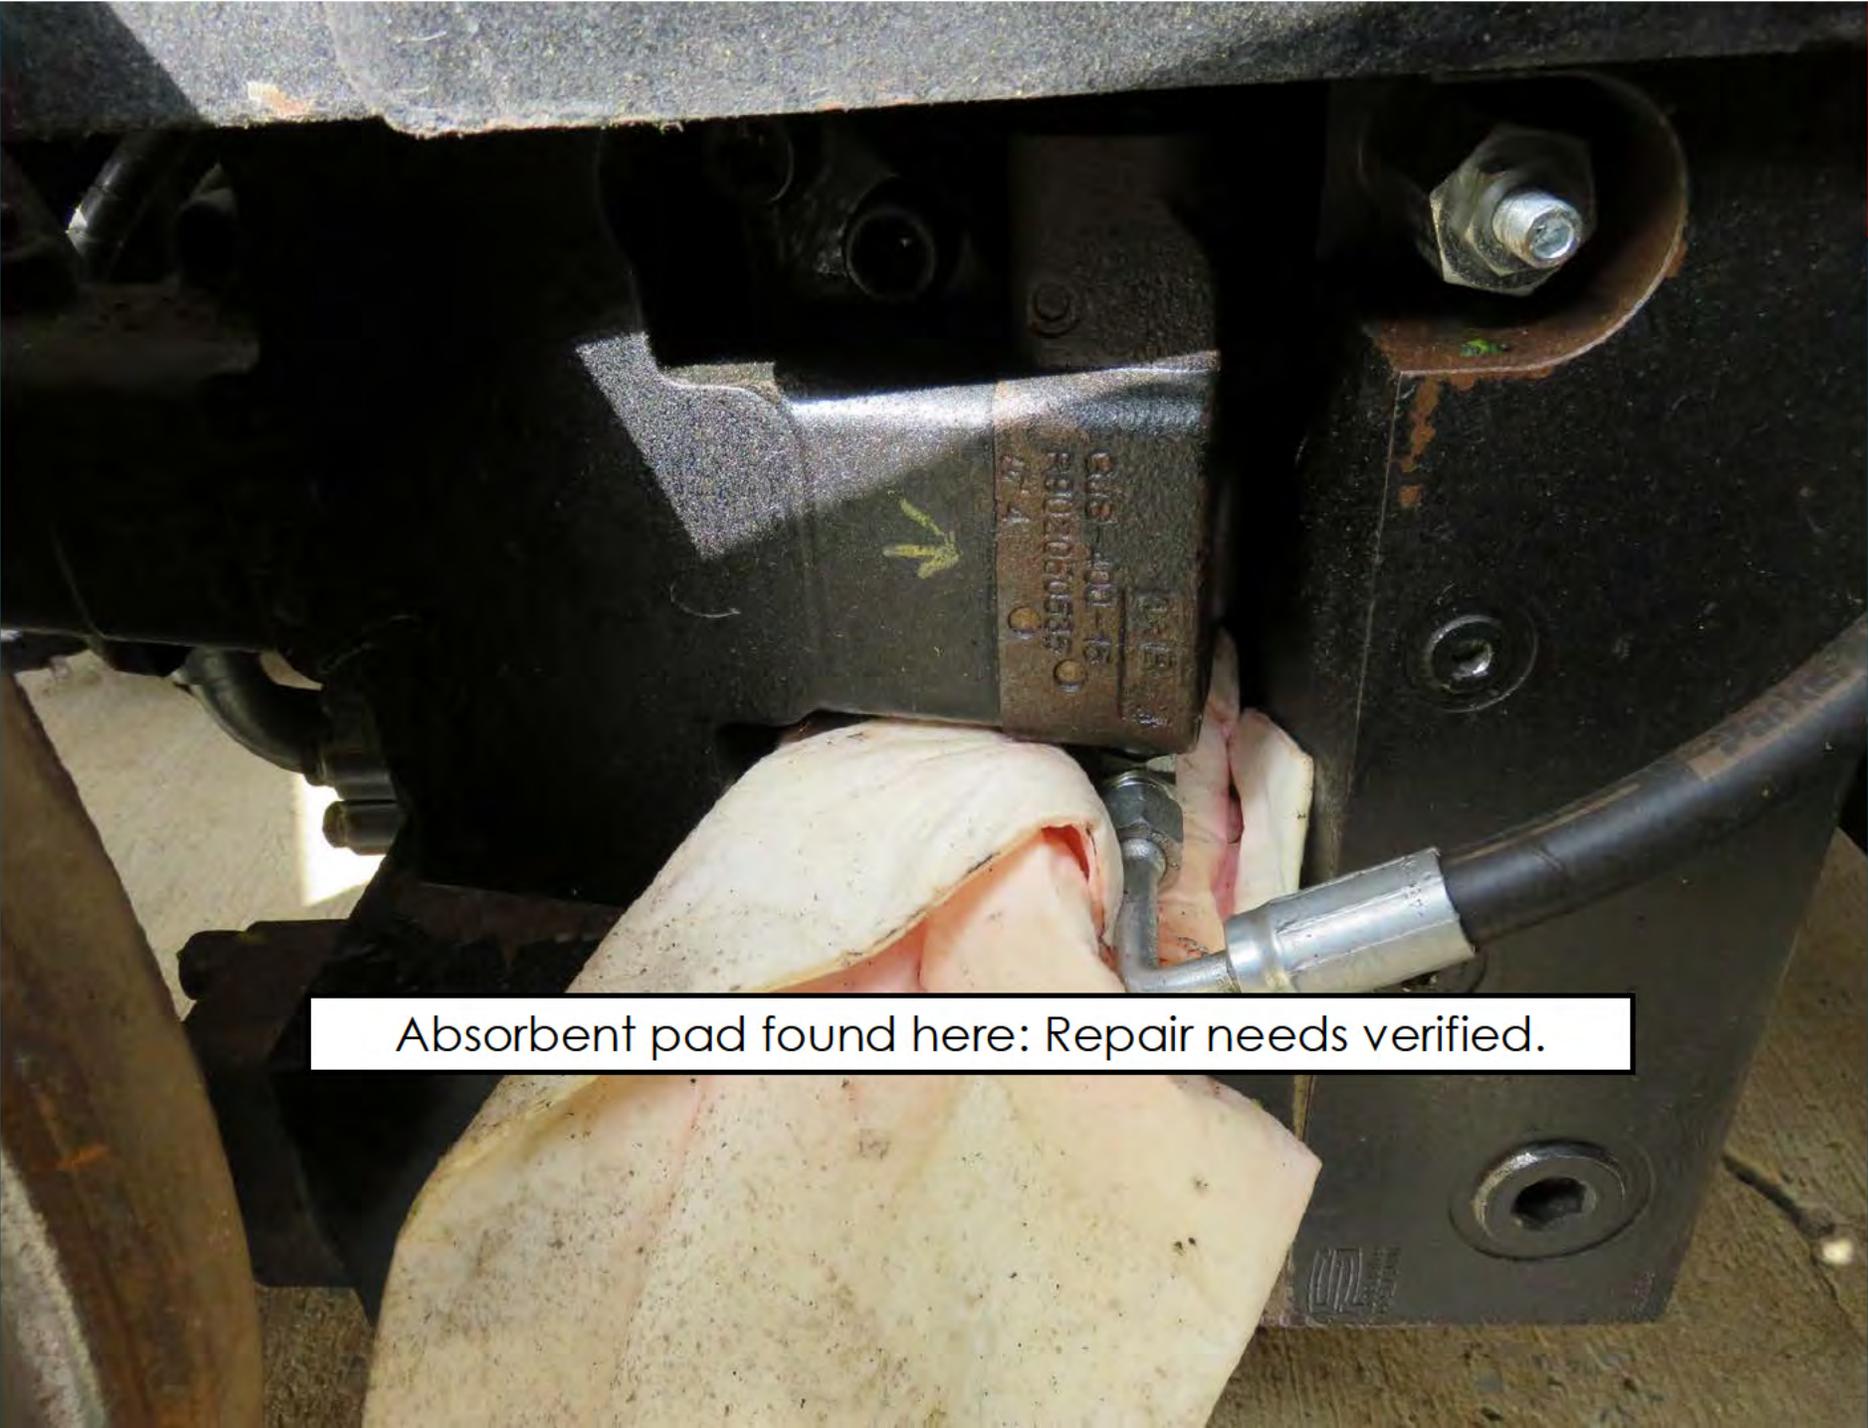
Absorbent pad found here: Repair needs verified.

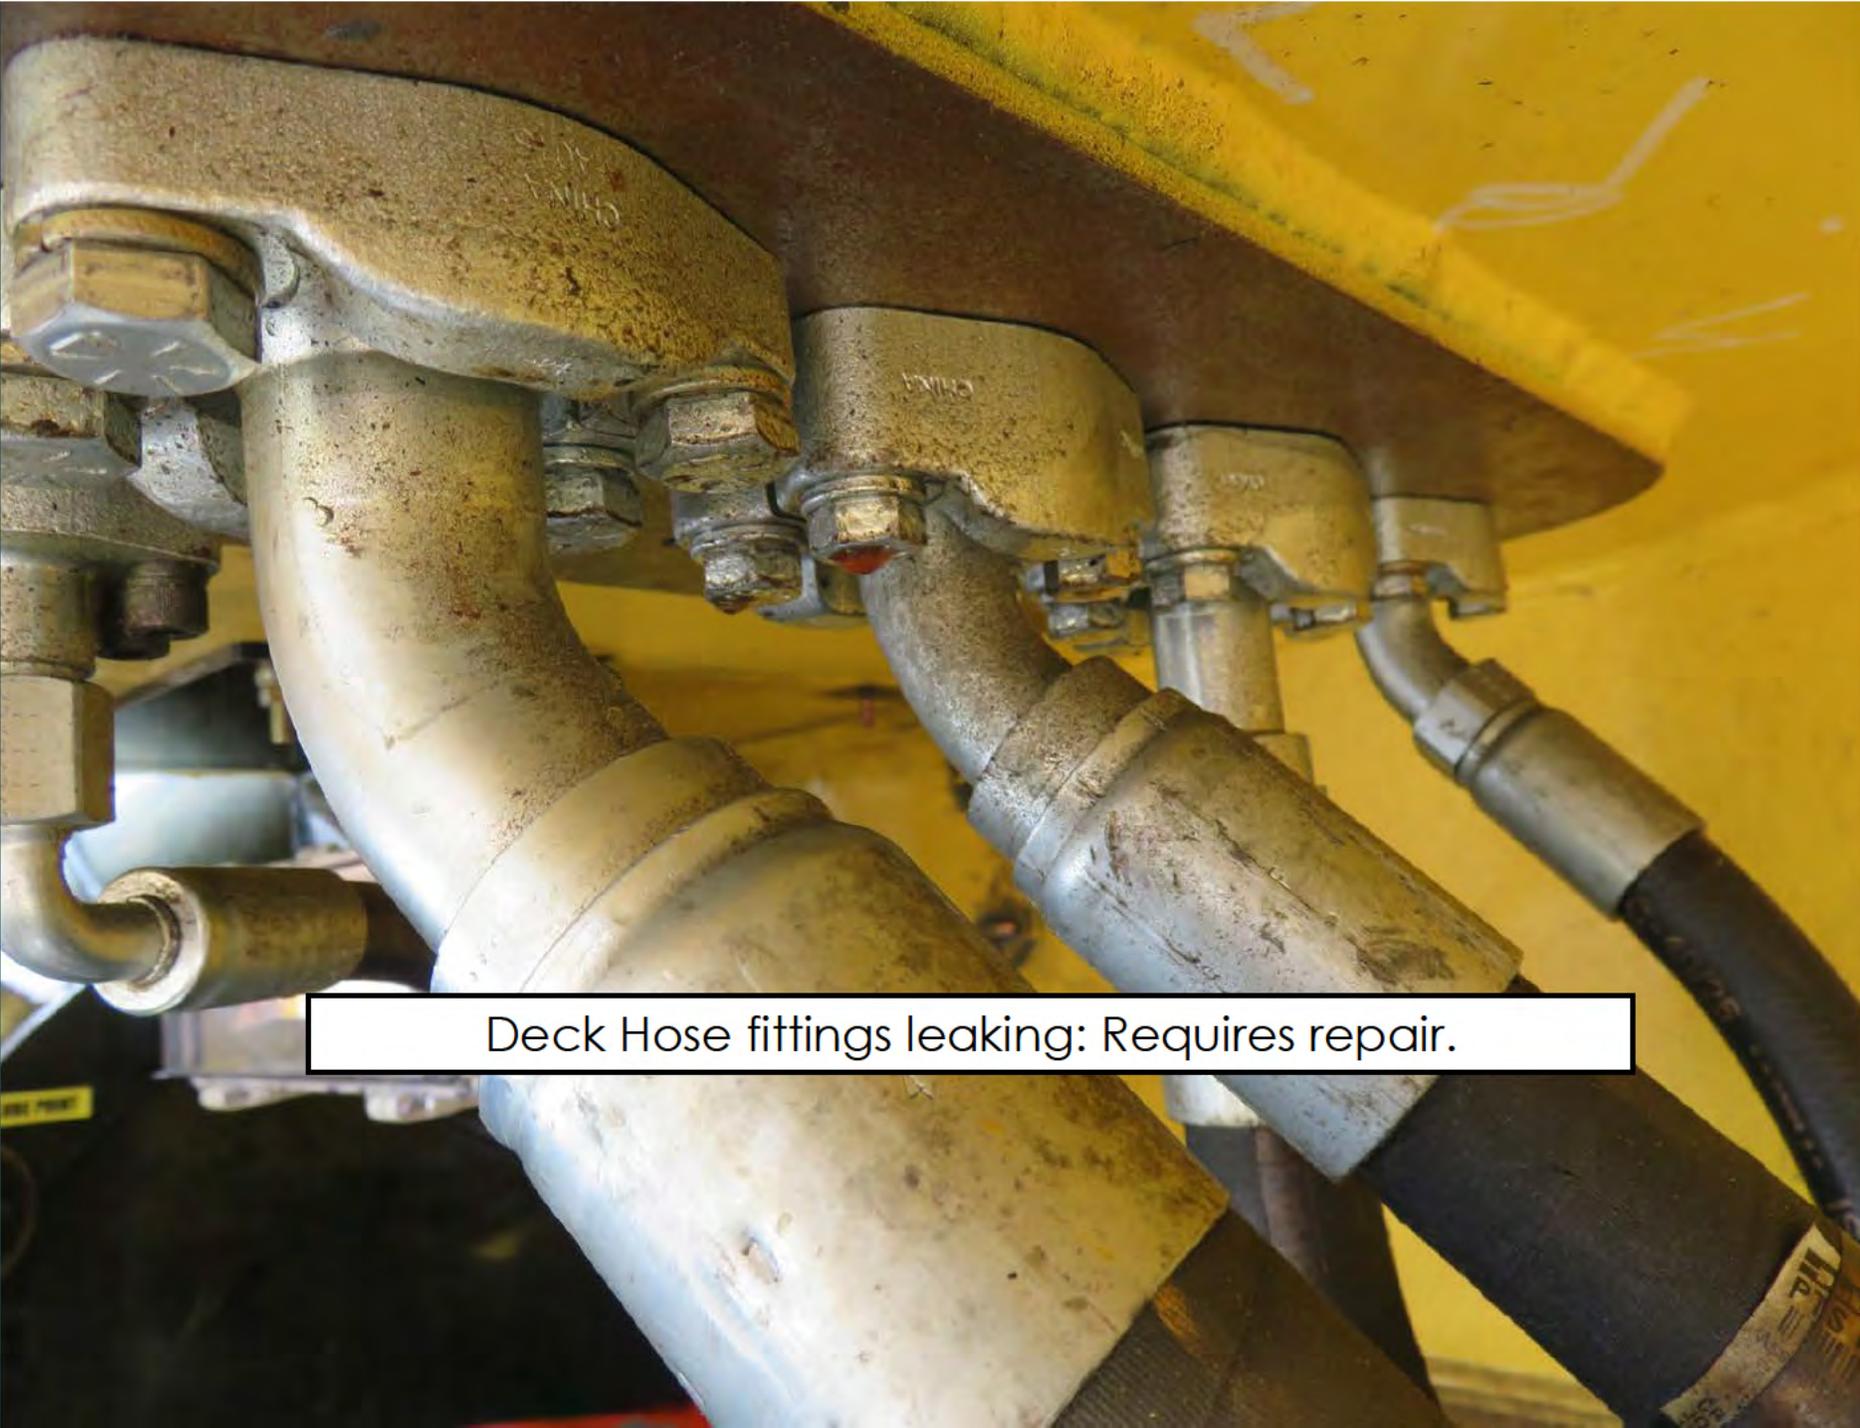
Deck Hose fittings leaking: Requires repair.

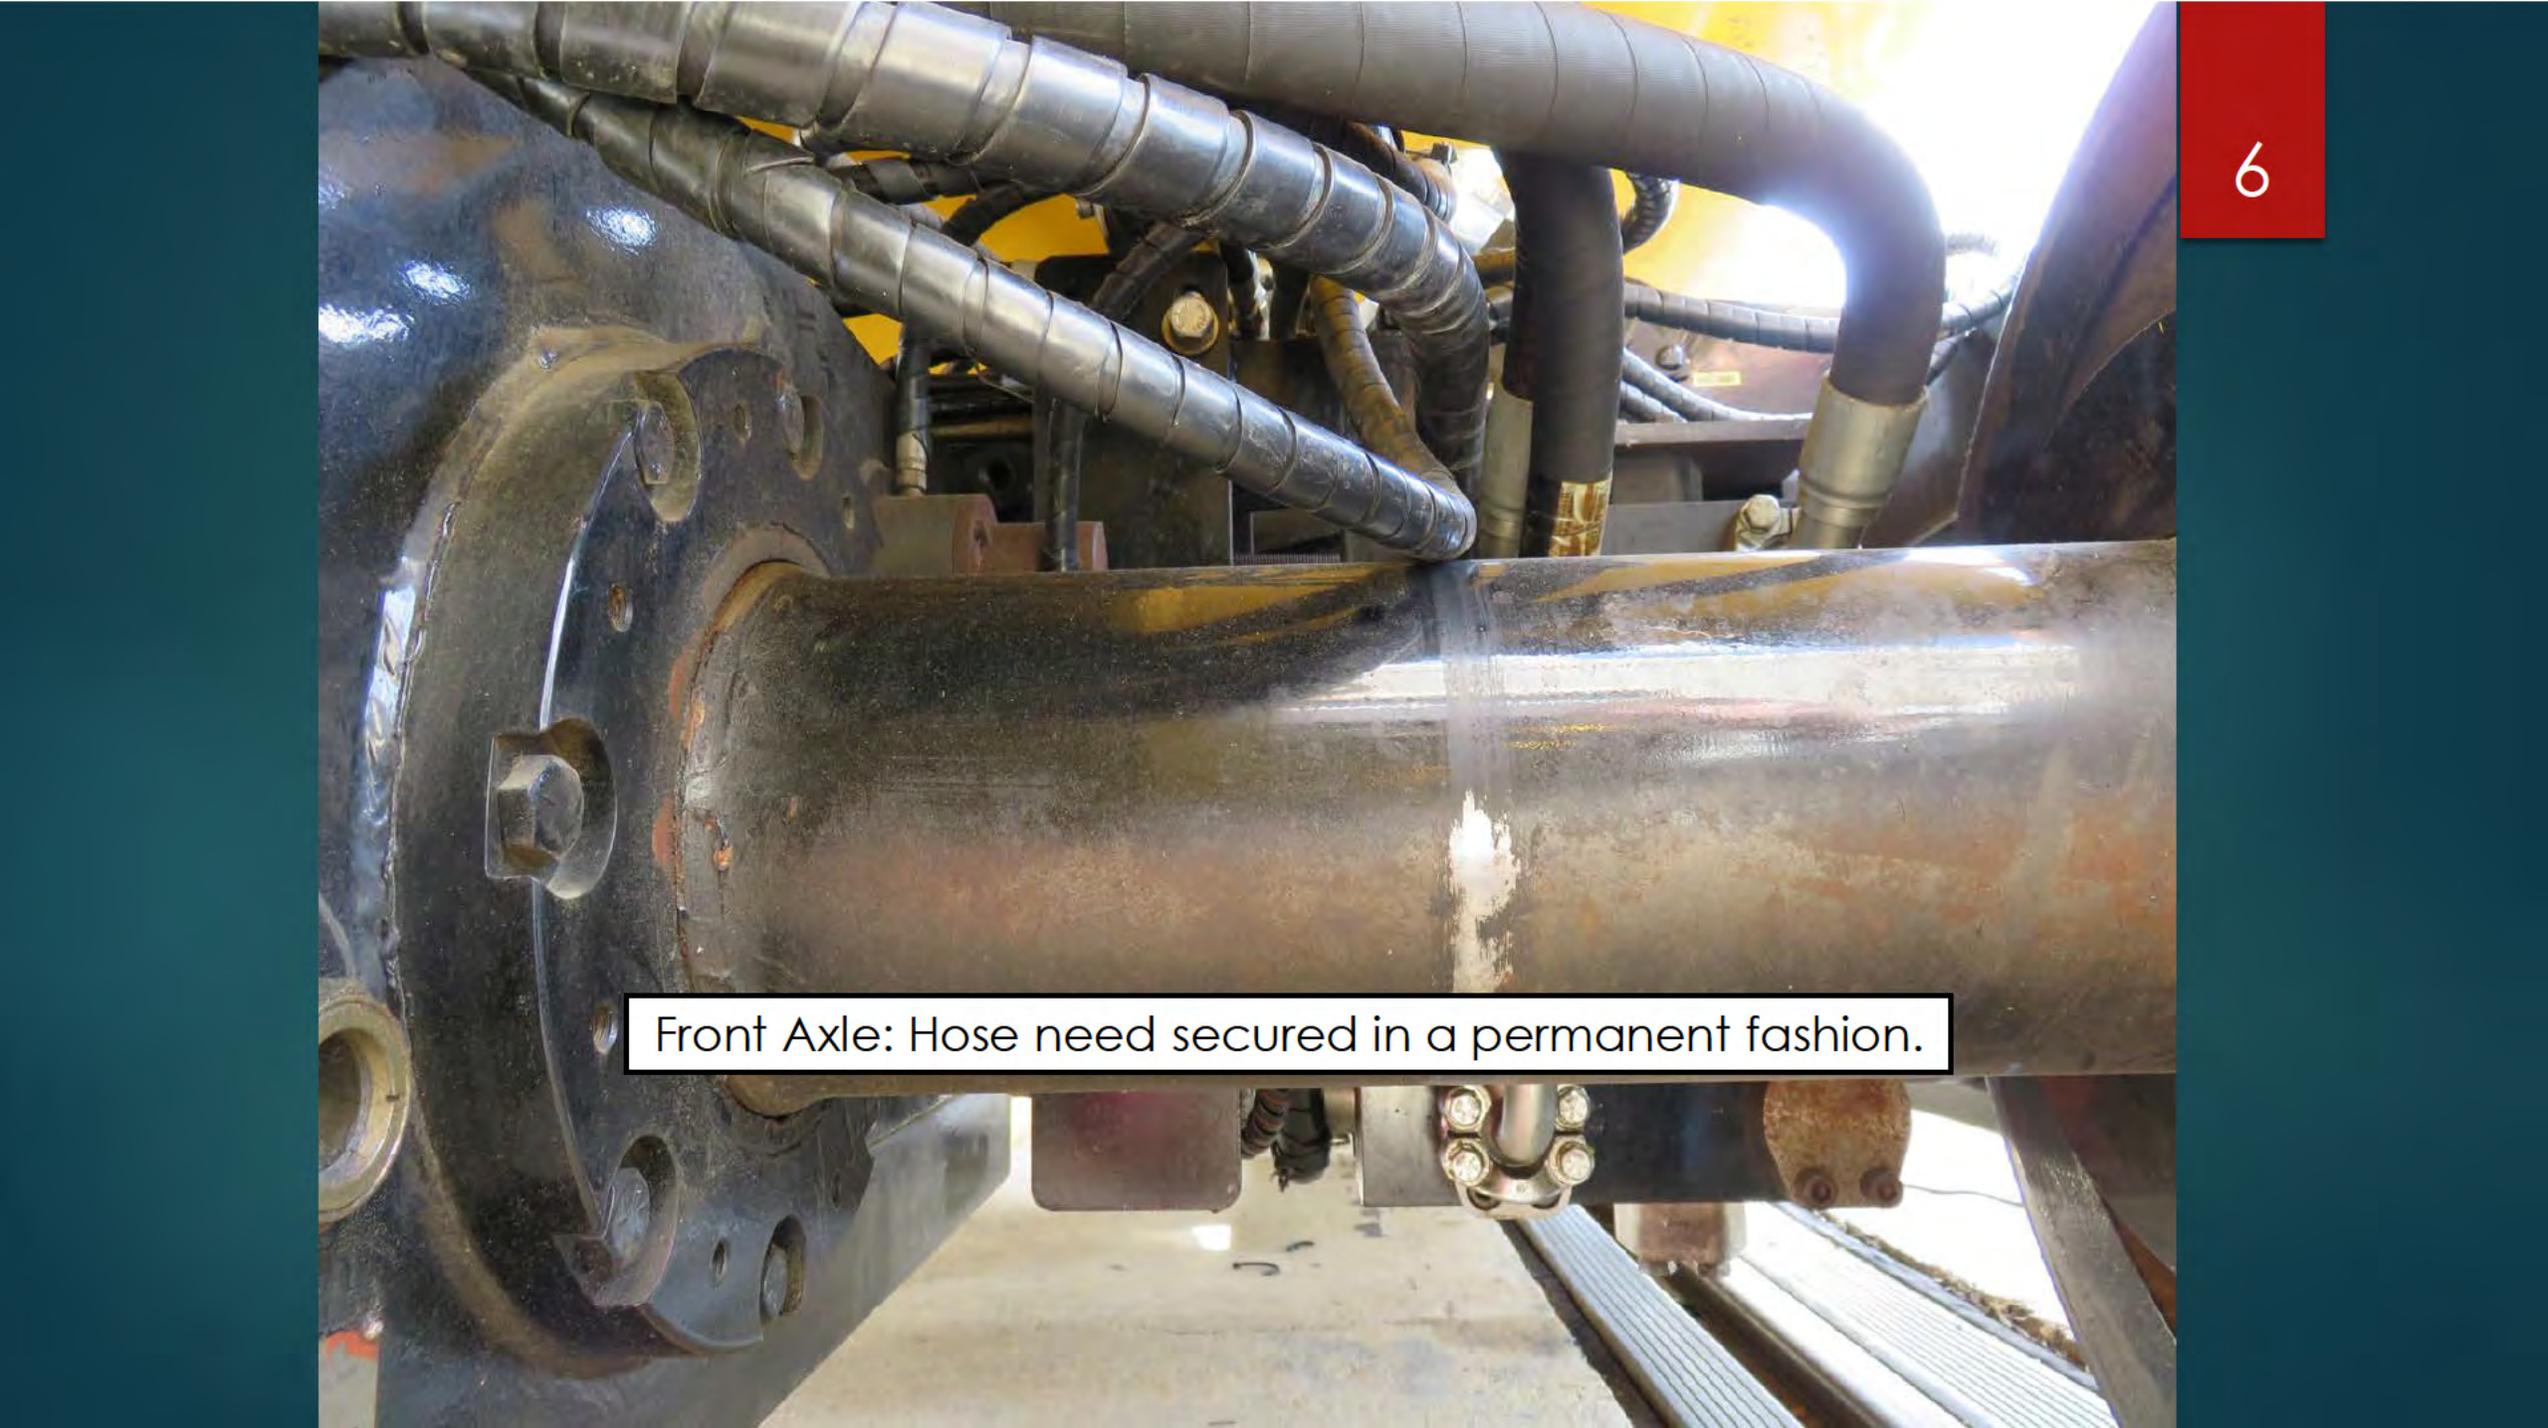
Front Axle: Hose need secured in a permanent fashion.

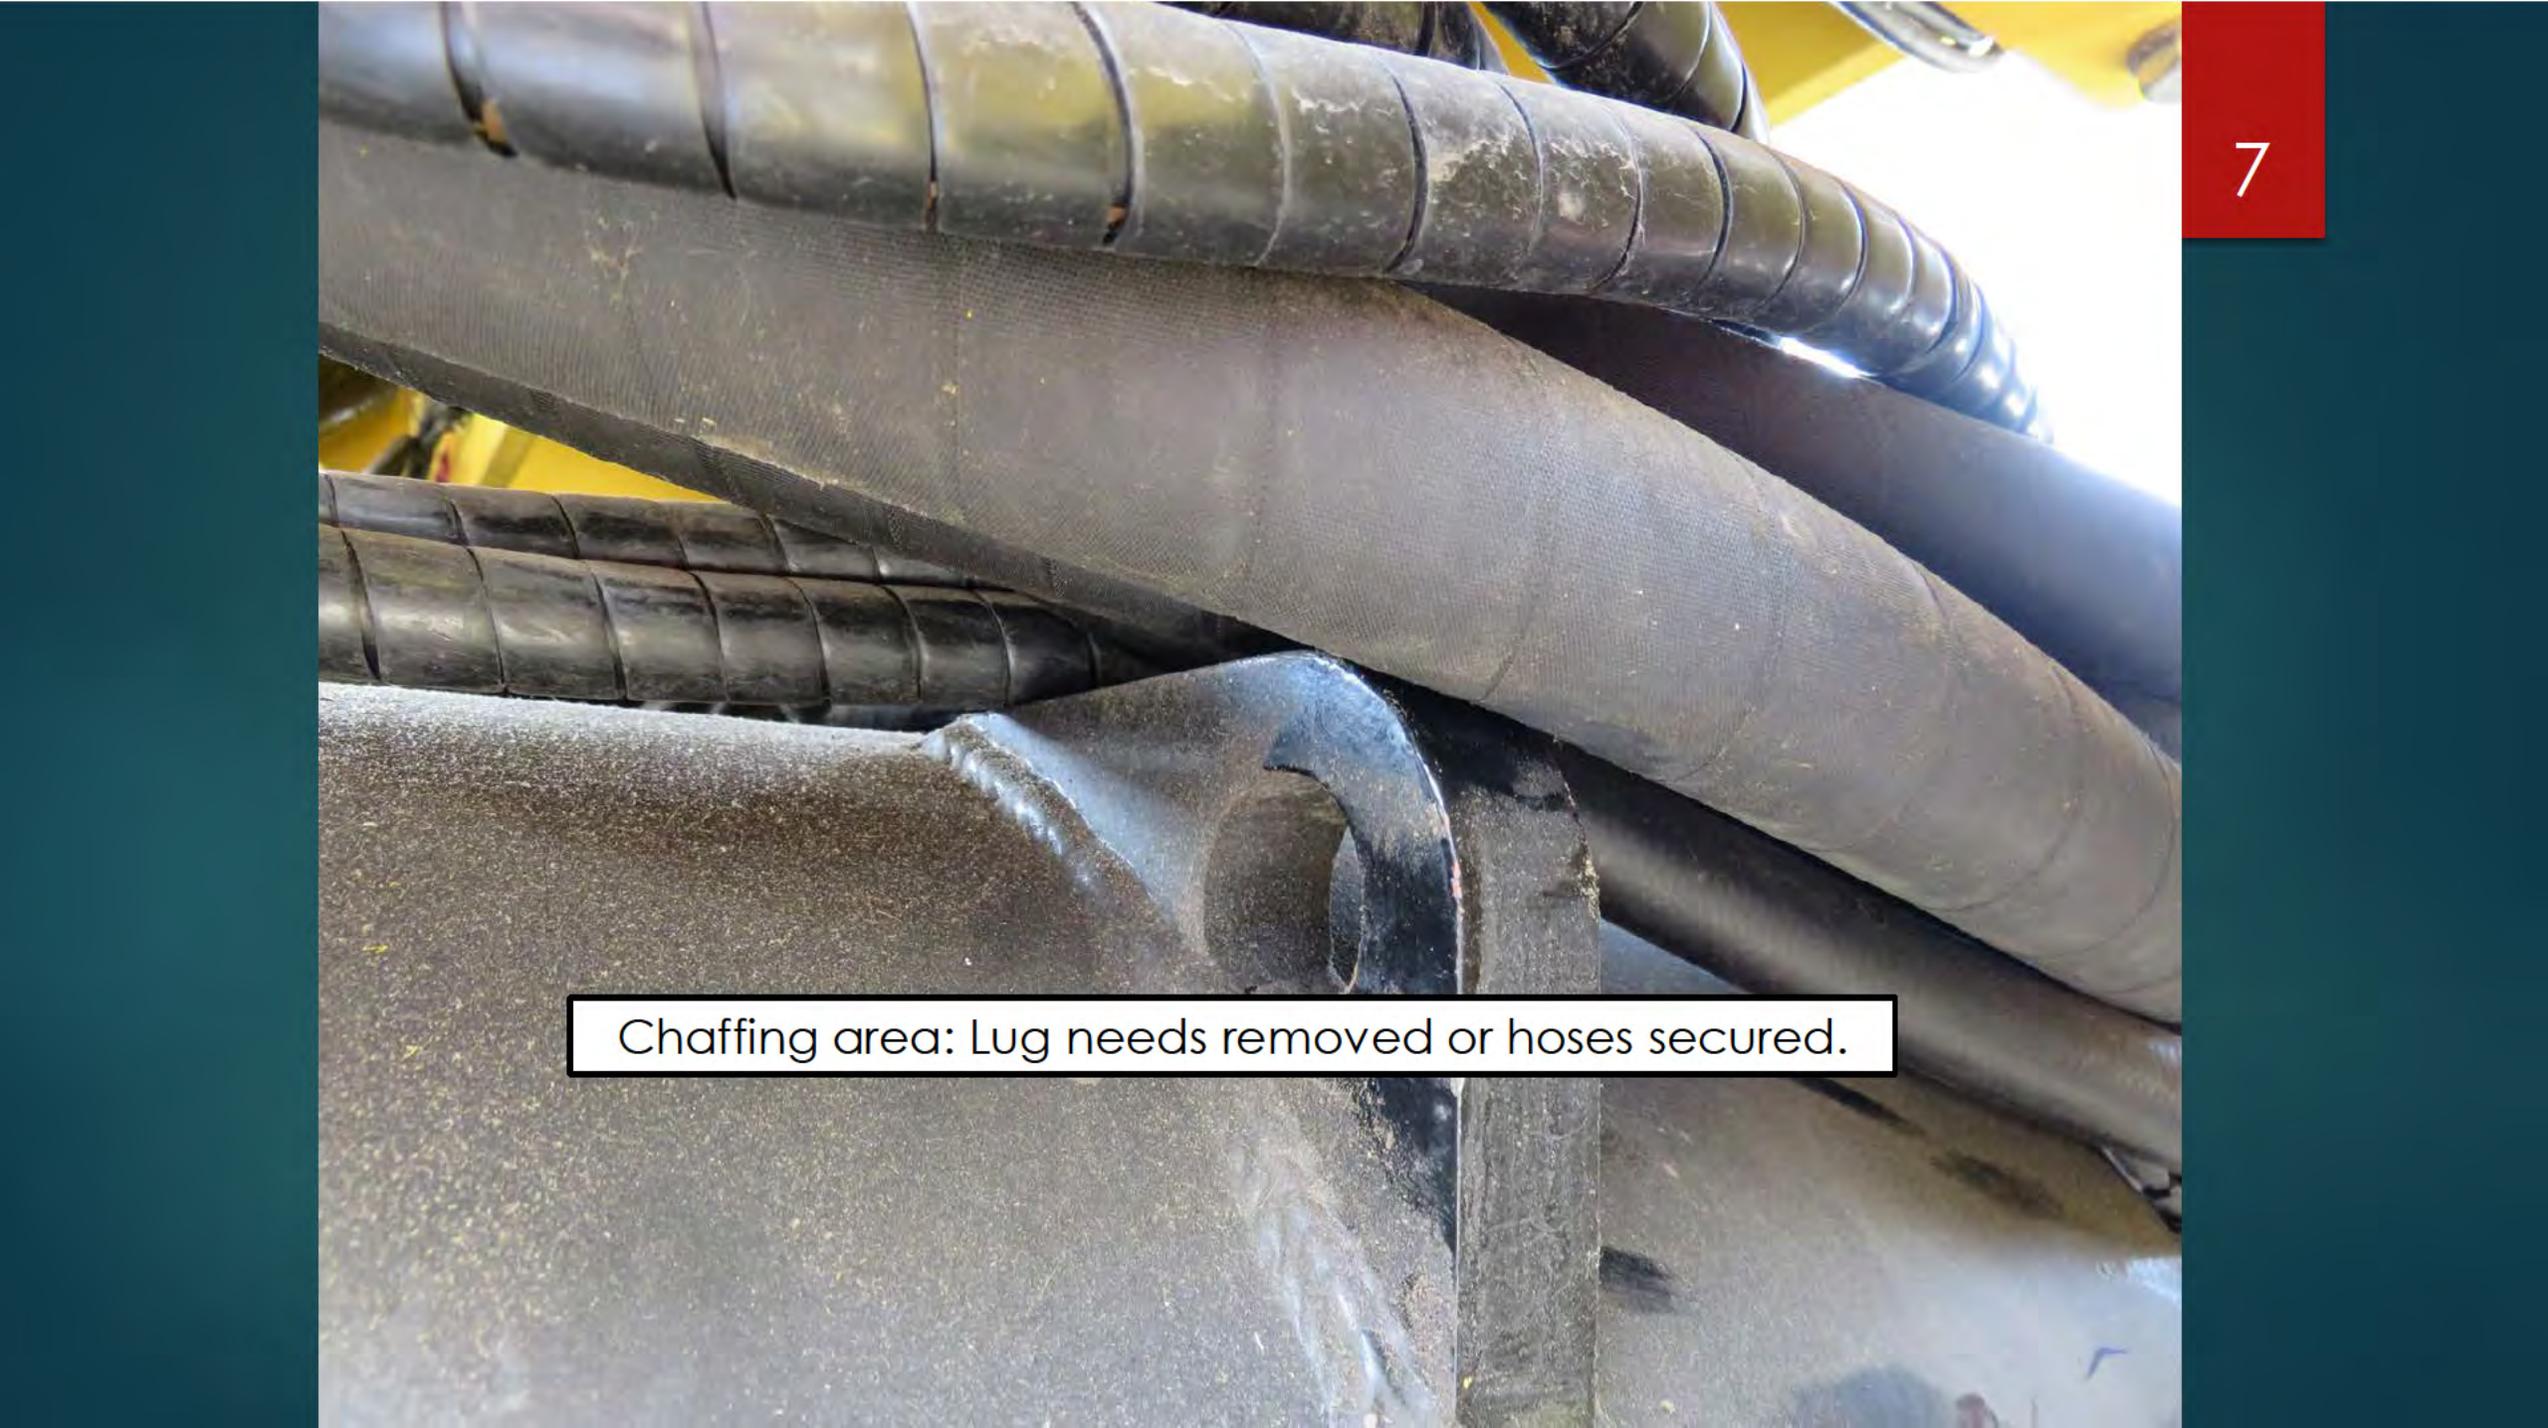
Chaffing area: Lug needs removed or hoses secured.

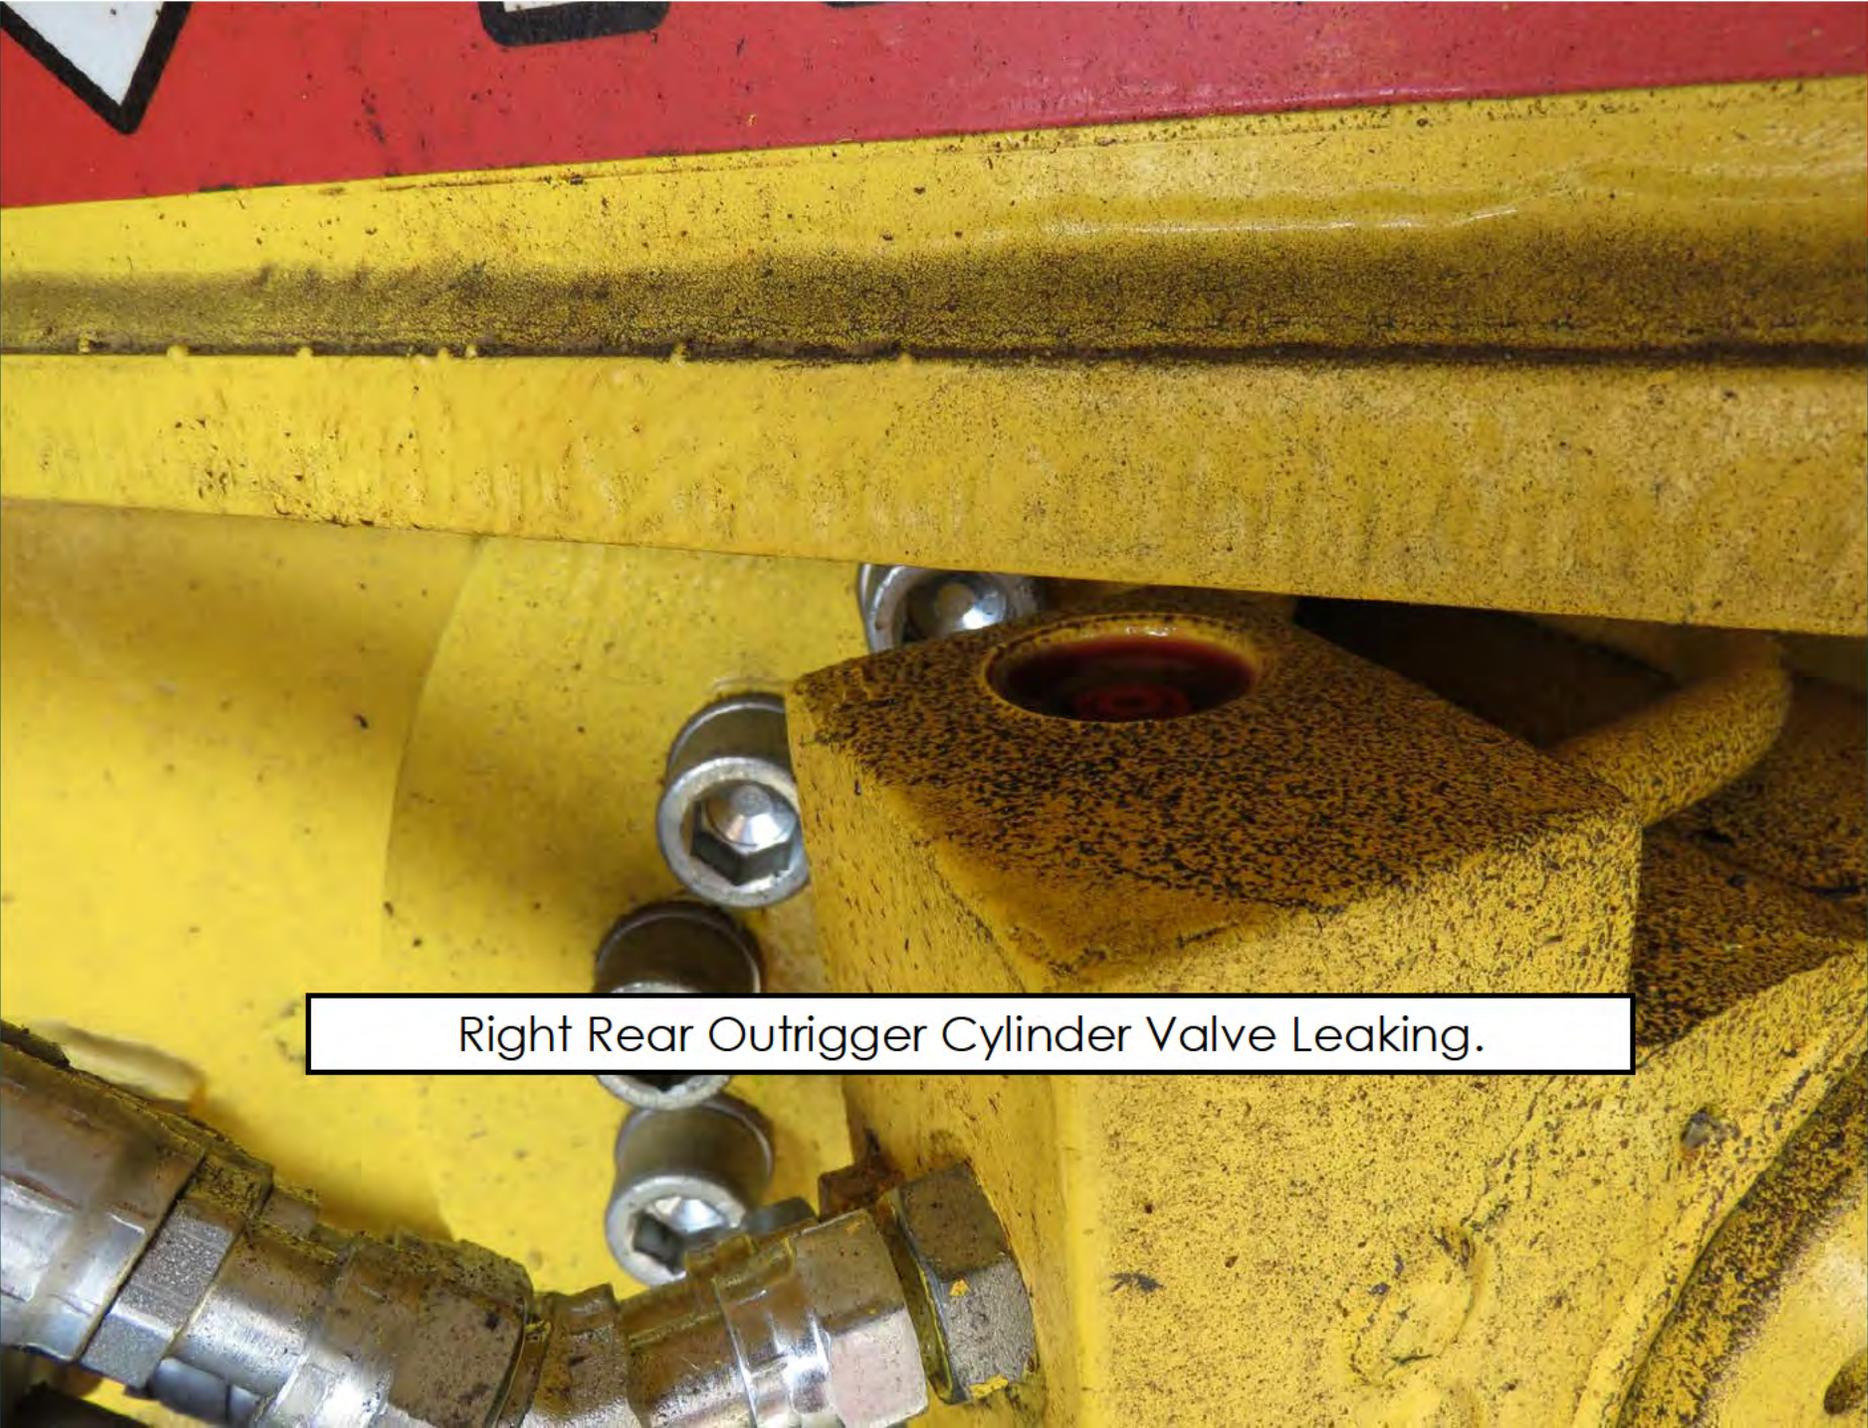
Right Rear Outrigger Cylinder Valve Leaking.

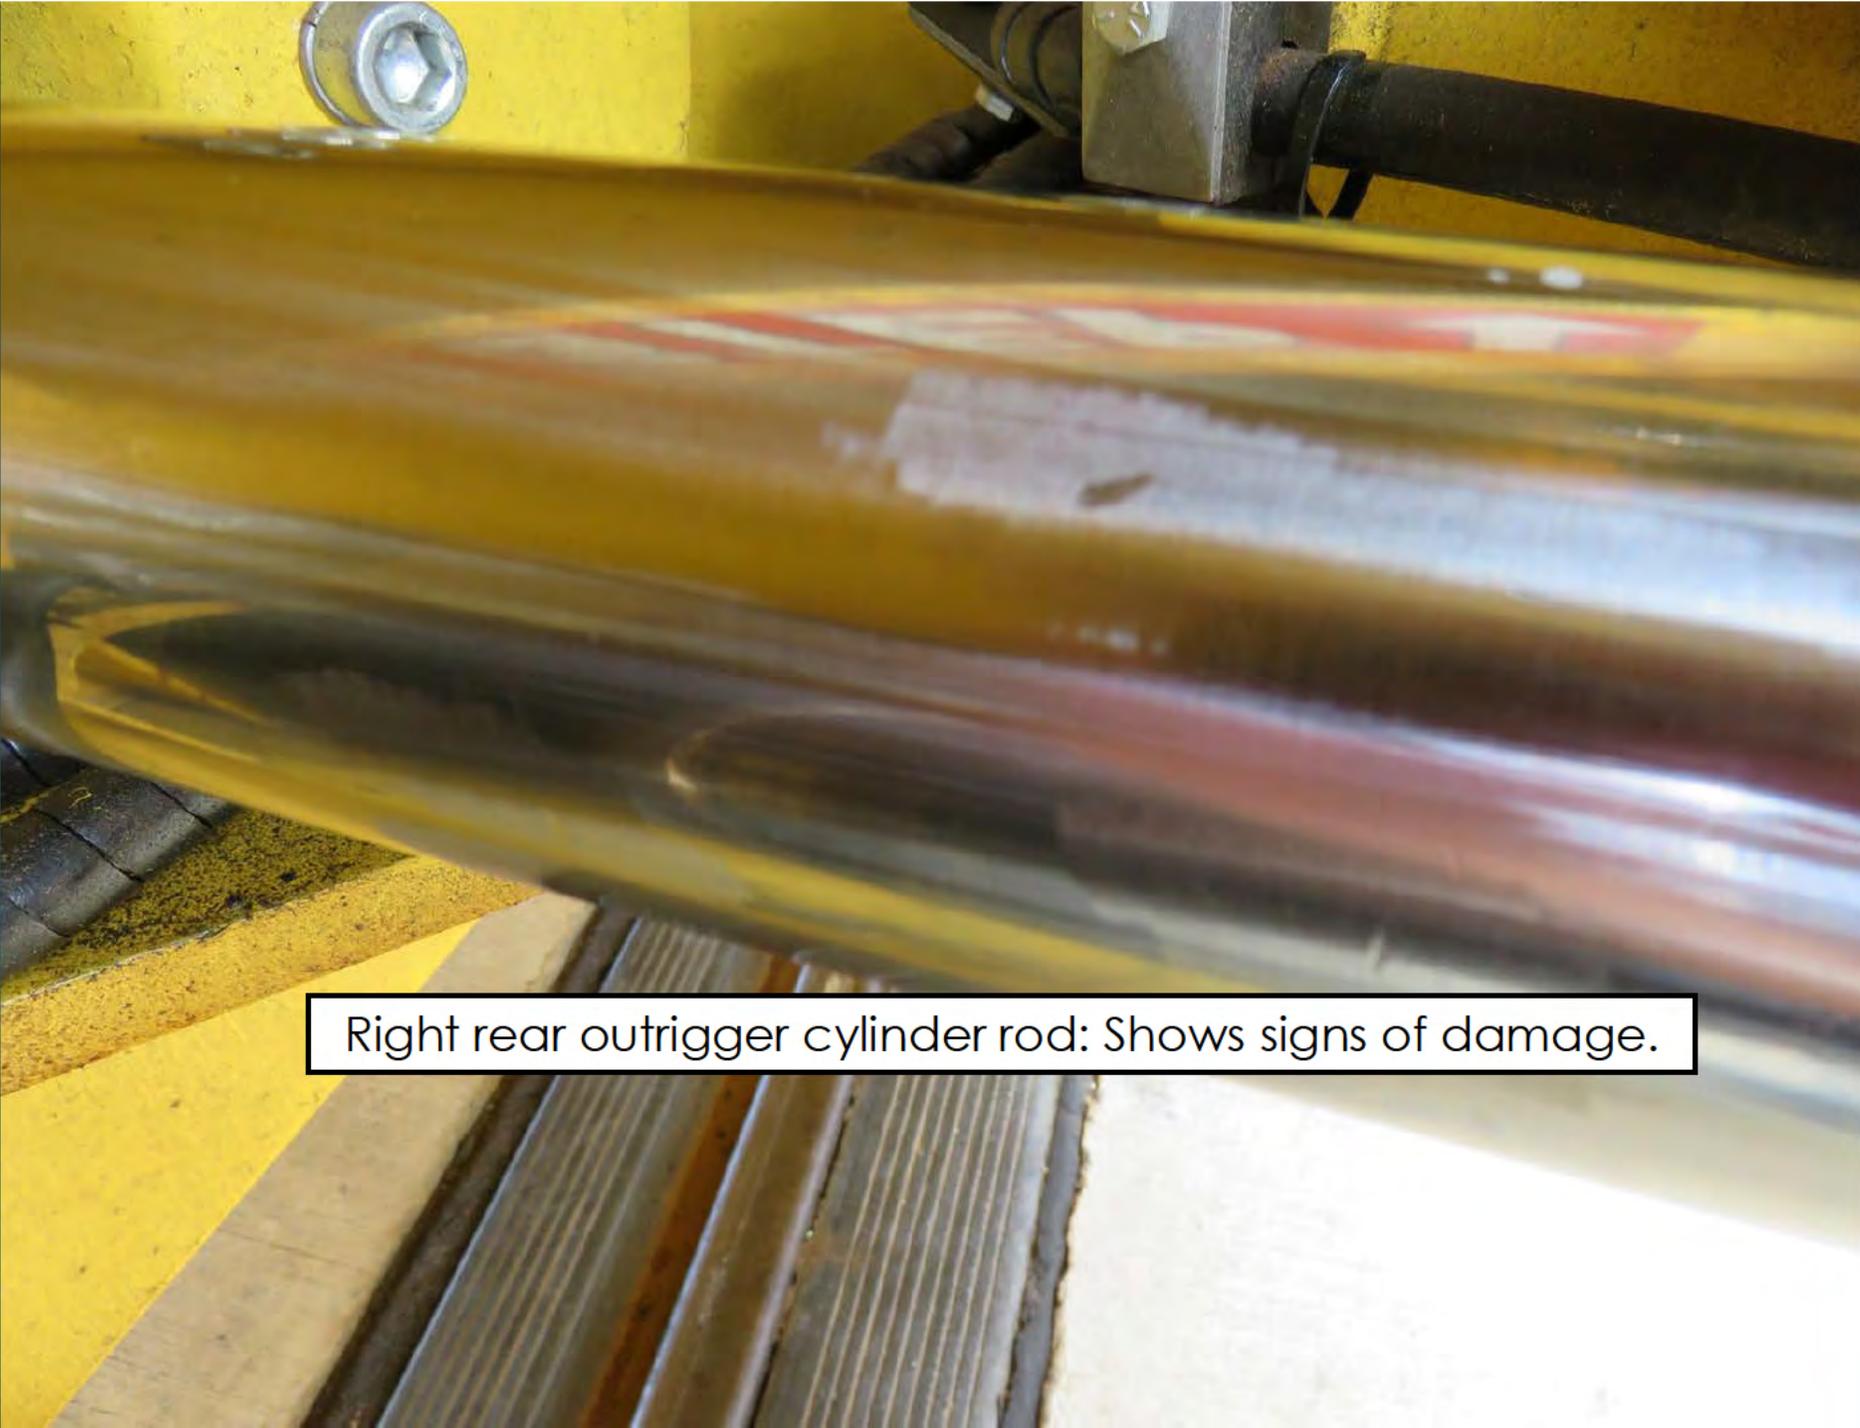
Right rear outrigger cylinder rod: Shows signs of damage.
