SUBJECT: Management Assistance Report
WMATA Crane Purchase
(MAR-23-0001)

DATE PUBLISHED: November 17, 2022

FROM: OIG – Rene Febles [REDACTED]

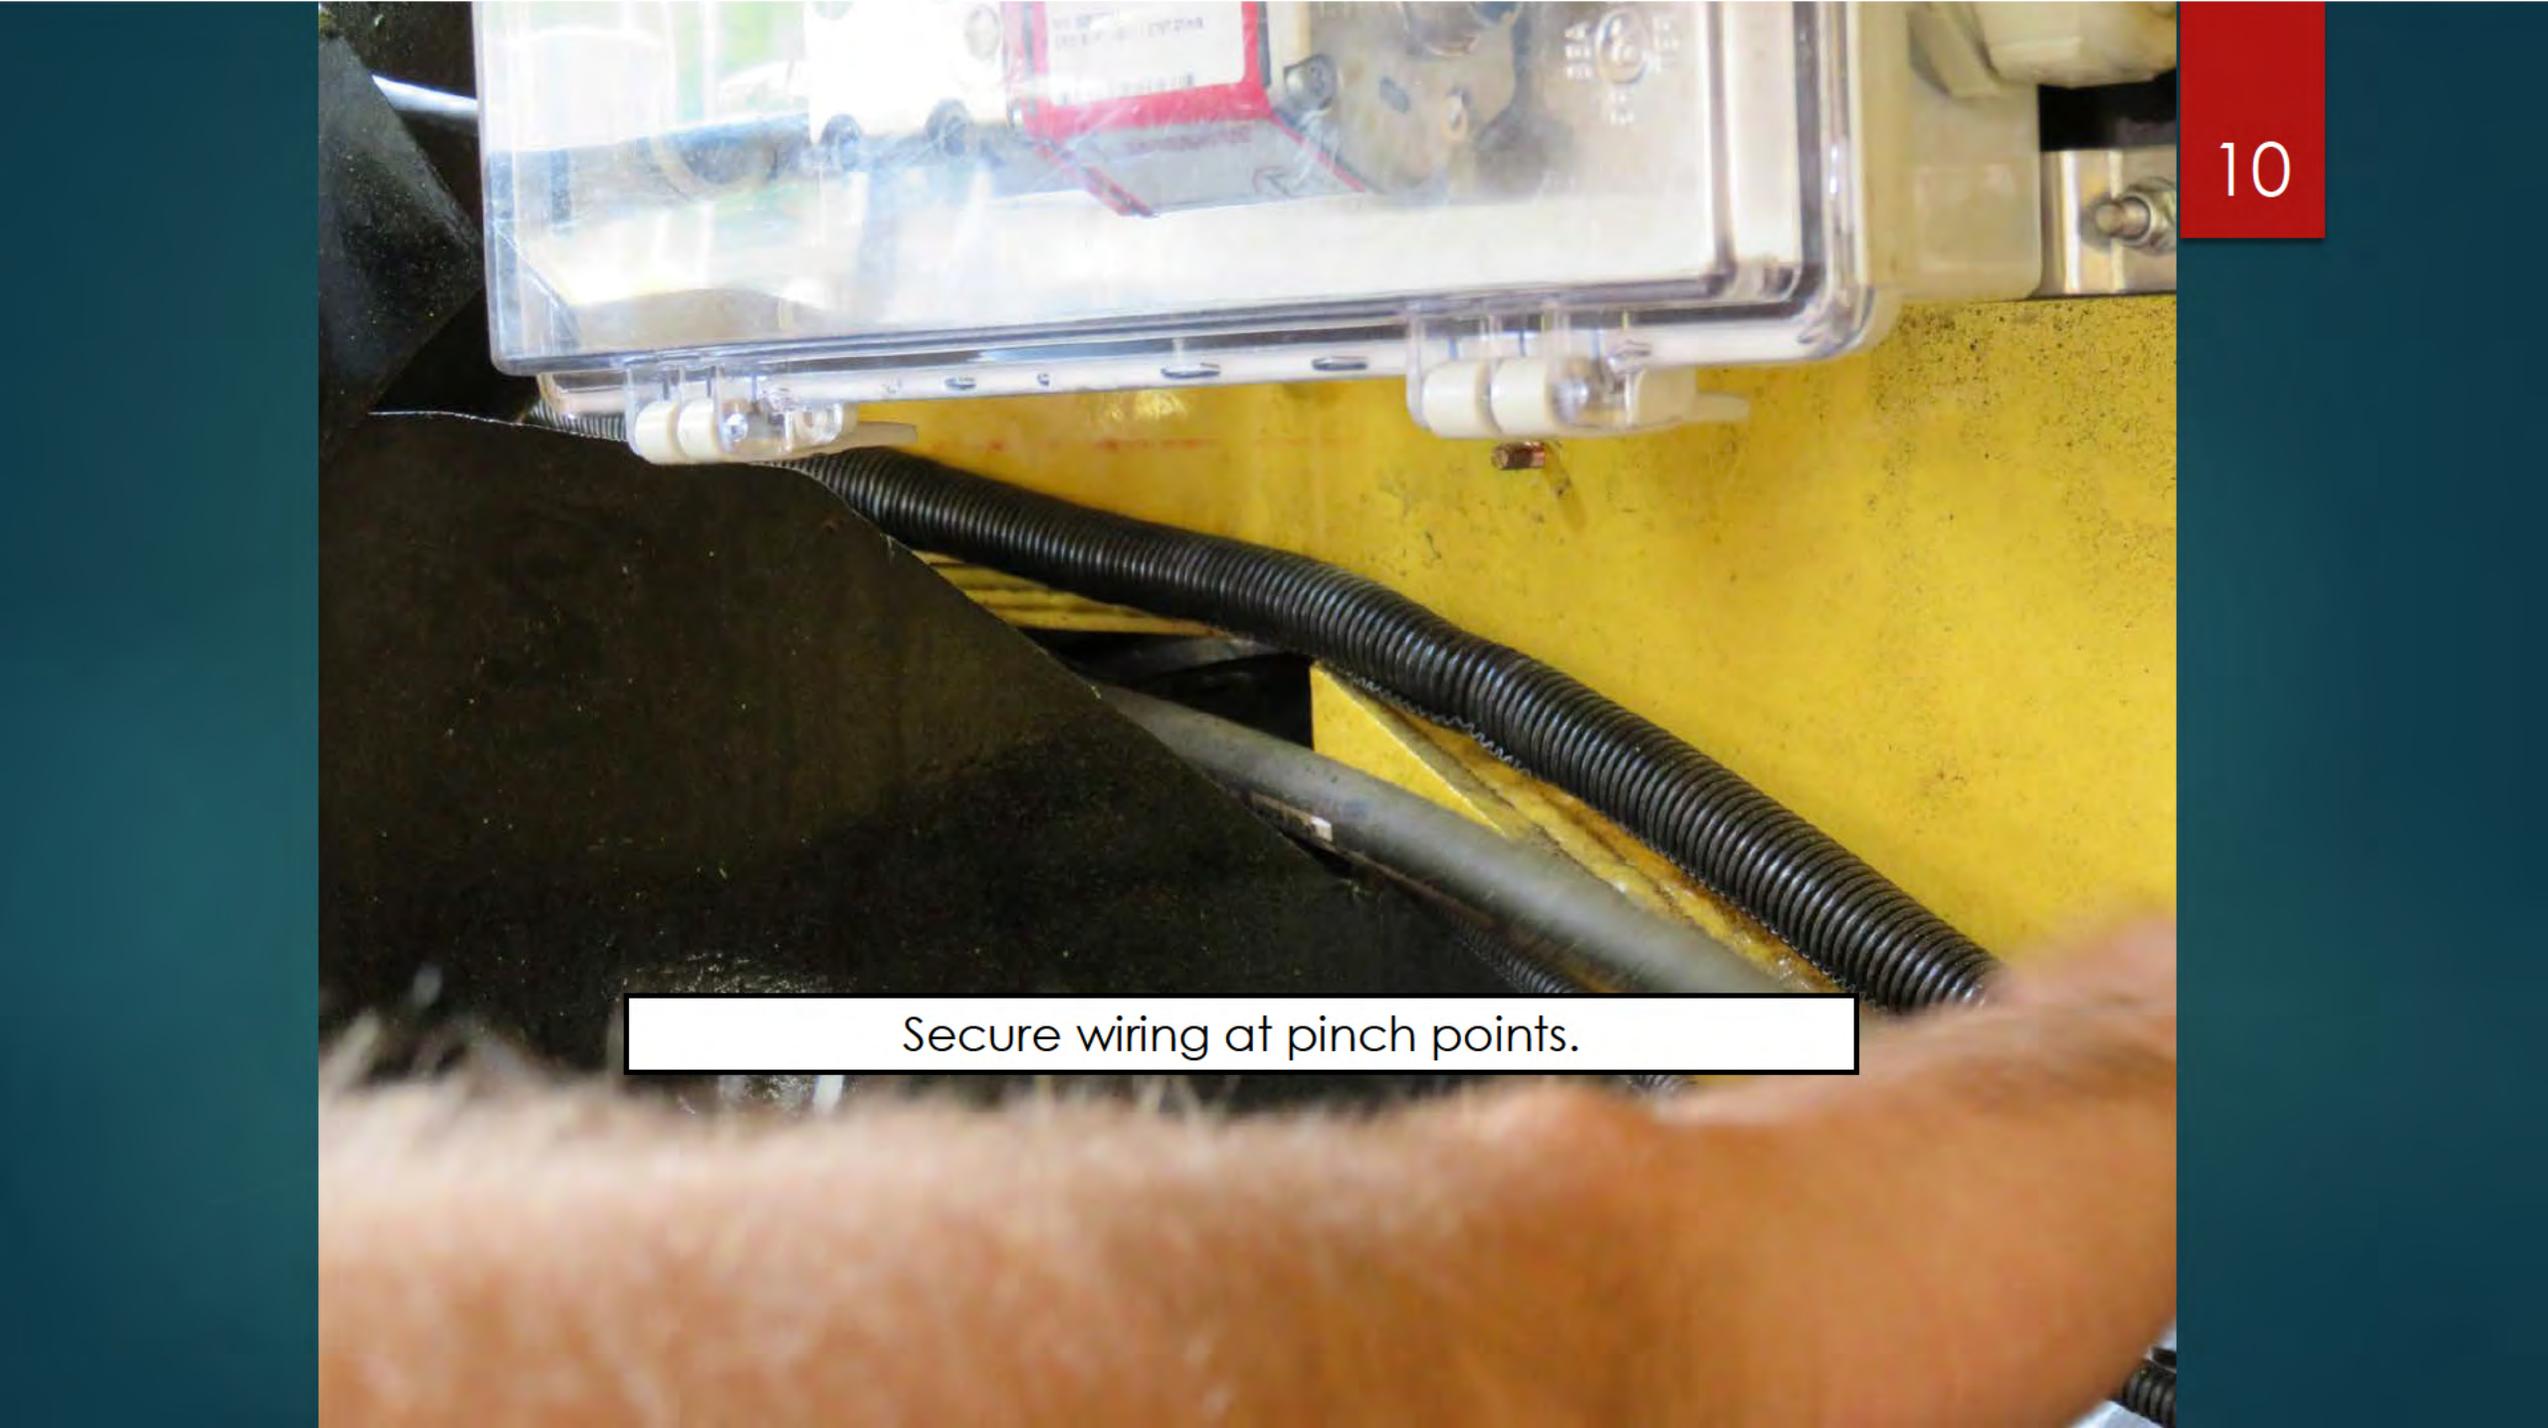
Secure wiring at pinch points.

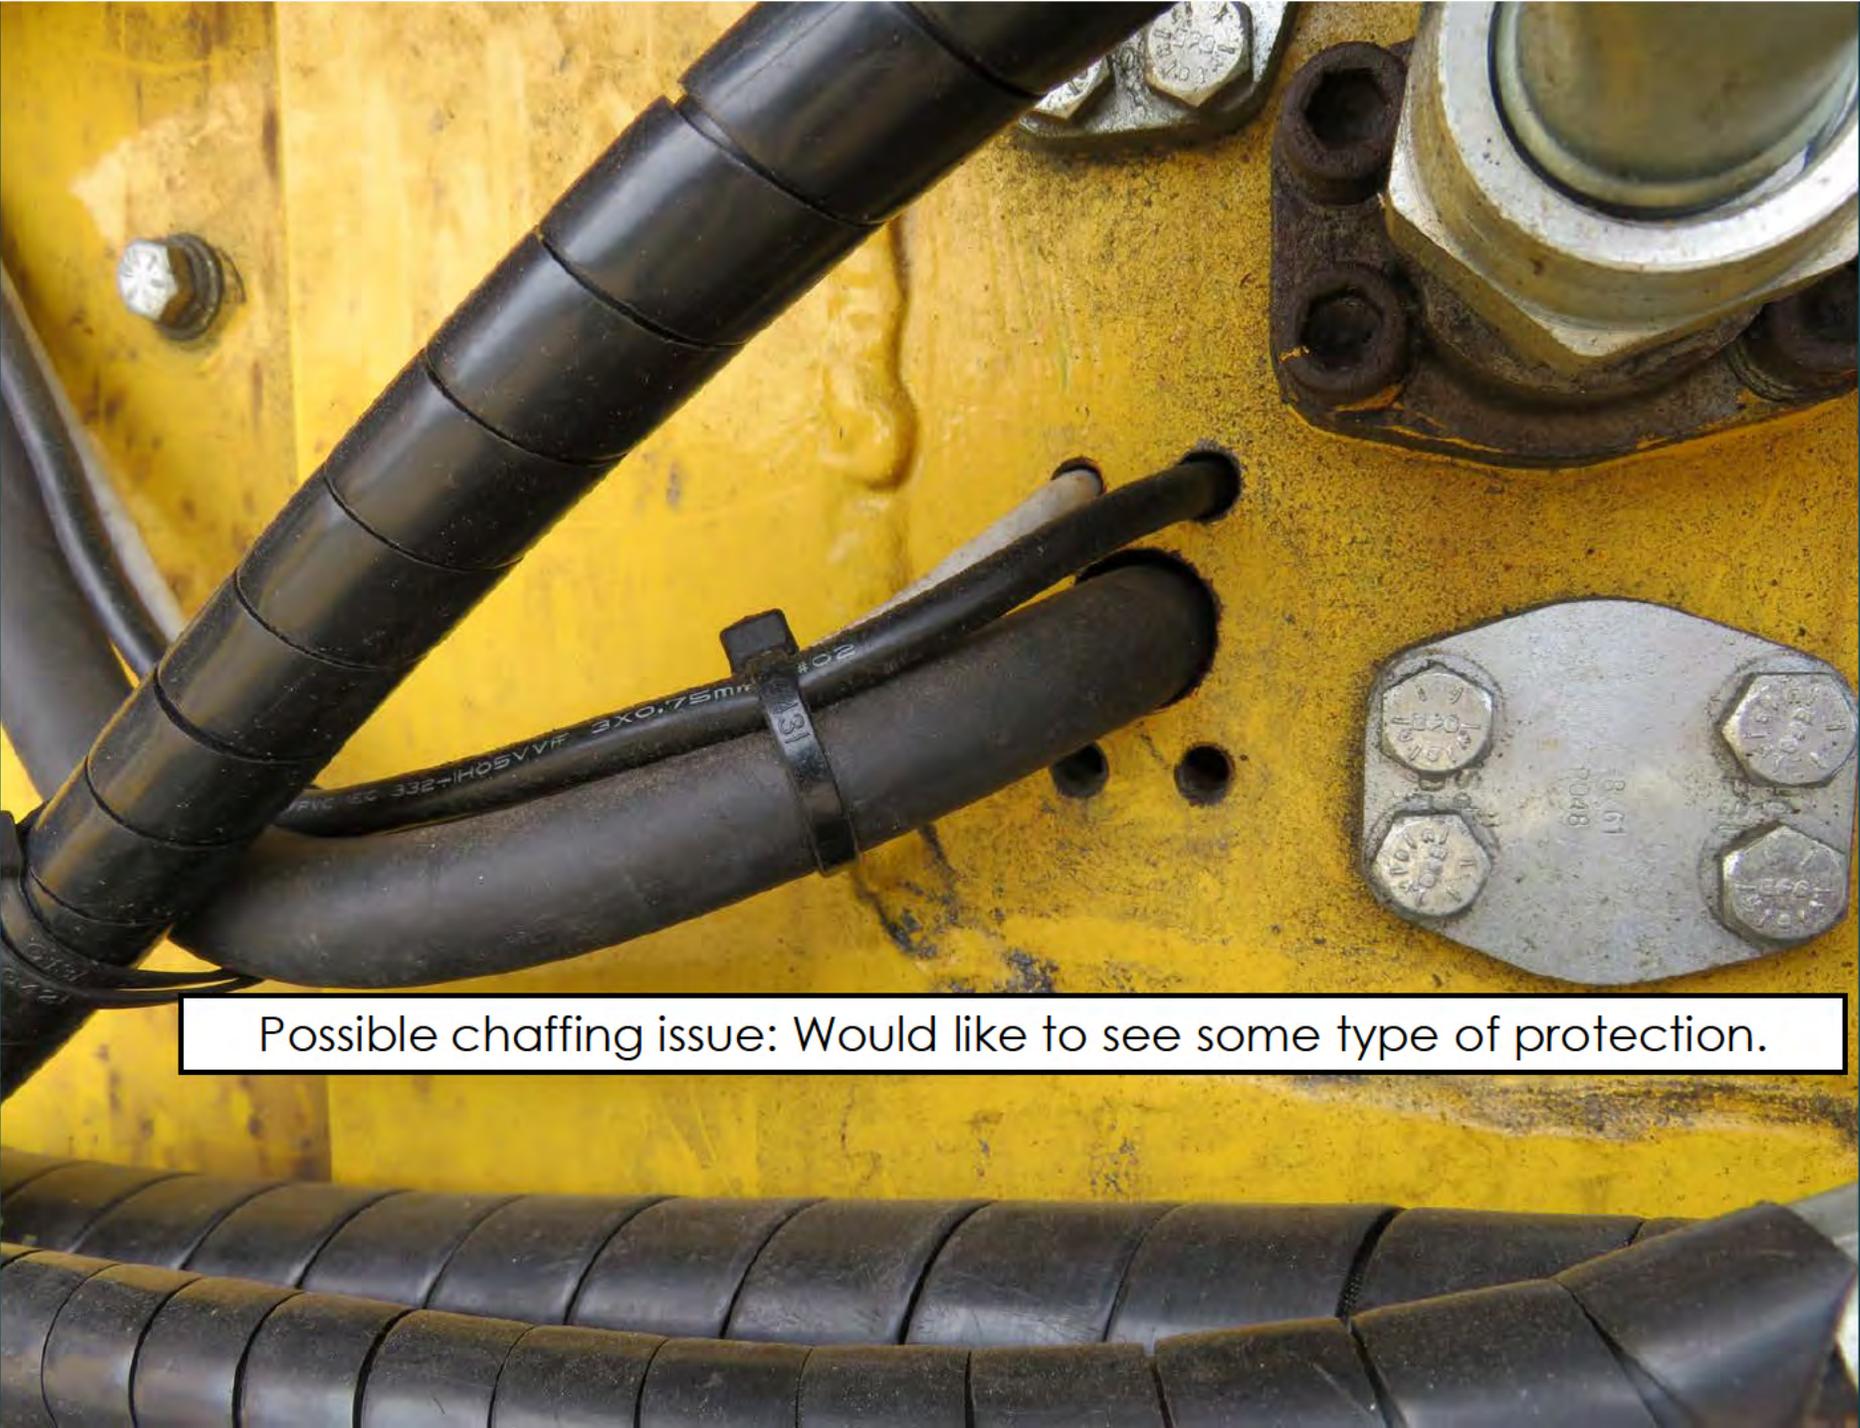
Possible chaffing issue: Would like to see some type of protection.

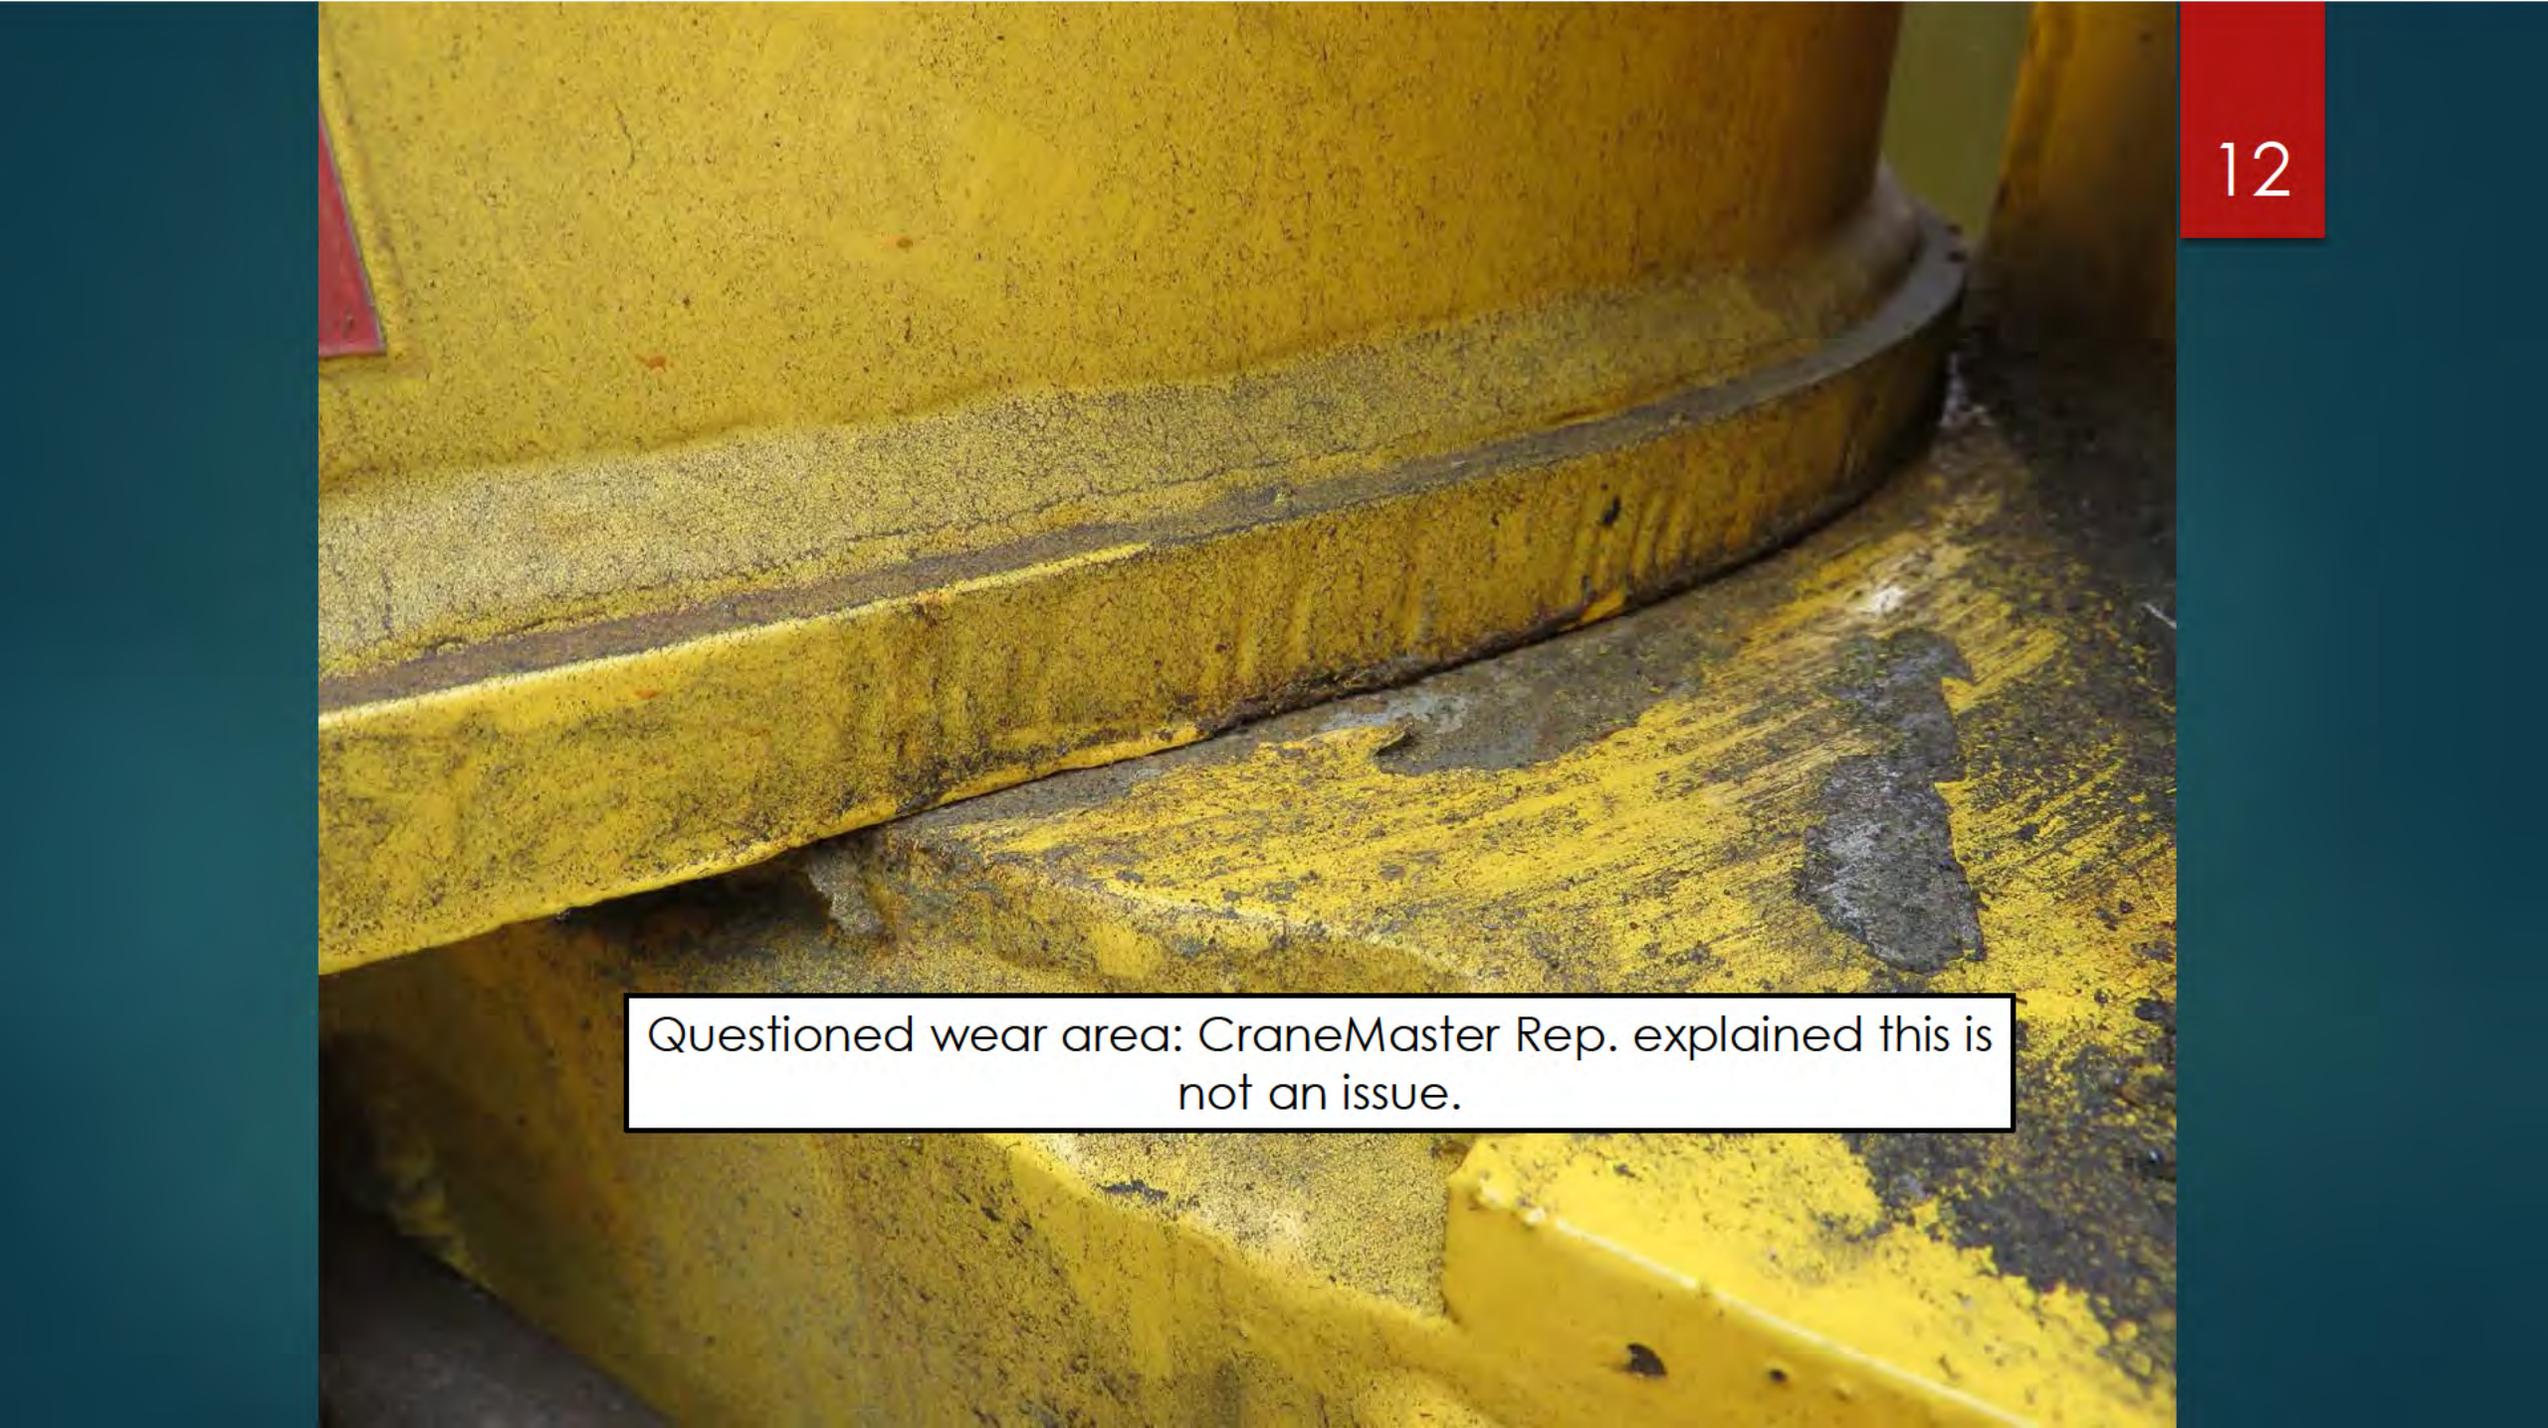
Questioned wear area: CraneMaster Rep. explained this is not an issue.

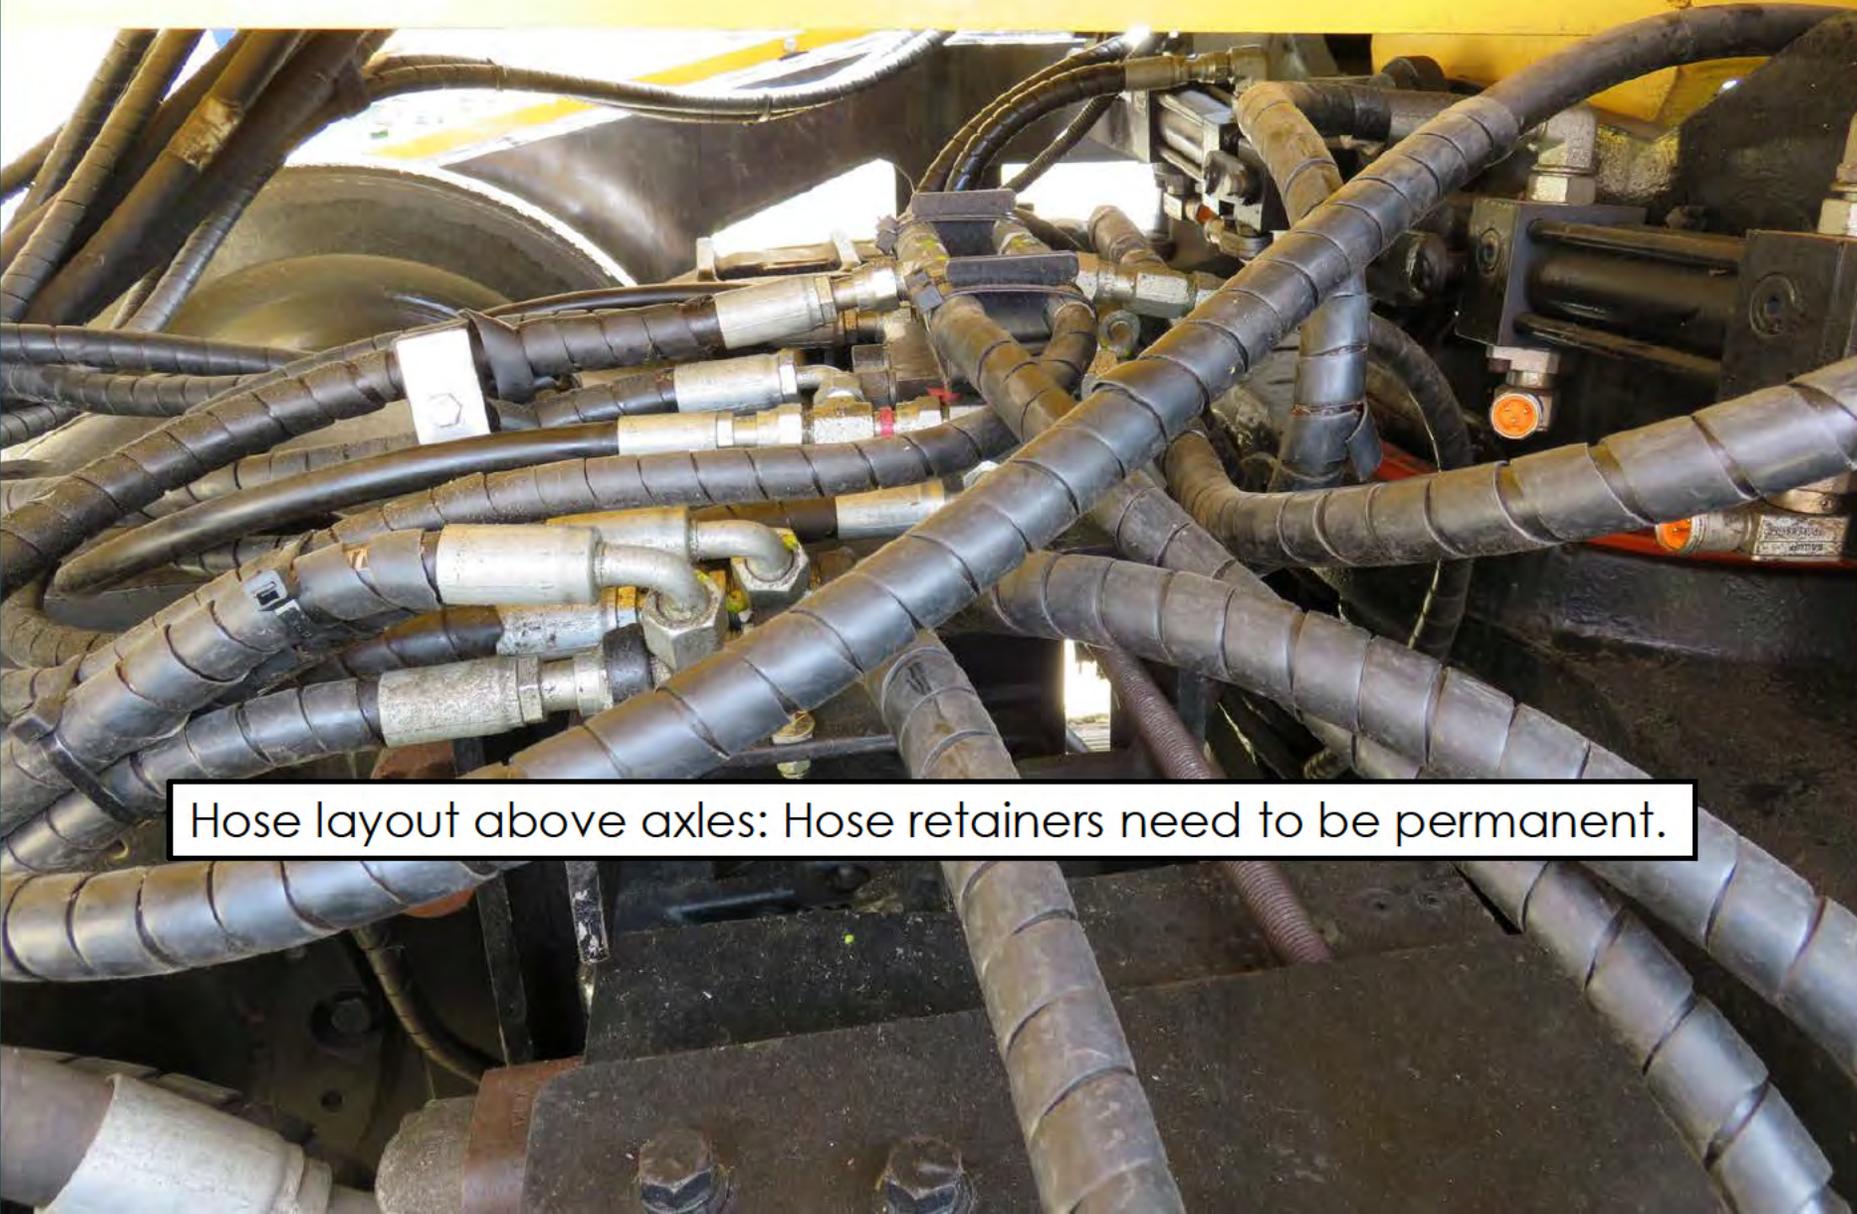
Hose layout above axles: Hose retainers need to be permanent.

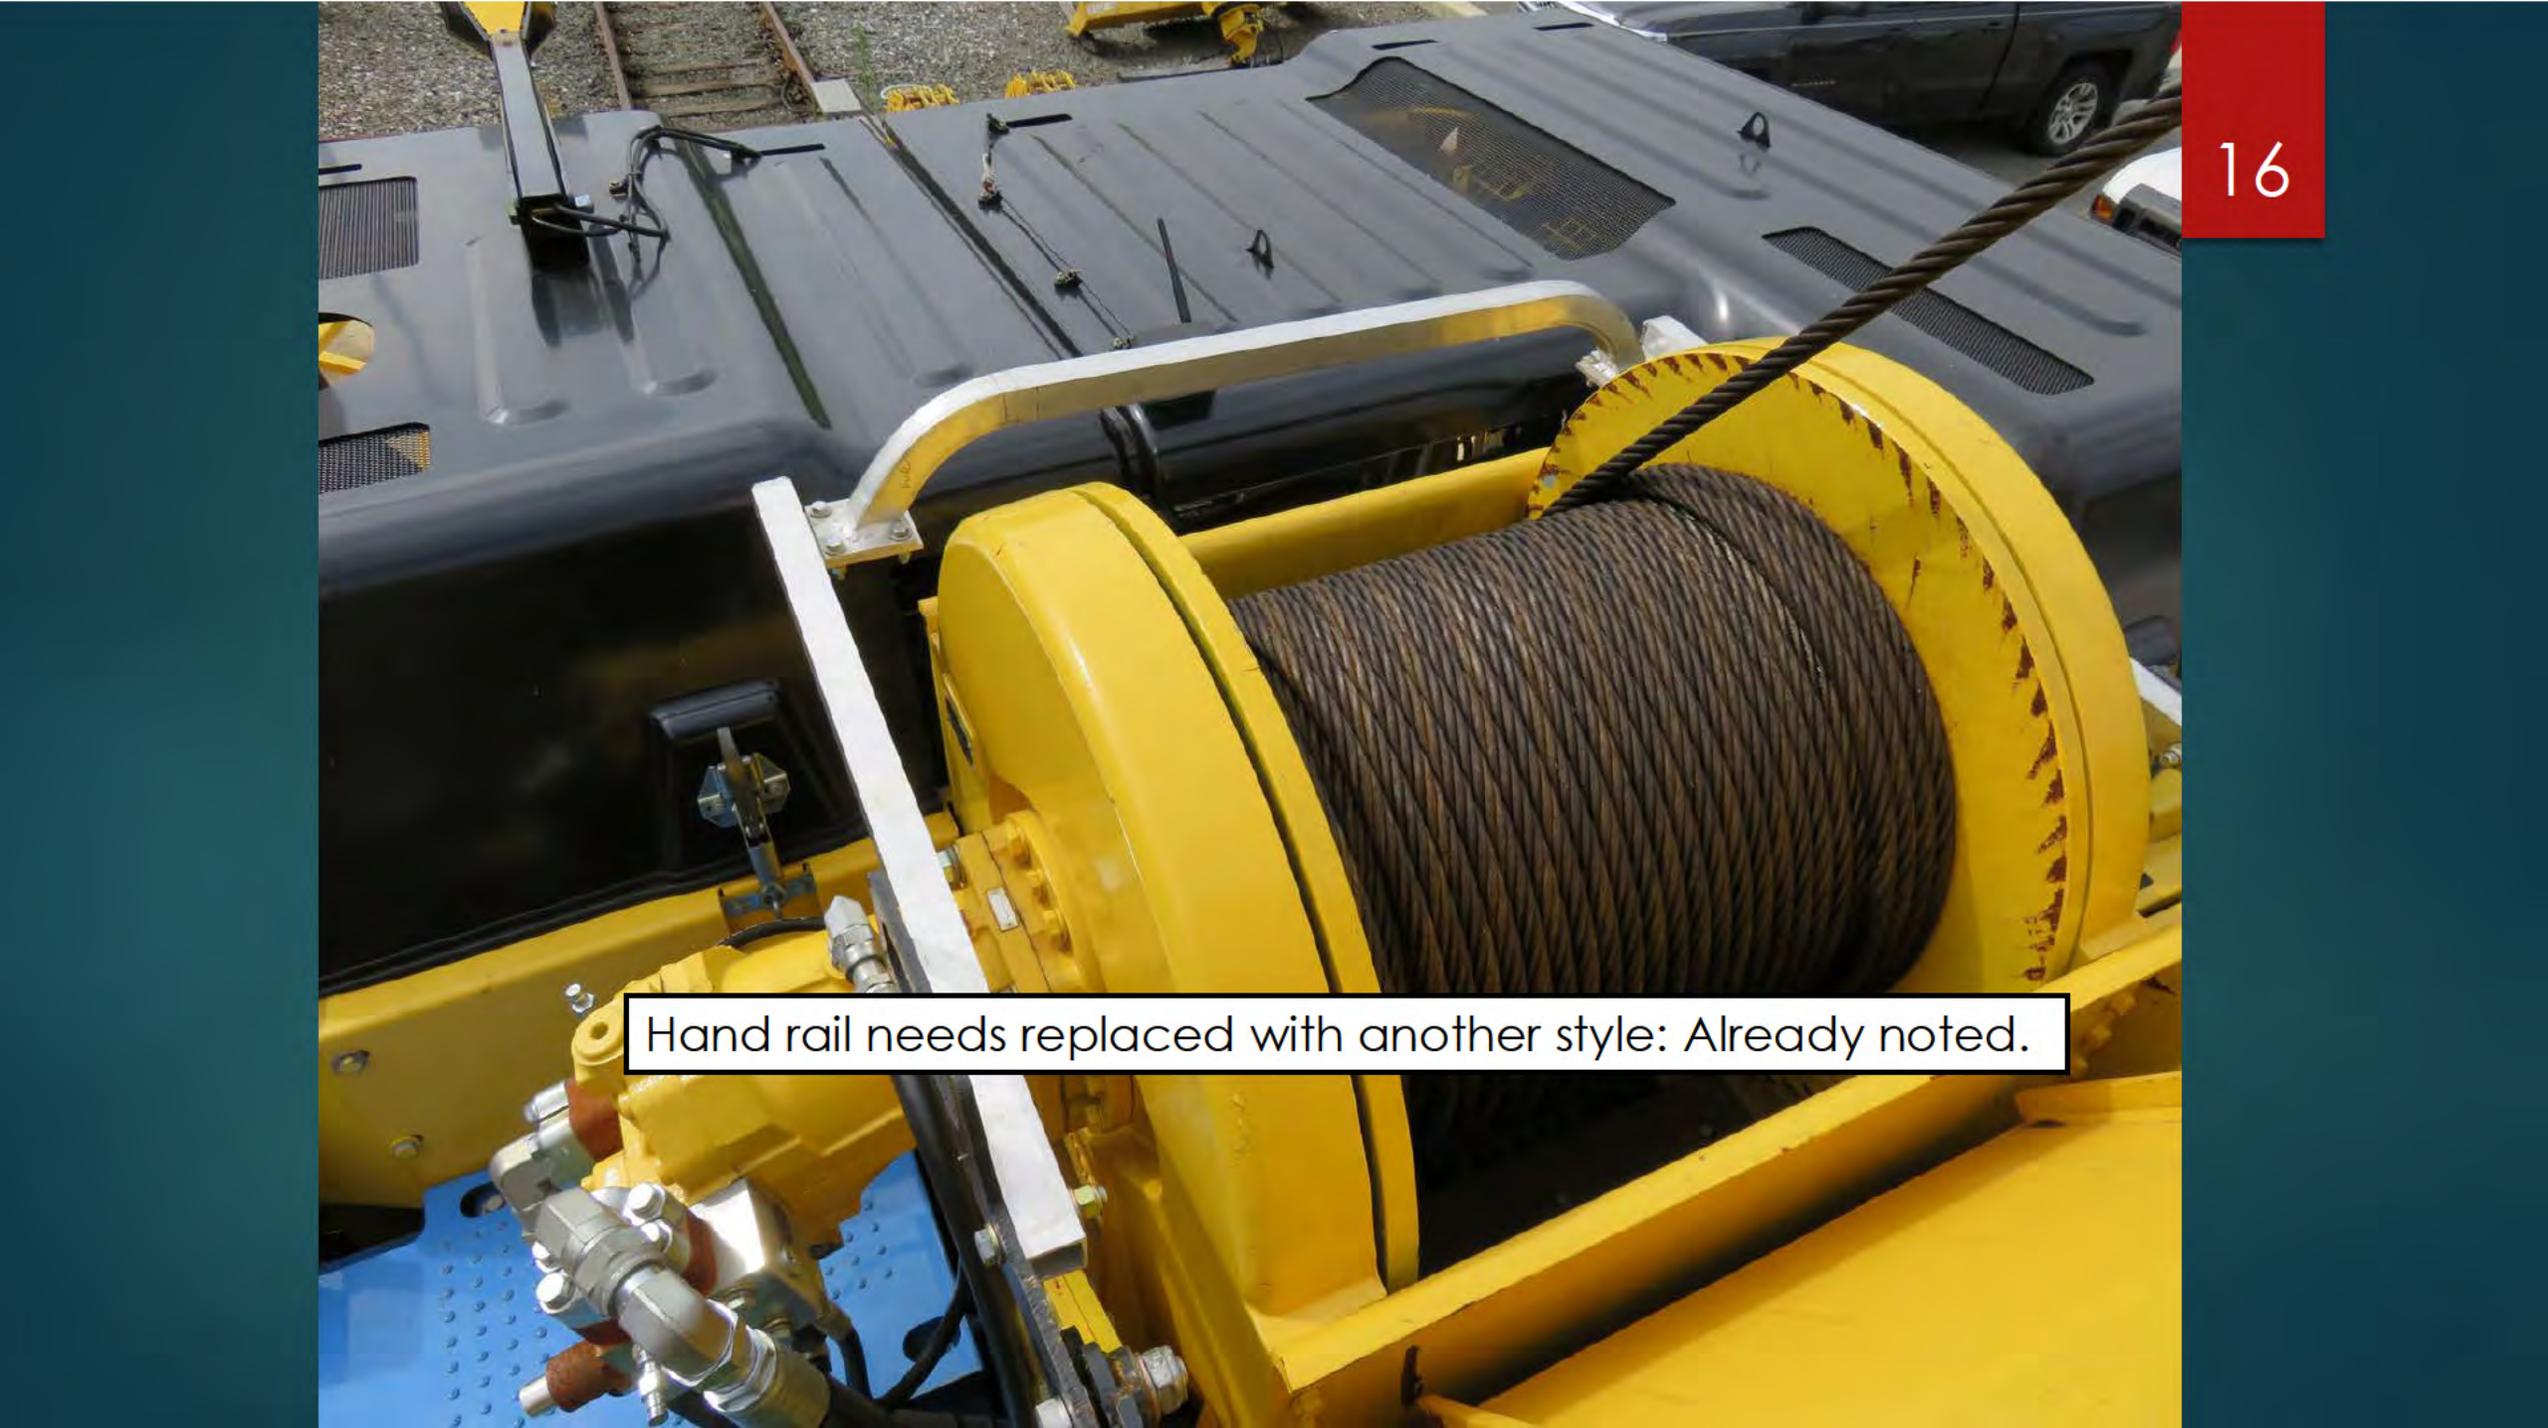
Hand rail needs replaced with another style: Already noted.

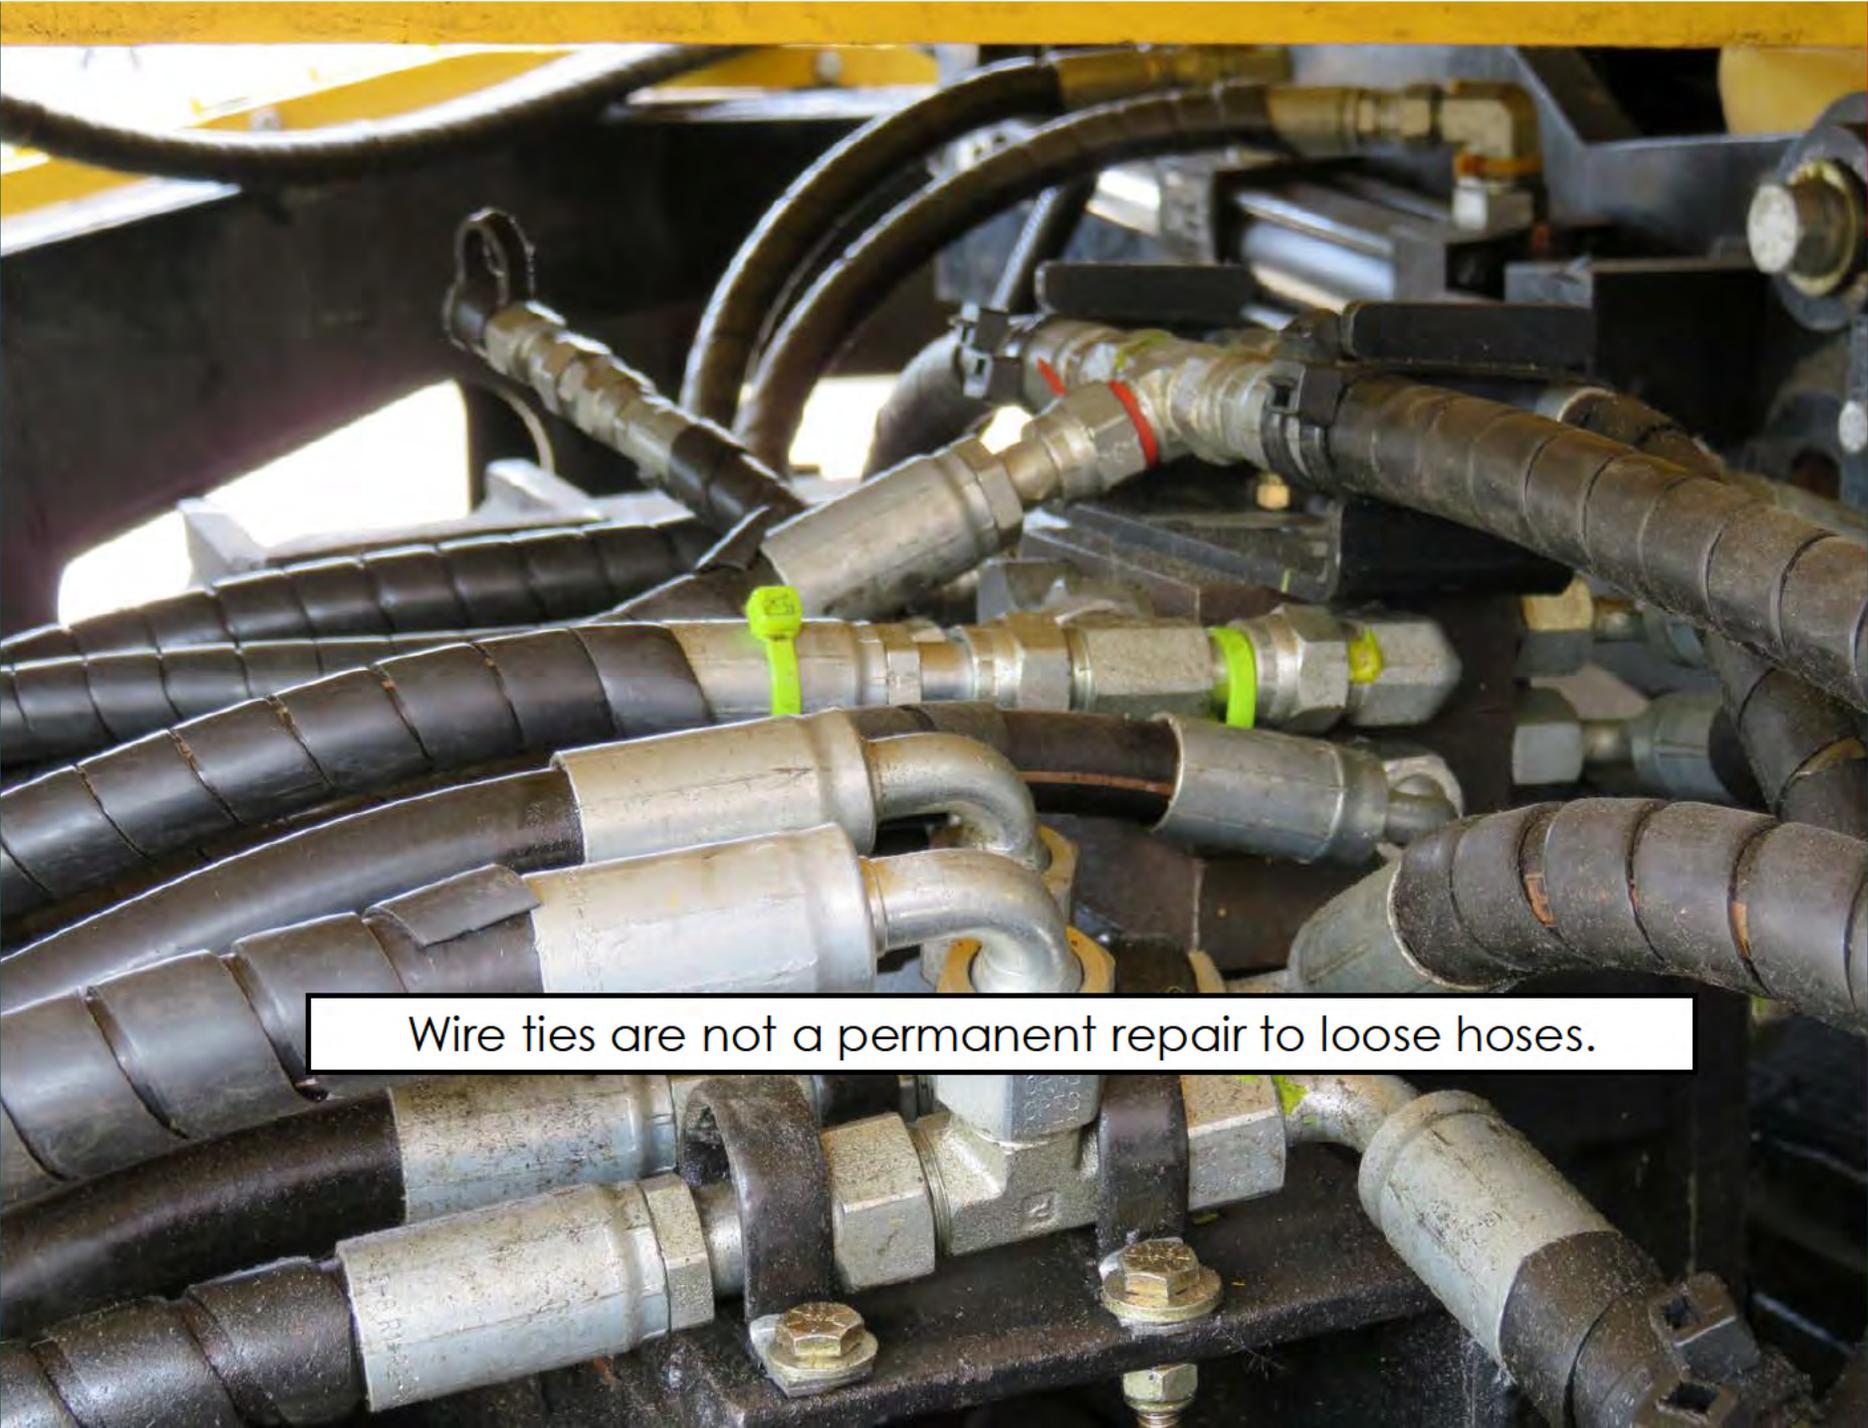
Wire ties are not a permanent repair to loose hoses.

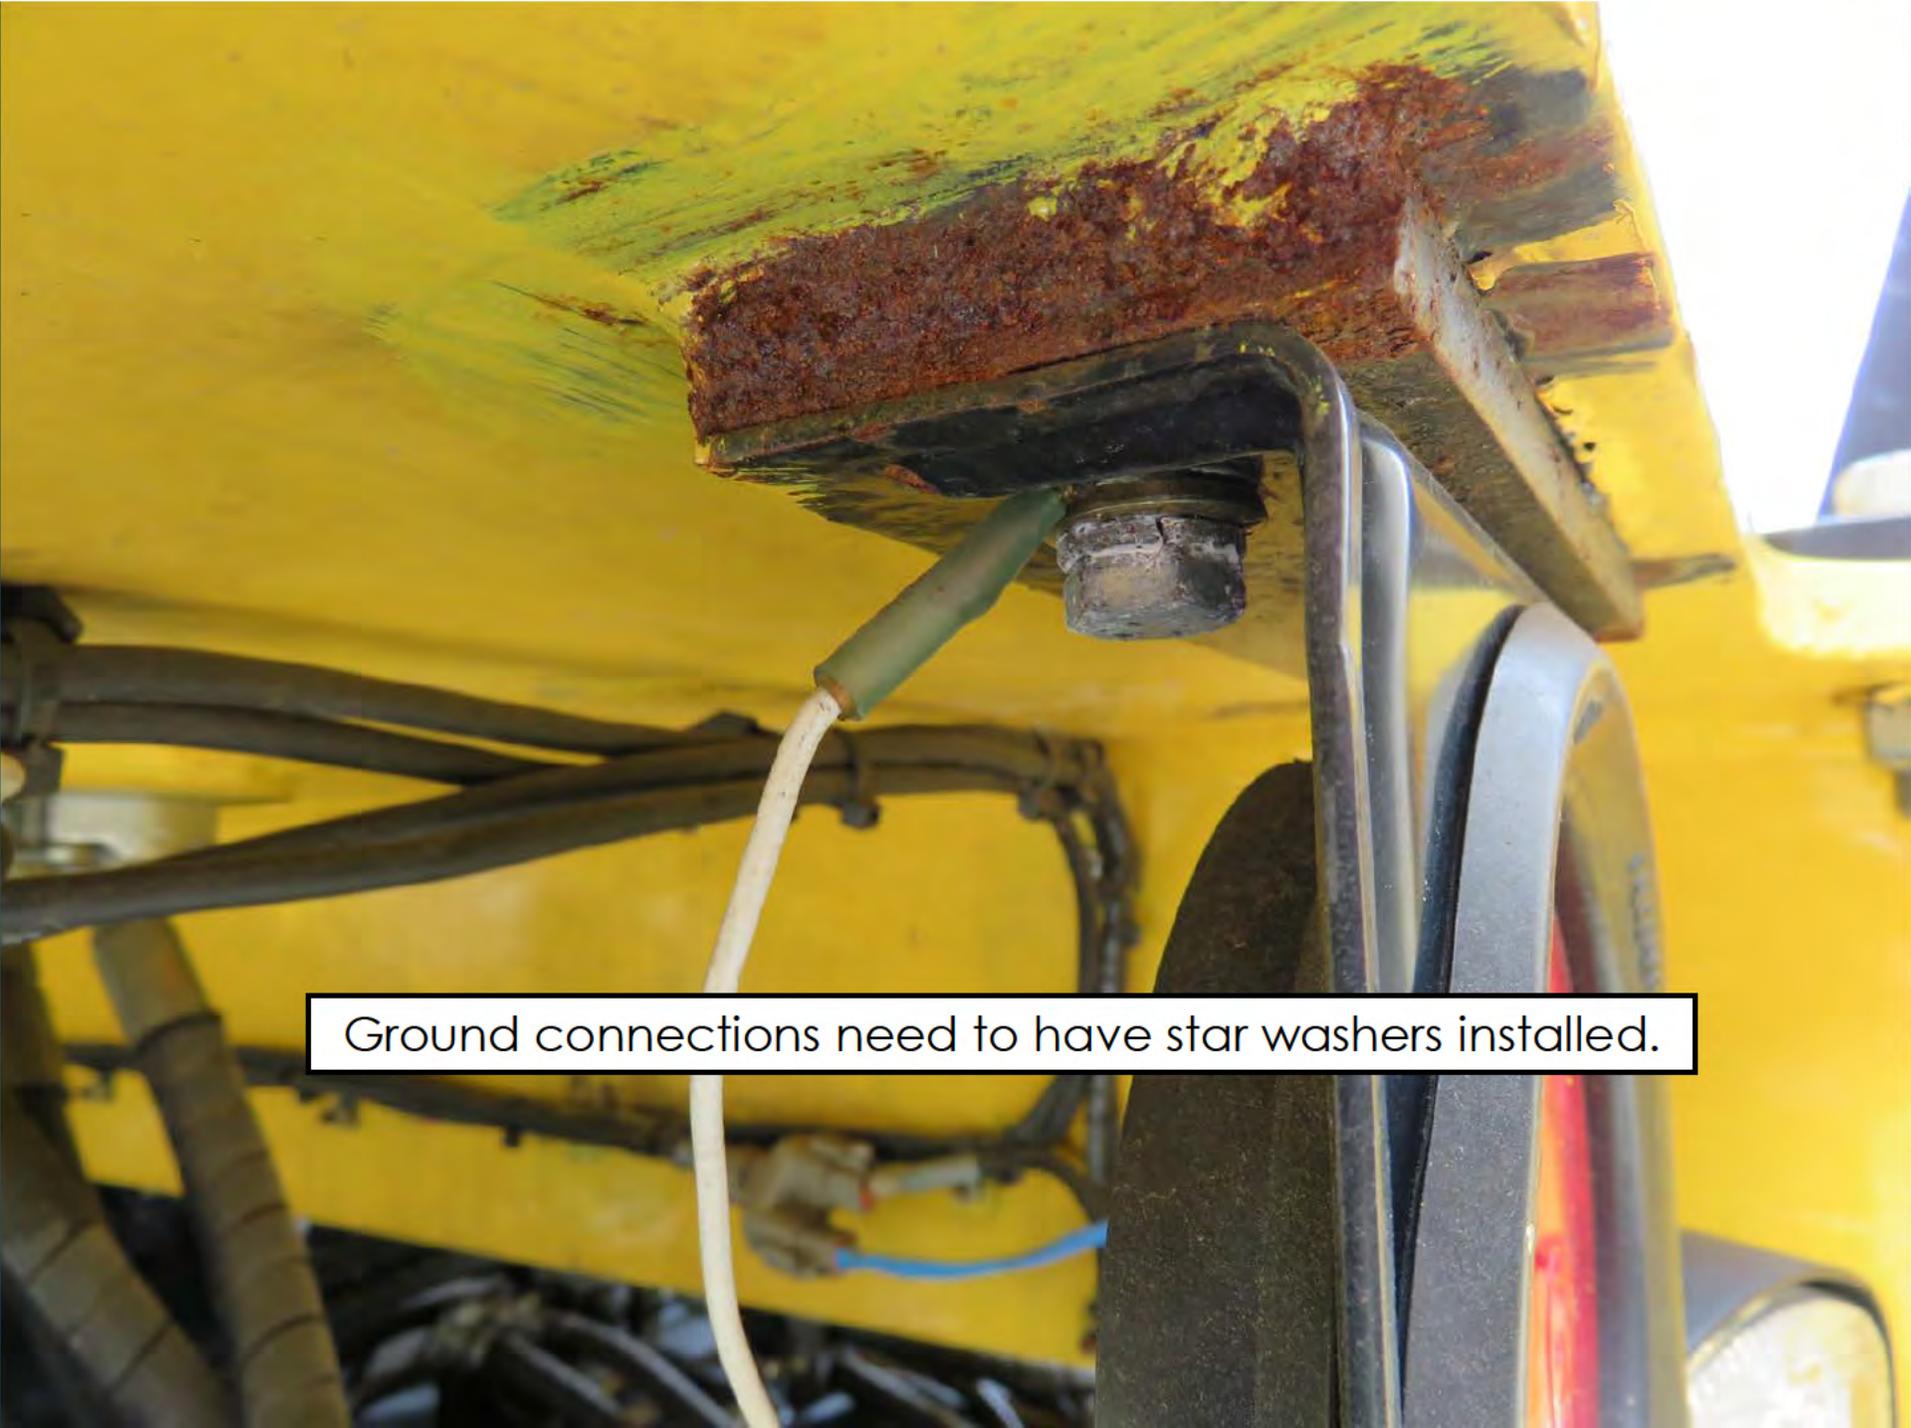
Ground connections need to have star washers installed.
