SUBJECT: Management Assistance Report
WMATA Crane Purchase
(MAR-23-0001)

DATE PUBLISHED: November 17, 2022

FROM: OIG – Rene Febles [REDACTED]

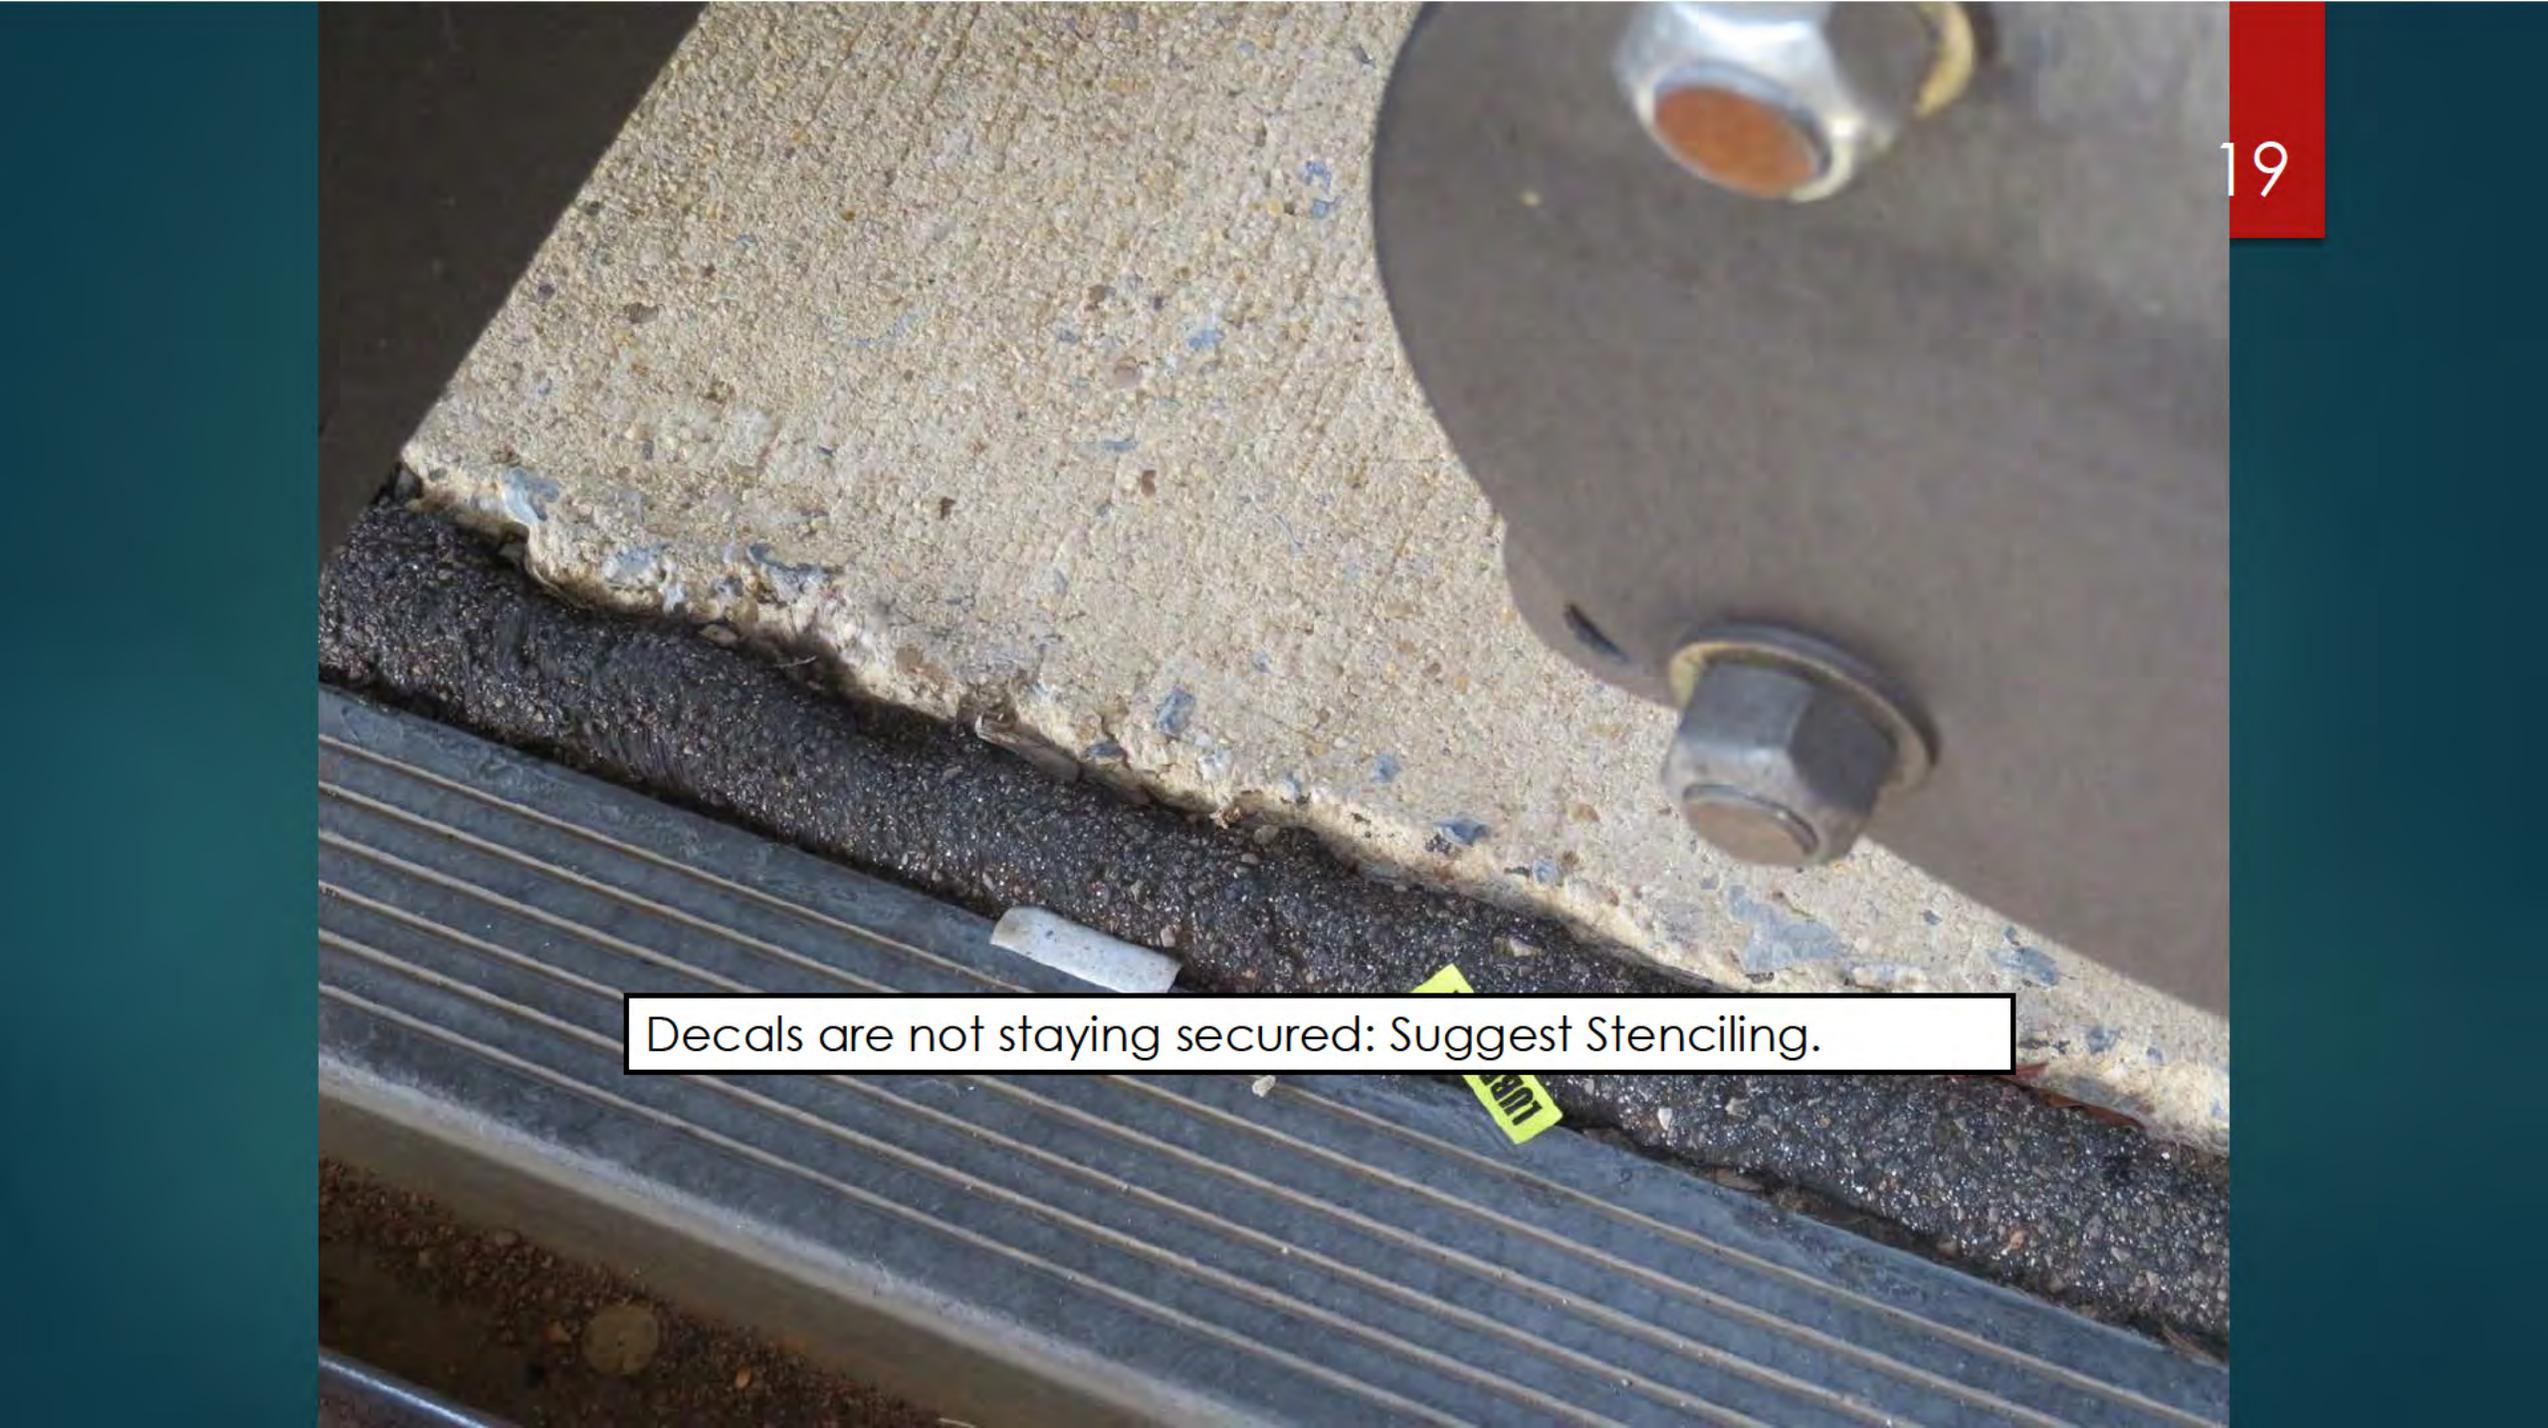
Decals are not staying secured: Suggest Stenciling.

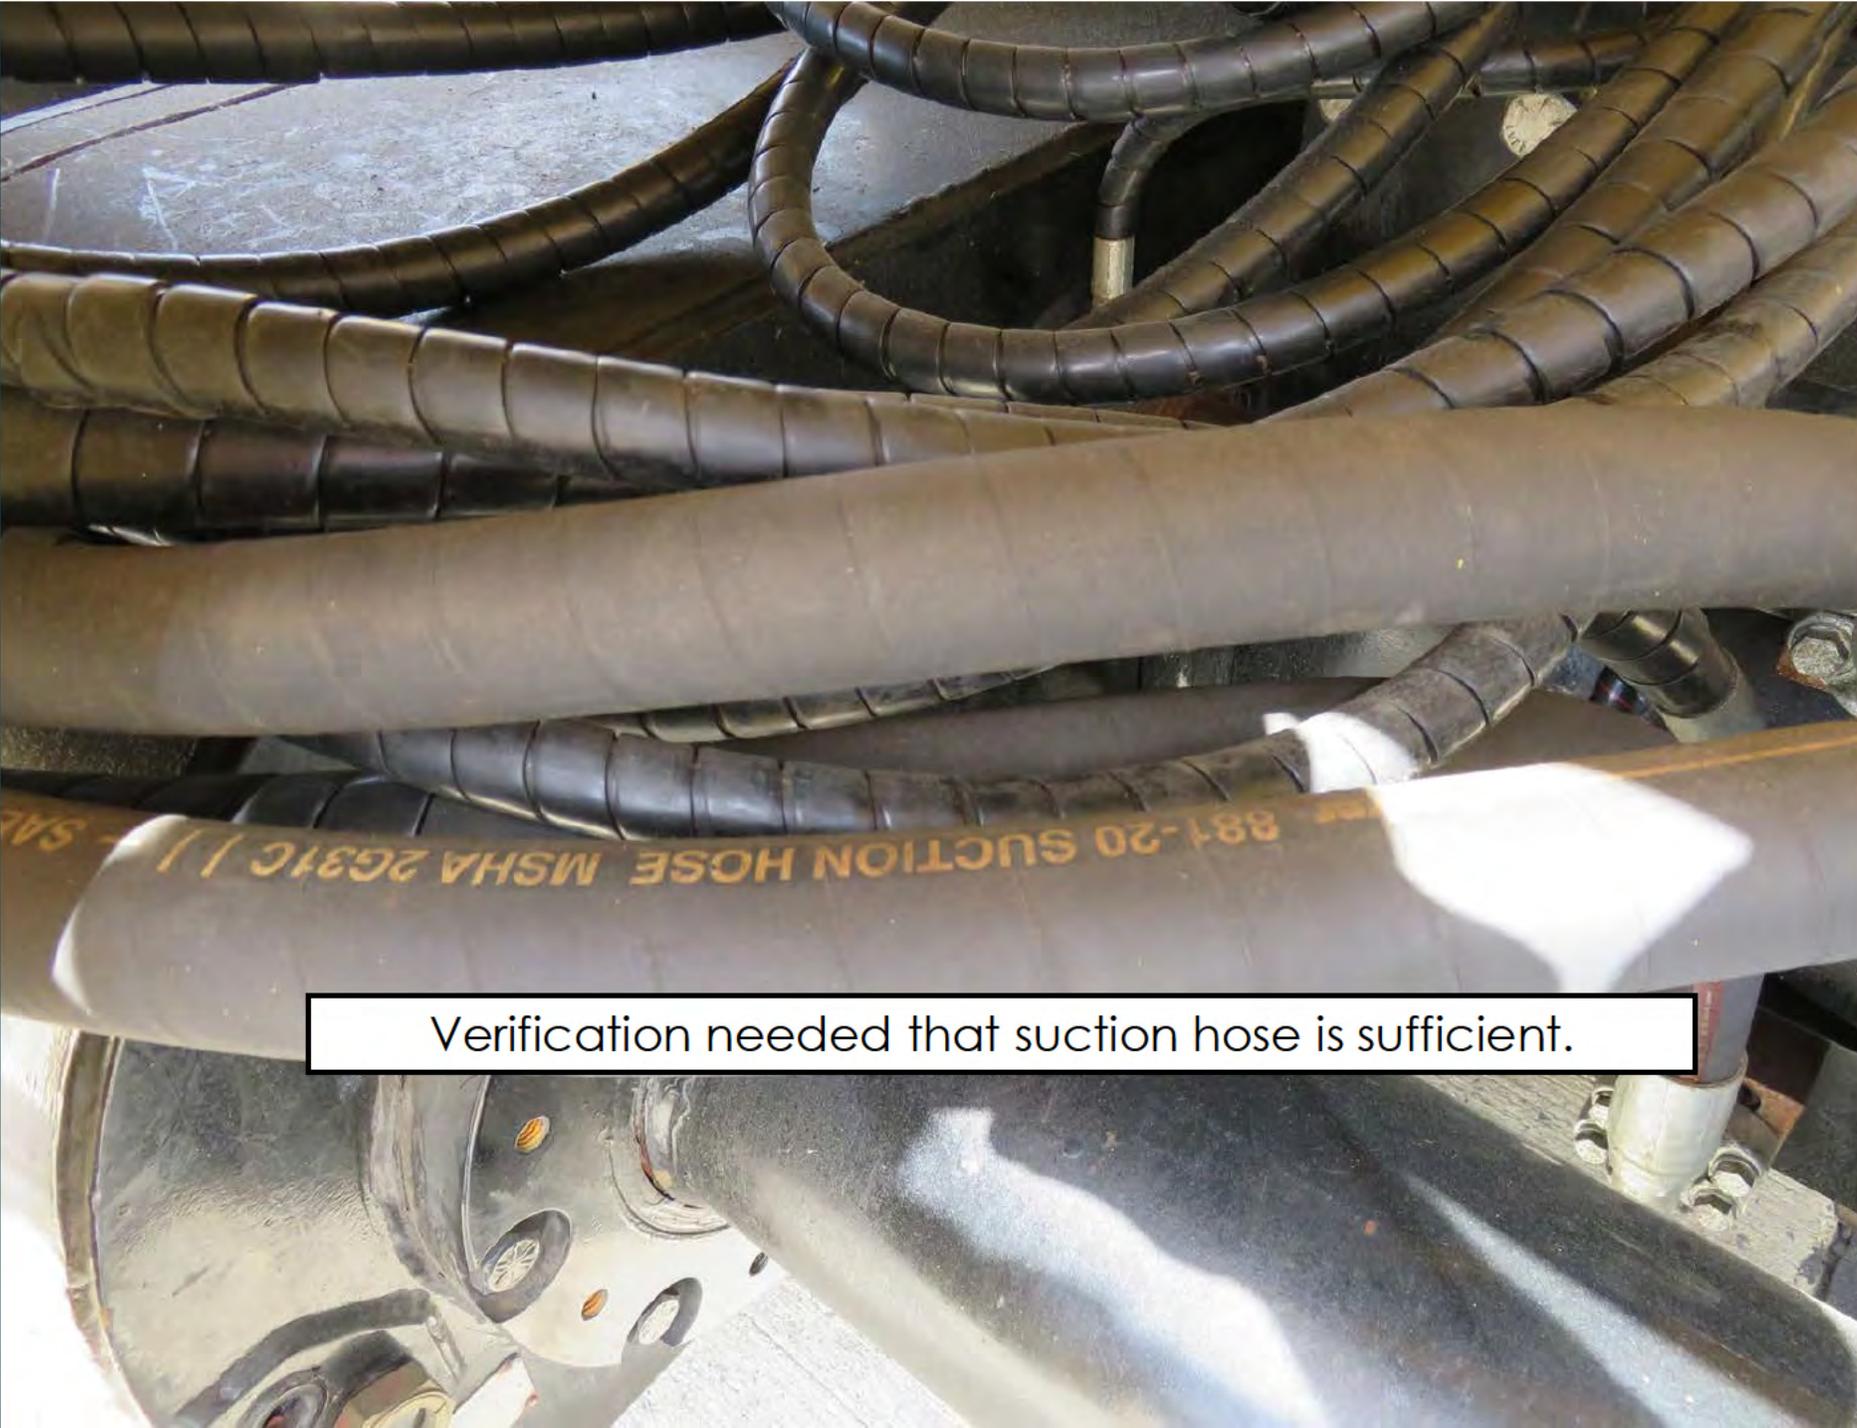
Verification needed that suction hose is sufficient.

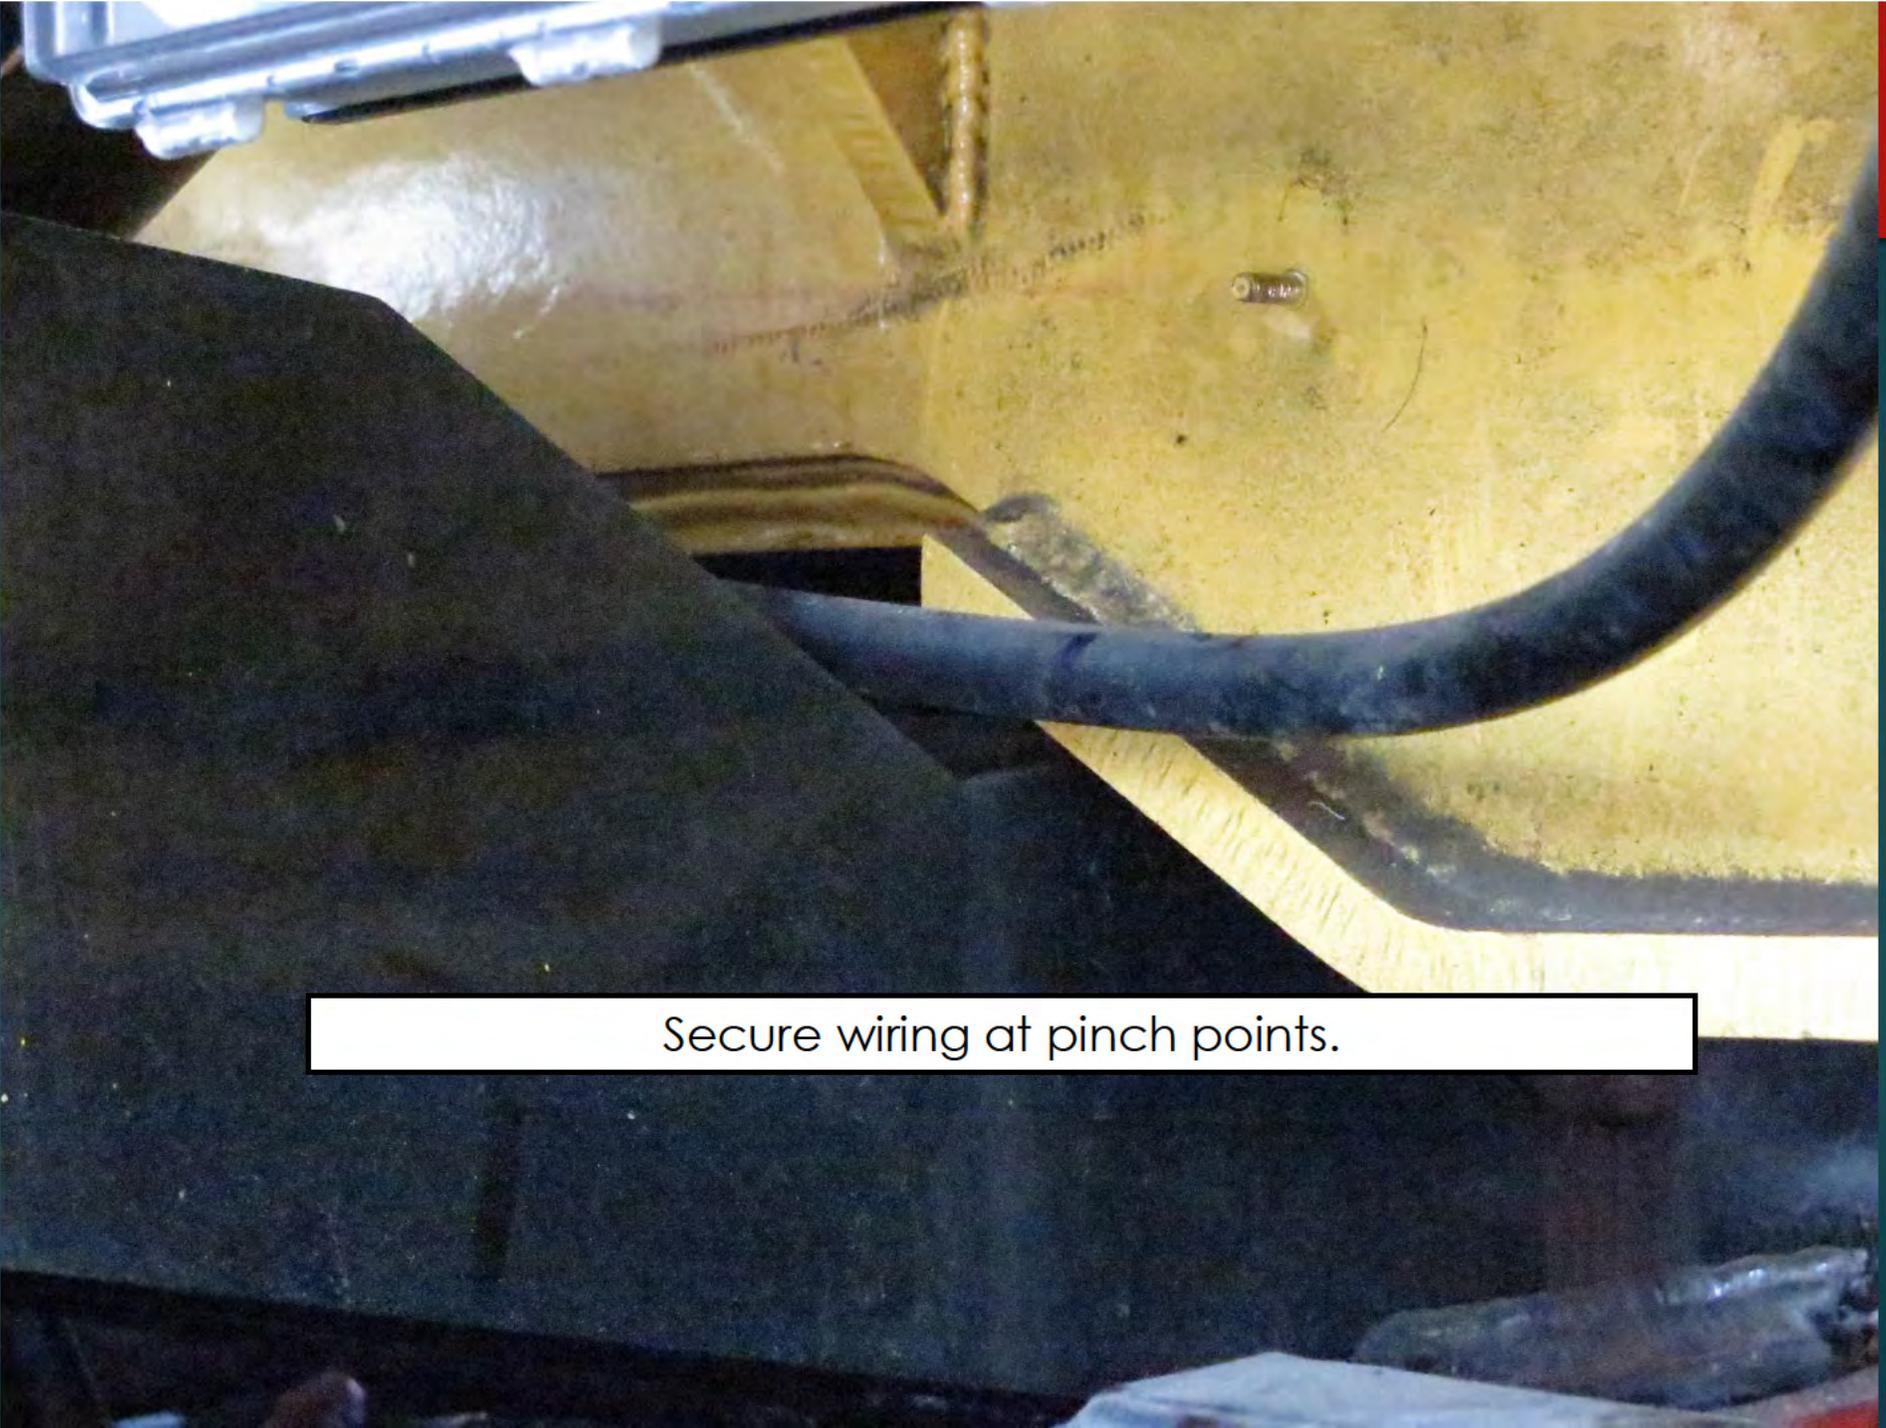
Secure wiring at pinch points.

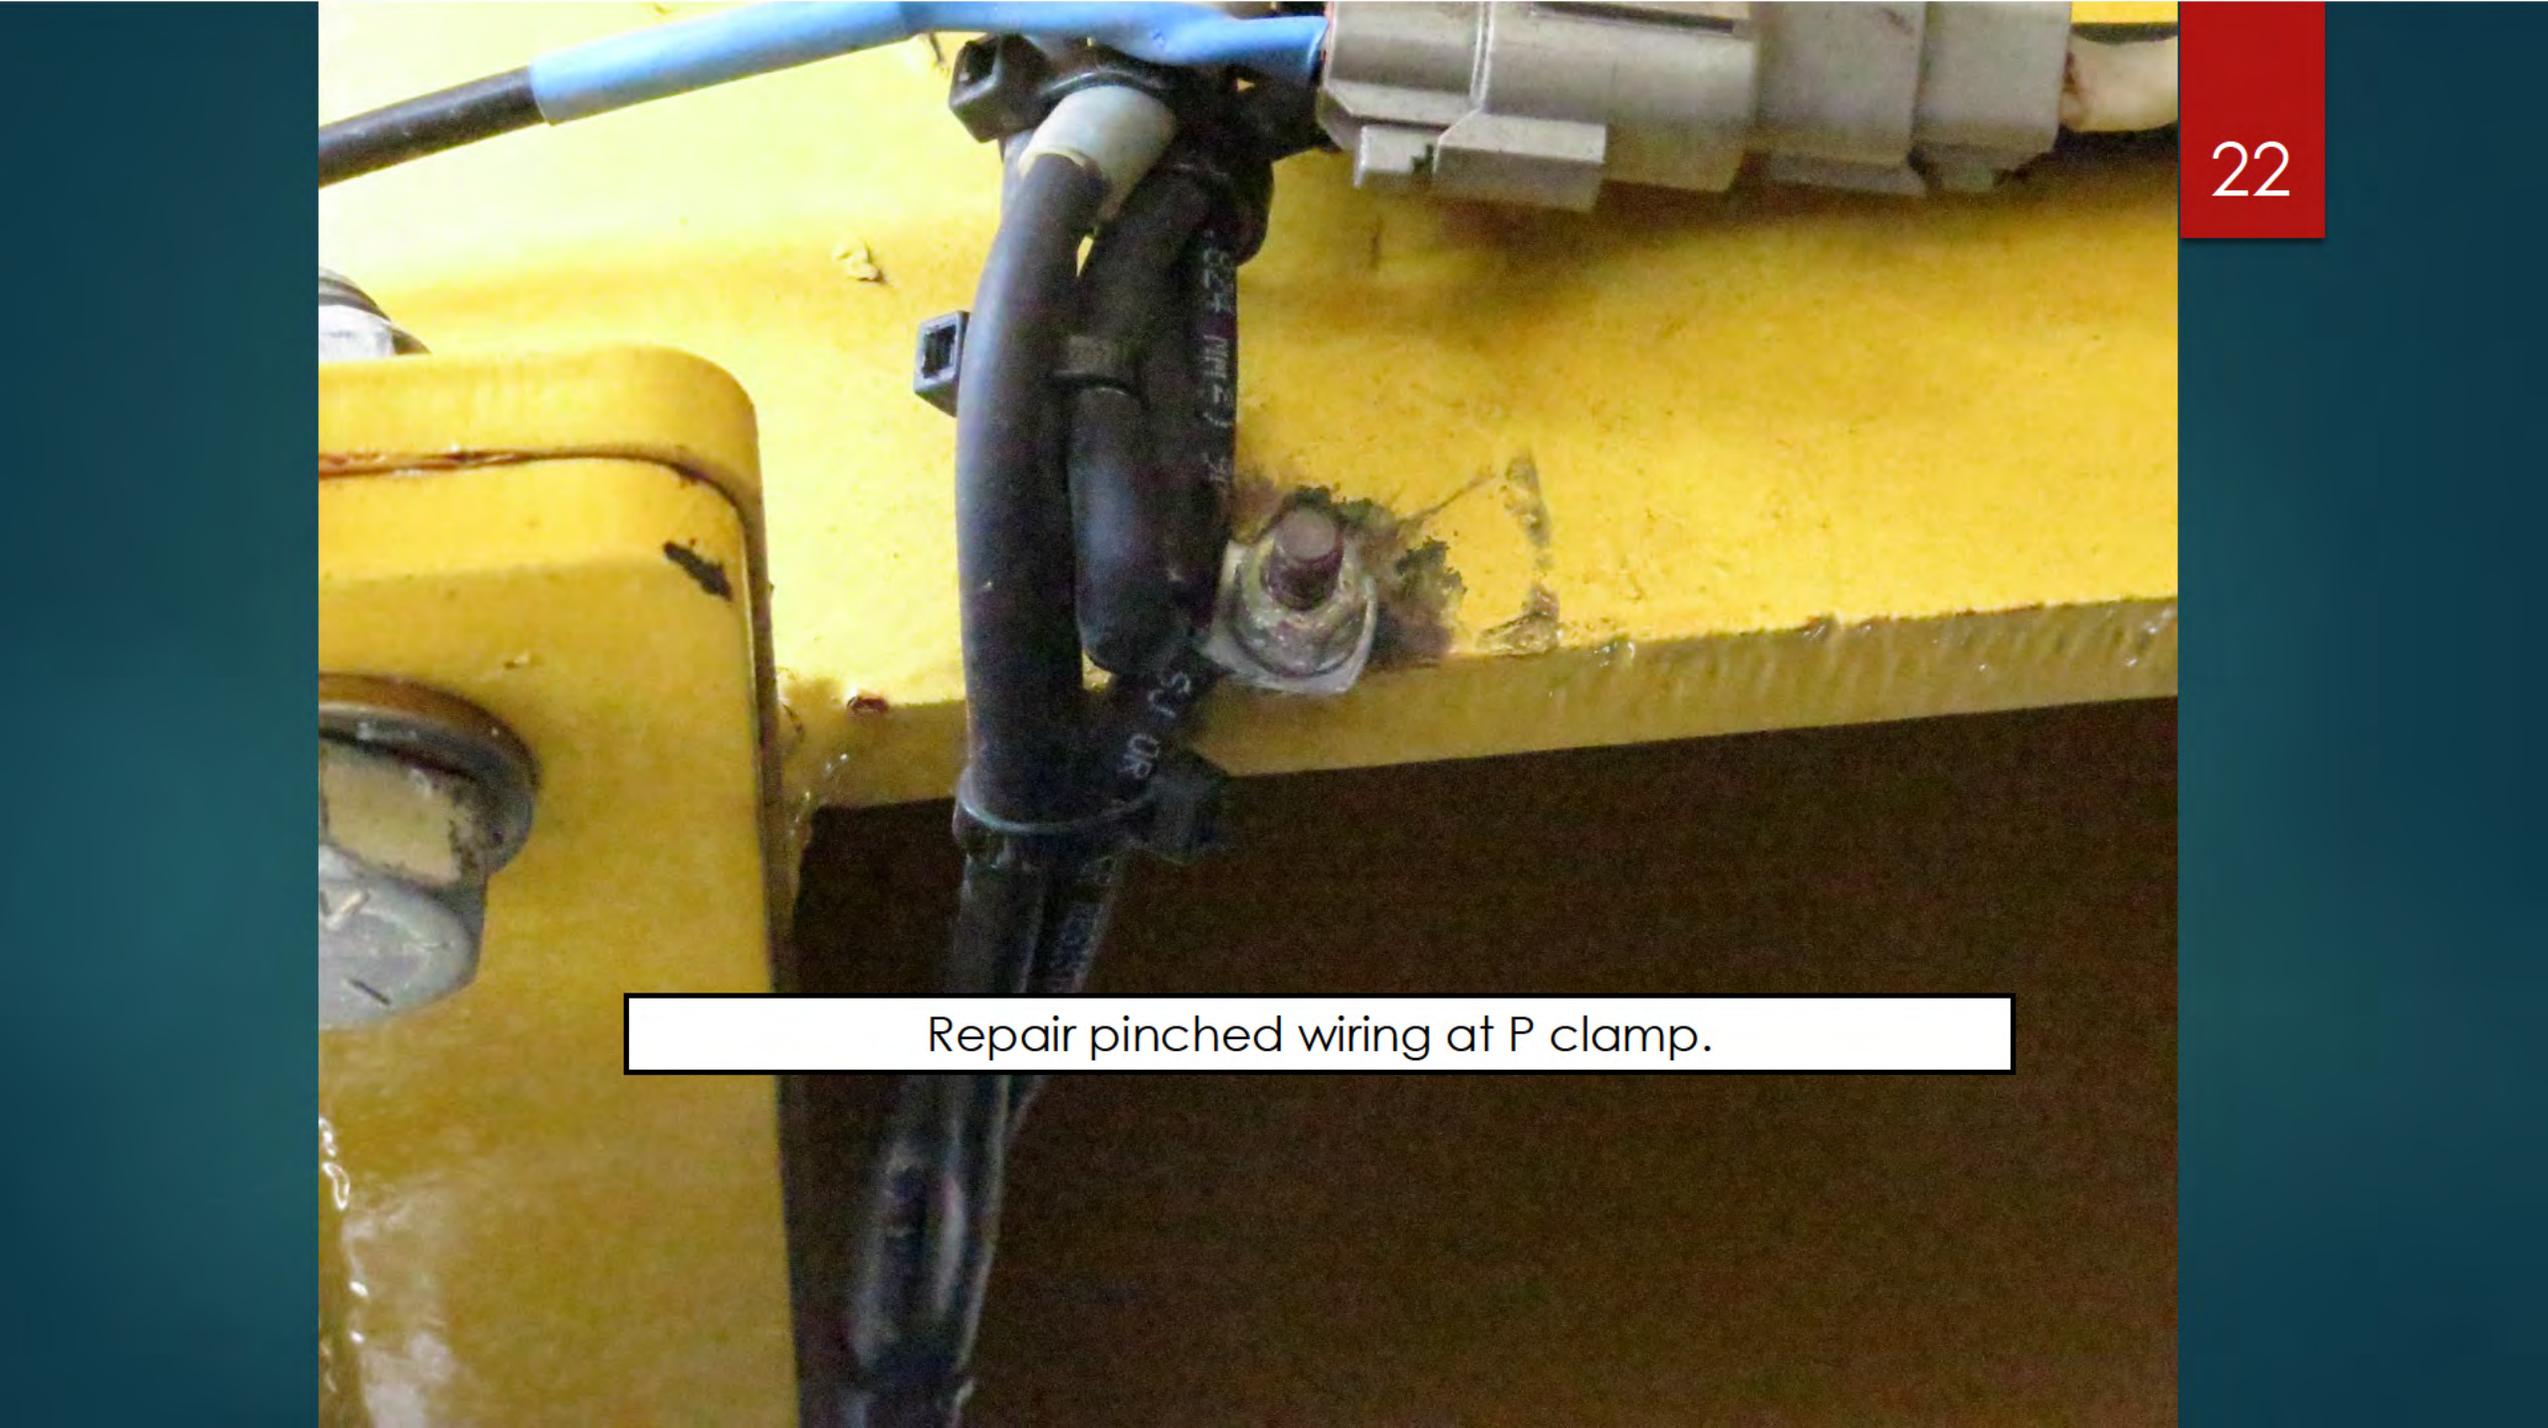
Repair pinched wiring at P clamp.

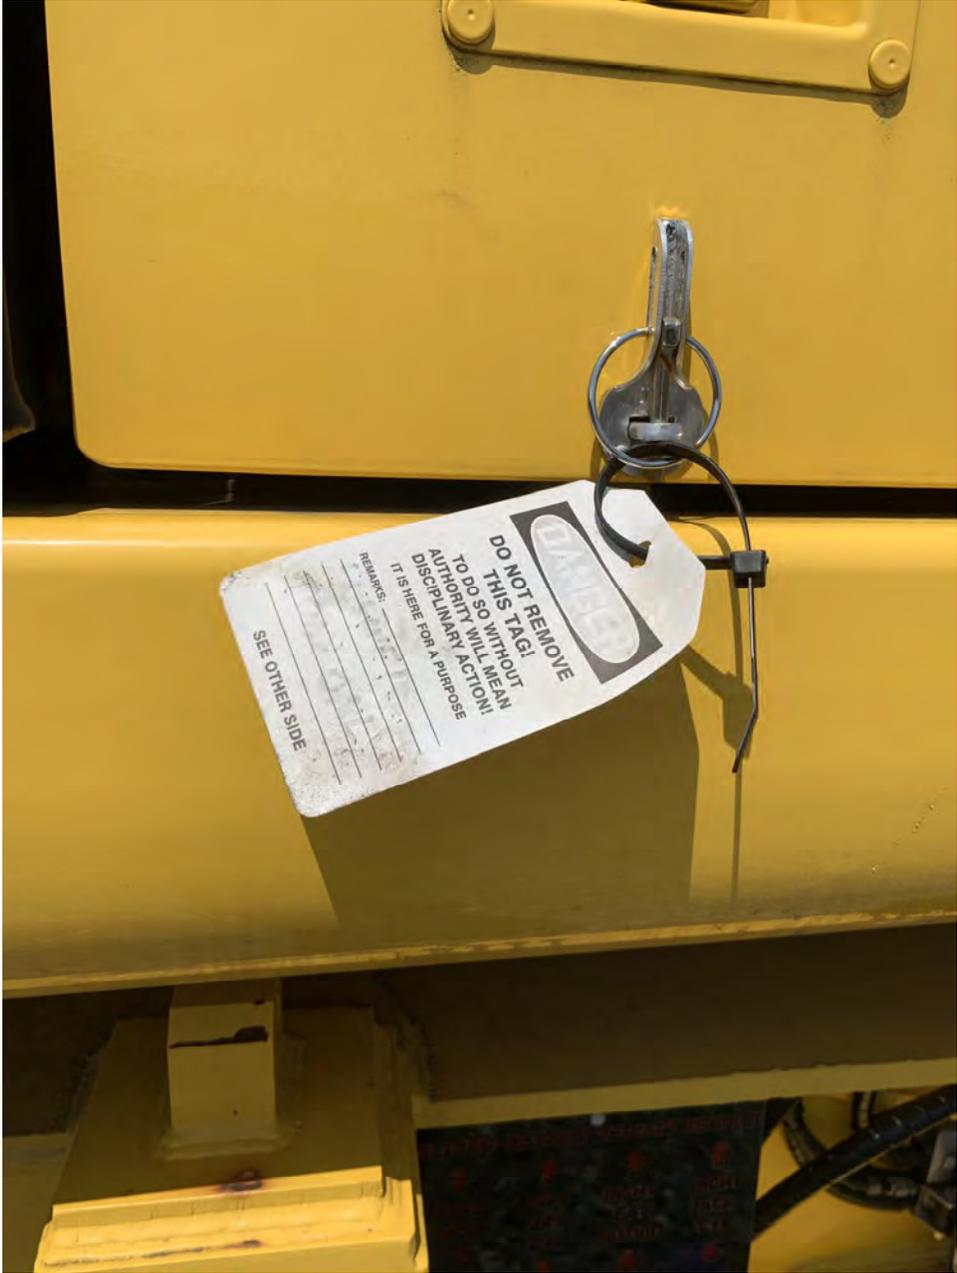
In December 2019, OIG advised WMATA management of the complaint we received and requested WMATA not move or tamper with RC35. In a recent site visit, OIG observed RC35 still present at the Greenbelt Rail Yard with a tag indicating "DANGER, DO NOT REMOVE THIS TAG!" with remarks indicating tow only (**Exhibit 10**). OIG is concerned that RC35 was used on multiple TRST projects after WMATA inspectors uncovered numerous issues with the crane being out of compliance with the RFP technical specifications at the onset of the crane being delivered to WMATA and has never performed as intended.

DANGER
DO NOT REMOVE
THIS TAG!

1. Follow WMATA safety protocols regarding unsafe equipment and apply them to RC35.
2. Make a determination if RC35 can be utilized or must be disposed.
