# SPECIAL PROJECT REPORT

December 8, 2021

## Station Cleaning Inspection

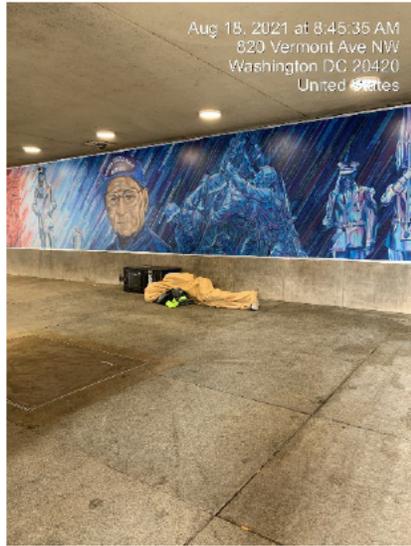
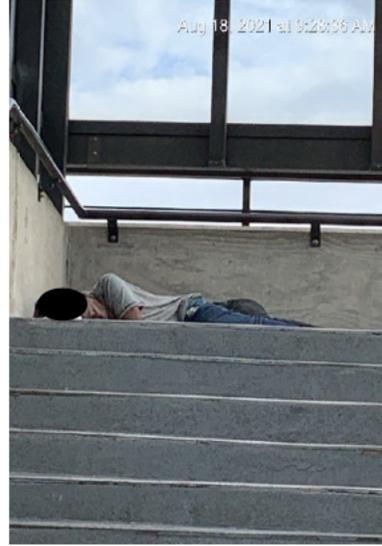
Persons Sleeping

- Person sleeping at station entrance area
- Person sleeping on stairway leading / in parking garage

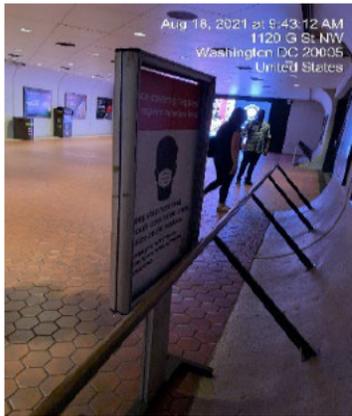
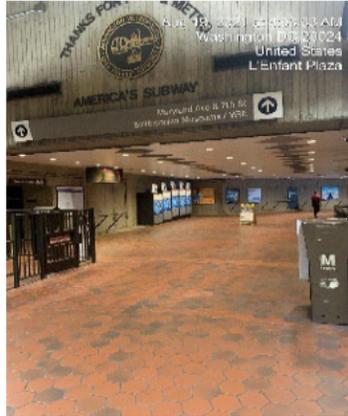
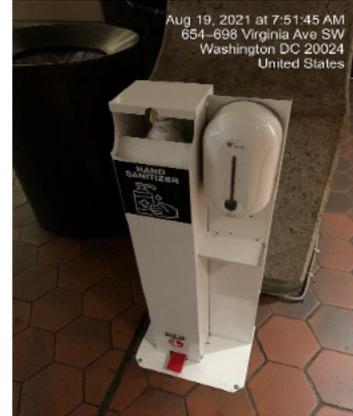
COVID-19 – Mask Compliance, Messaging, Hand Sanitizer Stations

Two of the 17 stations inspected lacked the free-standing "wear your mask" signs in direct view of the customer or did not have the mask requirement signage at all entrances. There were isolated instances of mask non-compliance noted with one customer and three employees. One station did not have a hand sanitizer station at all entrances; and five stations had hand sanitizer stations that were either fully or partially inoperable.

- Mask sign turned around not visible to customers
- Not all hand sanitizer stations were fully operational
- Missing hand sanitizer station at station entrance
- Isolated instances of mask non-compliance (1 customer/3 employees)

WMATA will continue to replace missing signs as reported to Maintenance Operation Control (MOC). WMATA also has its system-wide digital mask requirements signage posted in all stations and in the past 12 months, WMATA has distributed 2.7 million face masks to customers, roughly 52,000 face masks a week.

Furthermore, WMATA also conducts its own weekly face covering compliance reviews and inspections to monitor trends in passenger and employee compliance with the federal mandate to wear face coverings on public transit (see attachment #1). WMATA will continue to enforce the mask mandate according to Safety Alert SA#21-05a (see attachment #2).

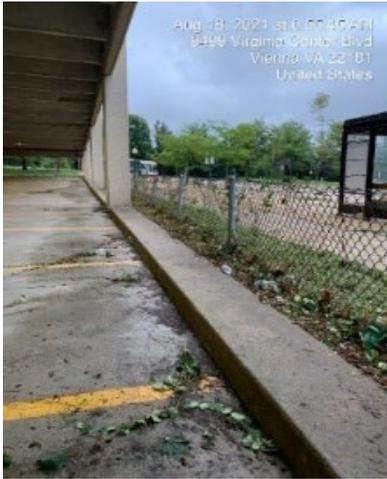
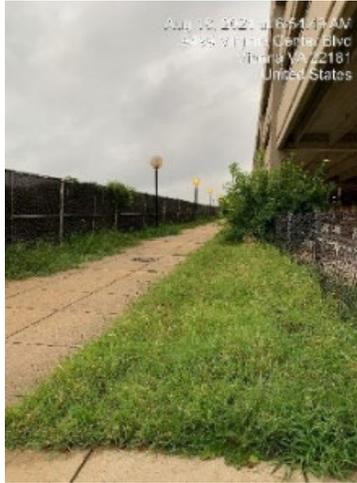
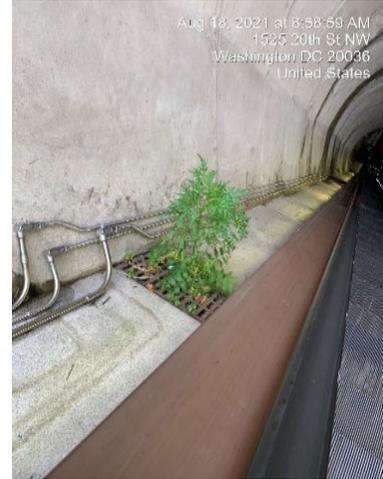
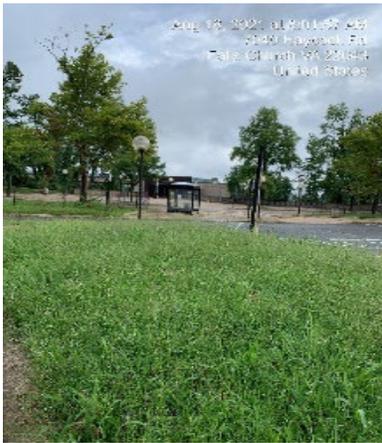
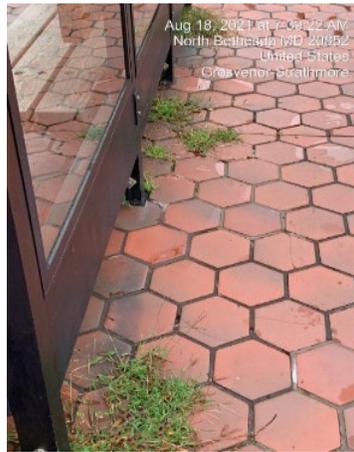
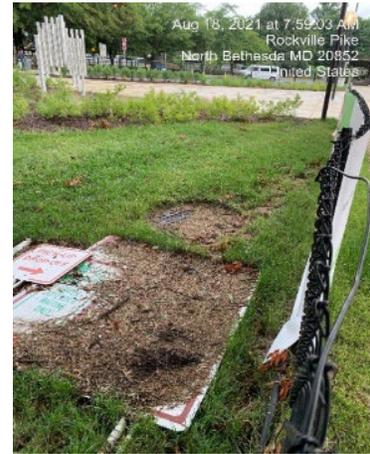
Landscaping

Overgrown grass and weeds were noted at the station entrances as well as around the parking garage area at two stations. At two other stations, weeds were growing through the platform tiles. At an additional station, there were weeds growing out of the storm drain near the escalator.

- Overgrown grass and trash
- Weeds sprouting from storm drain near escalator
- Weeds growing on platform
- Fallen signs in grass area

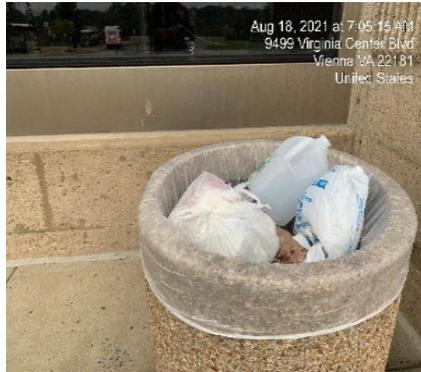
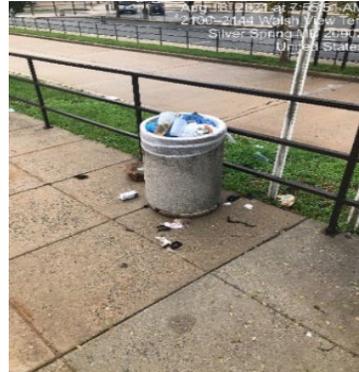
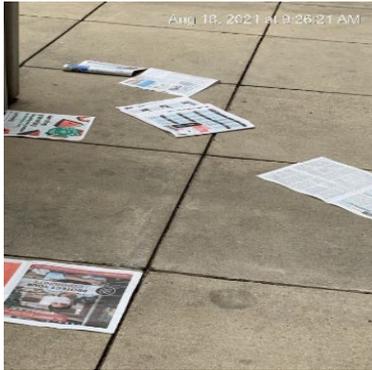
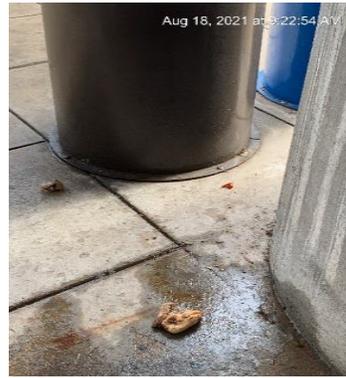
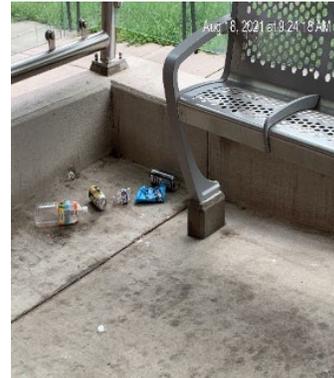
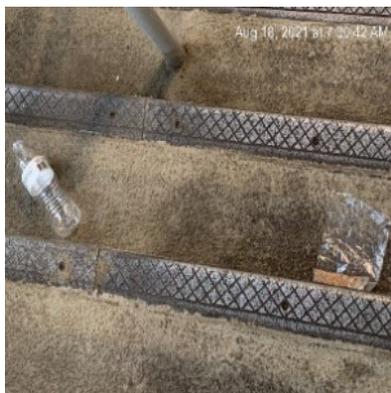
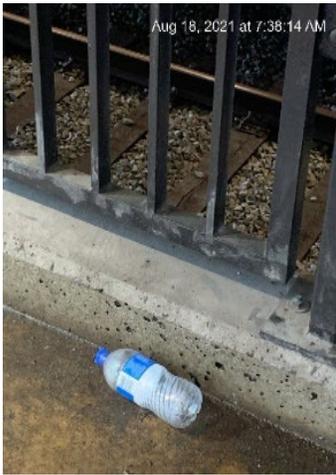
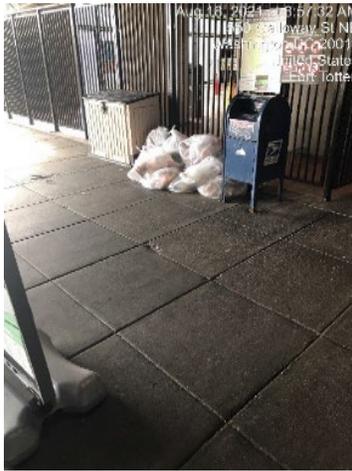
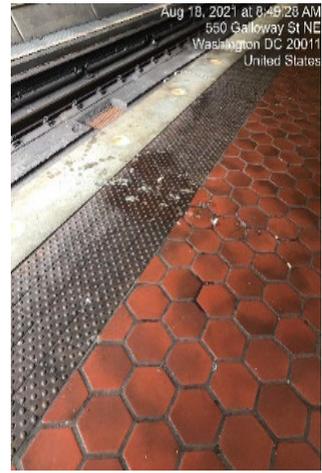
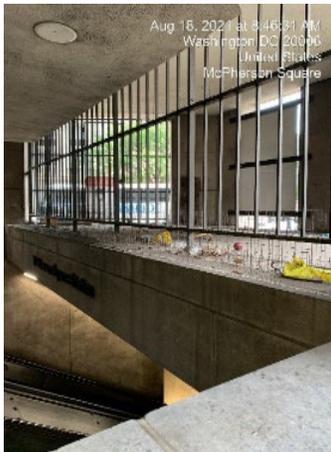
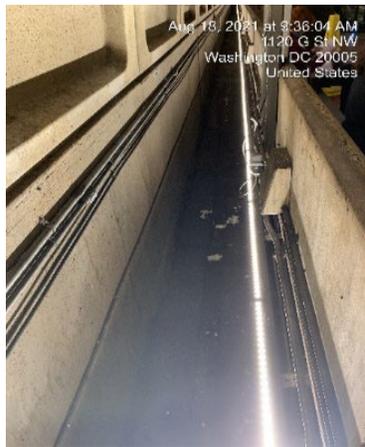
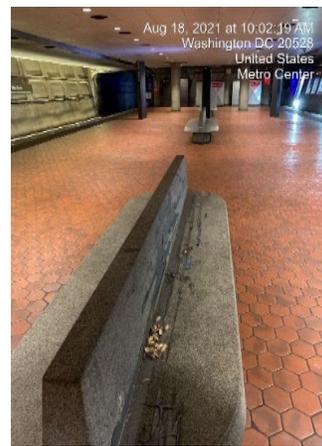
Stations - Trash and Debris

Debris and Trash: There were some instances of trash and debris in and around stations (2), near escalators (1), near faregates (2), on station platforms (7), and, behind platform walls (2).

- Debris and trash noted in entrances, outside areas, bus shelters, parking garages and platform areas, and behind platform walls.

Management Response: With the onset of COVID-19, custodial cleaning tasks have been changed to incorporate cleaning protocols recommended by the Centers for Disease Prevention and Controls (CDC). For example, touch points are disinfected twice daily, cleaning escalator decking once a day, inspecting/refilling hand sanitizers daily, cleaning bathrooms four times a day as well as pulling trash four times a day. Where custodians are assigned more than one station, they follow an assigned schedule, and corrective issues at neighboring stations are addressed as quickly as possible. Also, the team cleans behind restricted parapet walls with pick sticks on a weekly basis. Attached are the Quality Control (QC) checklists that the Supervisors use to review these cleaning procedures (see attachment #3).

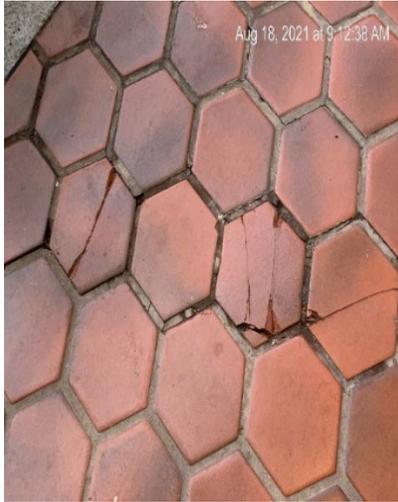
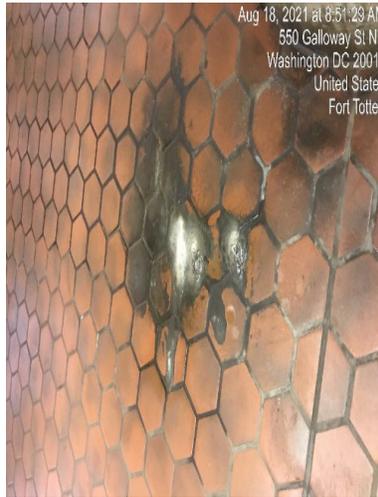
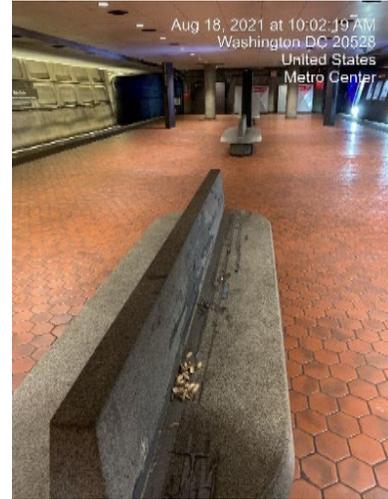
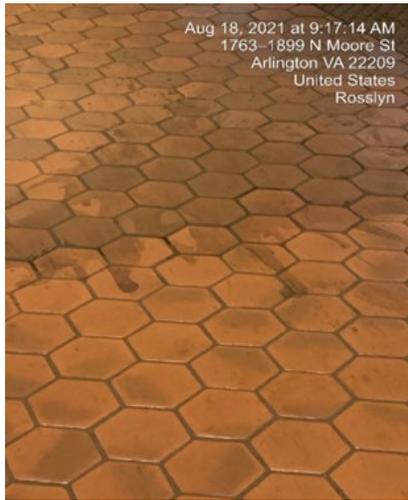
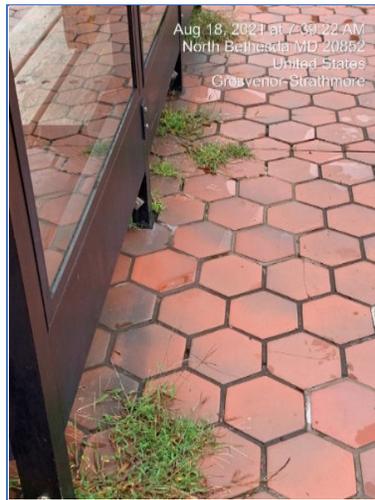
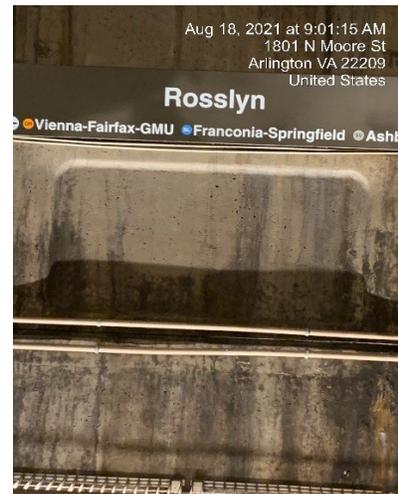
Station Platforms

Platforms: OIG also noted three stations with cracks or stains on the platform floor/tile, and one bench on the platform needed cleaning.

- Cracked tile, weeds between tile
- Bench in need of cleaning
- Floors in need of cleaning
- Moisture / Mold cement (track)

Consistent with current procedures identified in Metrorail Station Standard Operating Procedure (SOP) Handbook Section 1.5.2.3 (see attachment #4), station managers are responsible for inspecting the general condition of the station, as well as notifying MOC of any observed issues. The MOC in turn generates the appropriate work order to track and resolve the hairline cracks like those noted by OIG; these issues are considered cosmetic repairs. The workflow process of reporting, creating/prioritizing a work order, monitoring the condition, and then correcting the defect is executed on a regular basis. There are many instances, as in this case, where a condition exists but does not demand an immediate response. Conditions are assessed and remediations are scheduled in a timely fashion, as they are reported, however any potential tripping hazards are addressed immediately.

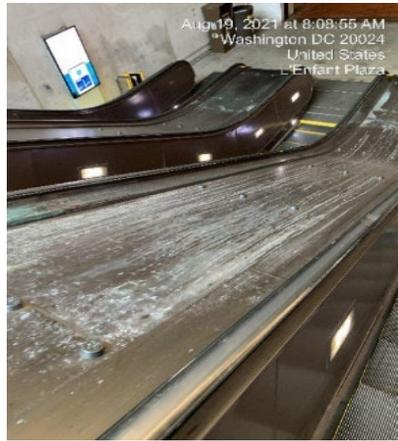
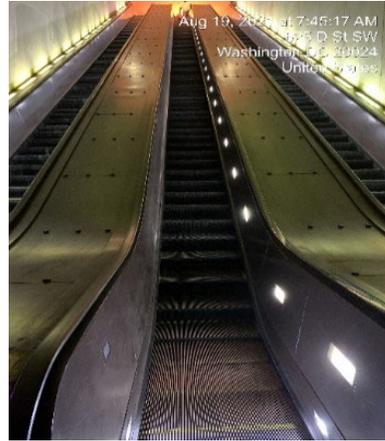
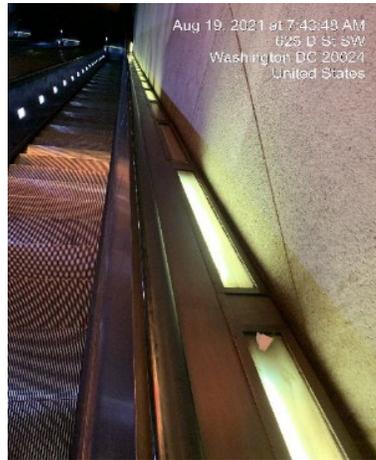
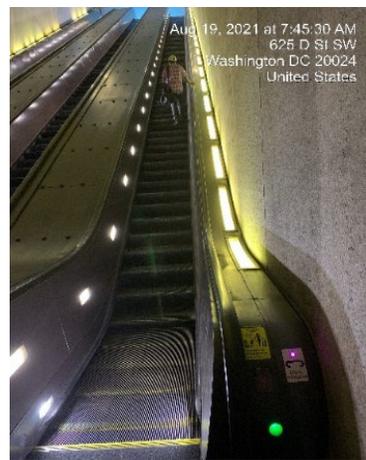
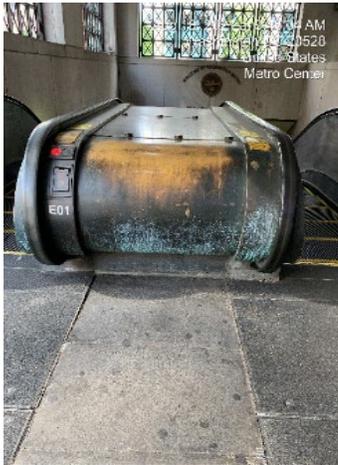
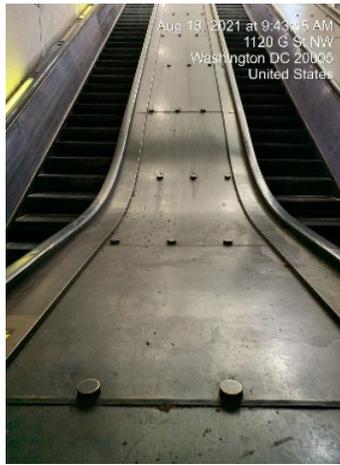
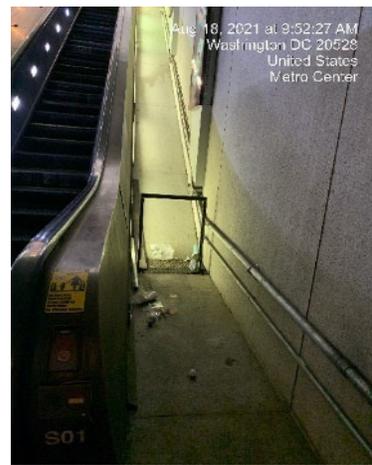
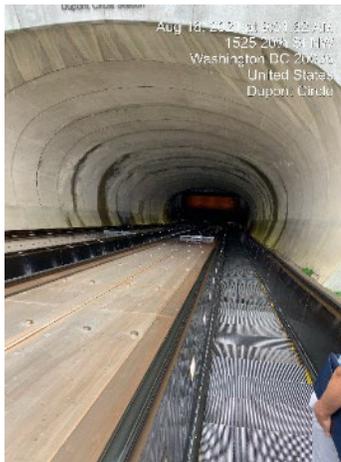
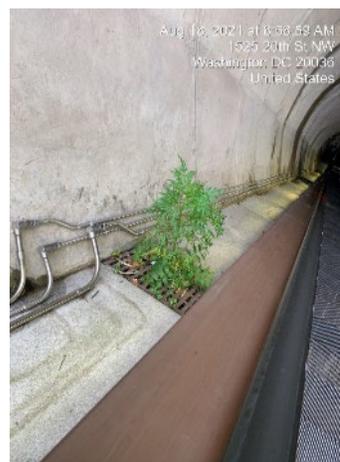
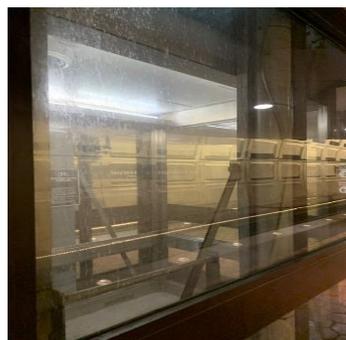
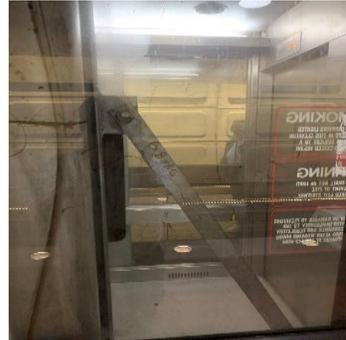
Elevators / Escalators

Escalators / Elevators: At one station, at the platform level, the elevator windows were dirty, and graffiti was noted on one of the windows. Some escalators at two stations needed cleaning.

- Escalator did not appear to be cleaned and polished
- Lights out on escalator
- Some elevator/escalators lacked or had faint yellow markings on the stairs
- Weeds growing out of storm drain near escalator
- Trash near escalator
- Elevator window dirty with graffiti

Elevators and escalators can be out of service for various reasons, including but not limited to modernization improvements, inspections, service calls, power outages, power spikes and repairs. Their service statuses are updated 24 hours a day, 7 days a week to reflect outages and service restoration as reported to the Escalator/Elevator Operations Center by station managers and maintenance staff. Elevator and escalator availability were 97.7% and 94.2%, respectively, in fiscal year 2021 (July 2020 – June 2021). Management will continue to monitor these performance measures.

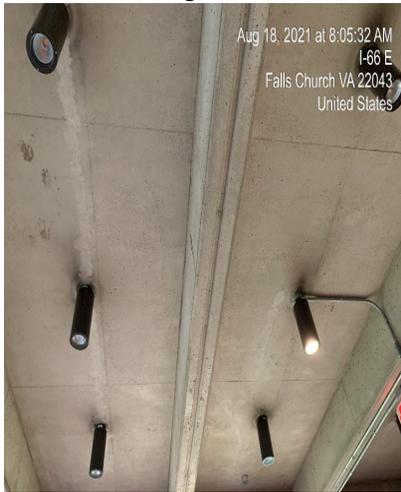
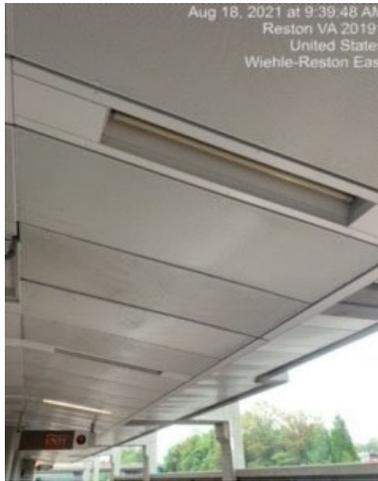
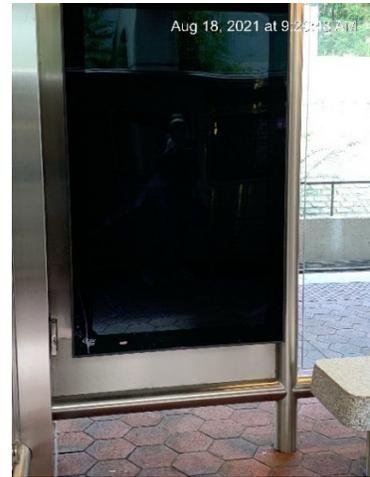
Stations – Lighting and Message Boards

Of the 17 stations inspected, all faregates were in working order. Five stations had one or more fare card machines out of service on the day of inspection, six stations reported some lights were not working, and two stations reported inoperable LED boards.

- Station lighting at platform level not working
- Message board not working

Fare machines and their lights fail sporadically. Similar to the process with addressing cracks, management will continue to respond to fare machines, lights and LED board outages, and dispatch appropriate crews as needed, consistent with standard operating procedure NO. S-18-01 Creation of MSSOPH SSOP #64 (see attachment #5).

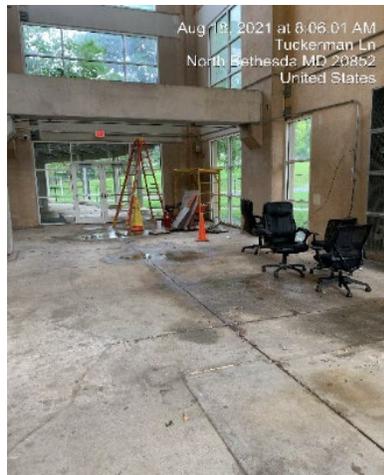
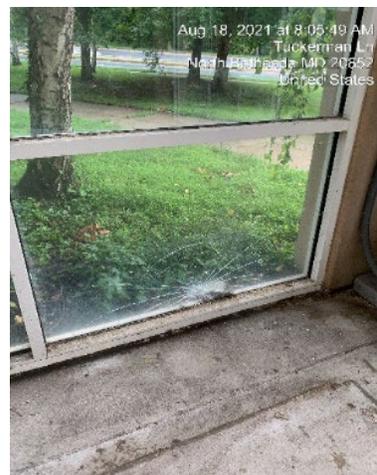
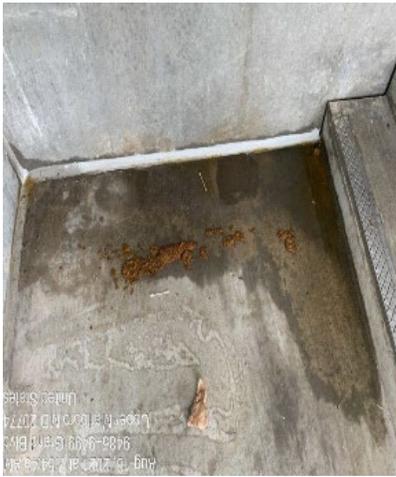
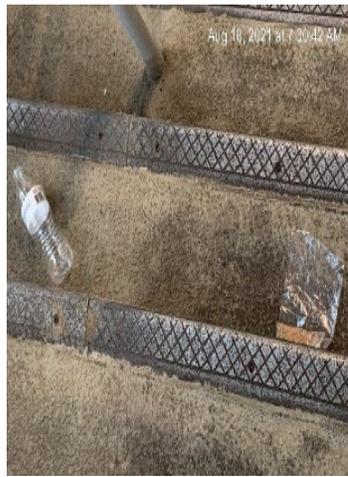
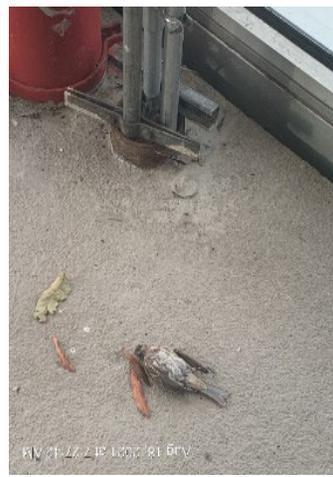
Parking Lots / Parking Garages

Nine of the 17 stations had parking lots/parking garages. While most were in overall good condition, trash and debris were noted on the floors and/or stairways at five of the stations, including one station with miscellaneous construction material, an open ladder and broken chairs, and a cracked window near the elevator in the parking garage. Our inspection also noted feces on the parking garage floor.

- Material, open ladder, chairs in garage near elevator
- Window cracked
- Feces on garage floor
- Dead bird on garage floor
- Trash on stairs

found that are not easily disposed of, a work order will be called in to MOC to ensure its removal. Custodial supervisory staff will continue to monitor these areas for cleanliness and removal of debris. However, broken glass is removed/taped and replaced as a priority because of the immediate safety hazards it poses to customers.

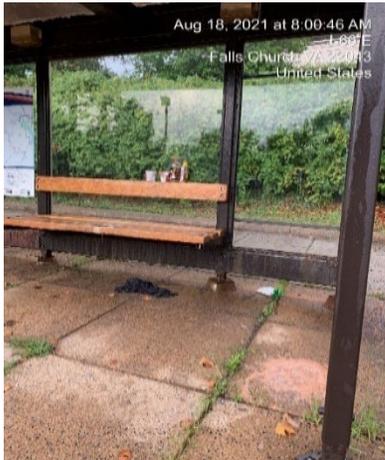
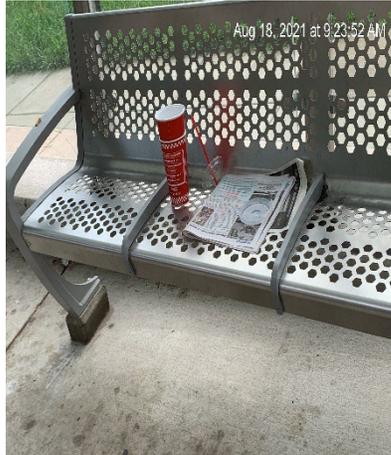
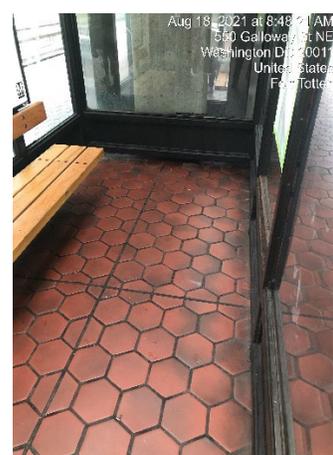
Bus Loops / Bus Shelters

Thirteen stations had bus lanes and/or bus shelters. Eight of which were found to be generally clean and in good condition. Of the remaining five stations, OIG noted cleanliness issues in and around the bus shelter/bus lane, including one shelter with noticeable vomit and trash as well as another with a broken bus shelter panel.

- Trash in and around bus loops and bus shelters
- Vomit noted in bus shelter at one station

The broken bus shelter panel was replaced at Fort Totten station on January 26, 2022 (see attachment #7). Corrective maintenance work orders are addressed in a timely fashion, as discussed above. Management will continue to monitor all maintenance work orders to closure.

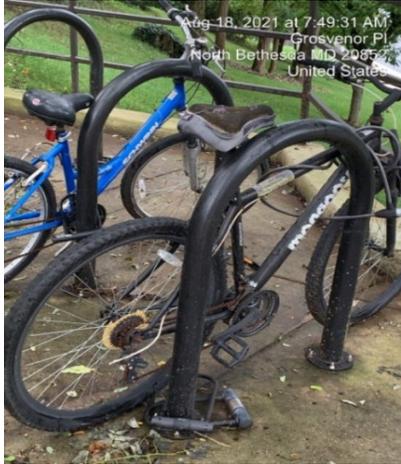
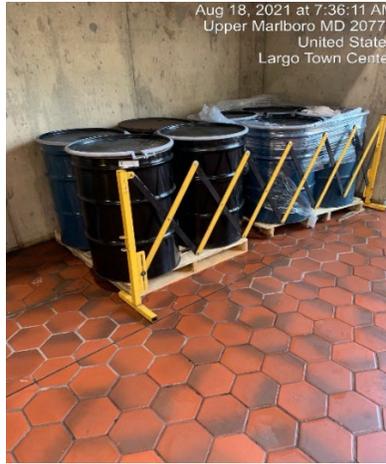
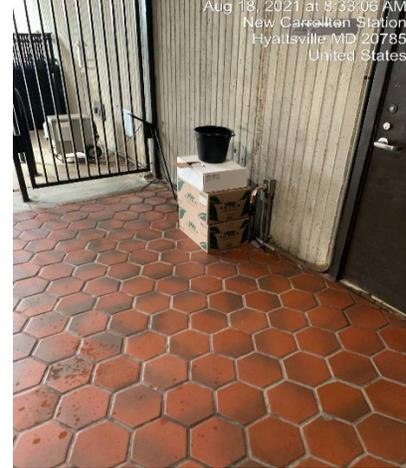
Other Observations

On the day of the inspection, OIG noted what appeared to be abandoned bikes that were left in the bike rack; these bikes had flat tires and rusted locks.

At one station, OIG noted that cleaning supplies were left unattended and large drum-like containers were placed in the station entrance area.

- Abandoned bikes in bike rack
- Large drums in station entrance area
- Cleaning supplies left unattended

The drums OIG observed are used to store water that collected in elevator and escalator pits. Under 212-SOP-35 Maintenance and Operations Safety Manual (see attachment #9), the drums are requested and staged in stations in response to maintenance repairs as needed and picked up 24 hours after repairs are completed.

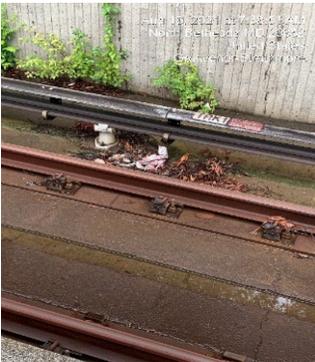
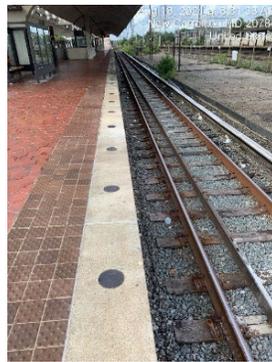
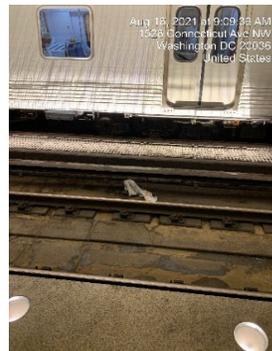
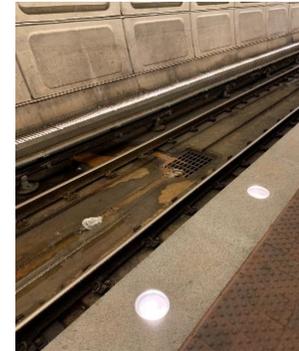
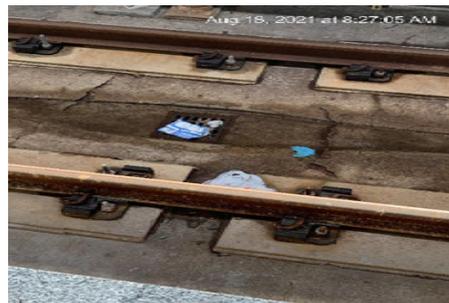
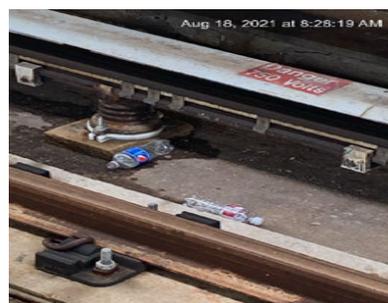
Rail Beds

OIG noted debris in the rail/track bed that was visible from the platform at 14 of the 17 stations inspected. This ranged from a minimal amount to OIG reporting a lot of debris noted at one station. OIG recognizes that this is not under the GMAC's purview of the janitorial services and provides this as information.

- Trash and debris noted in rail / track beds

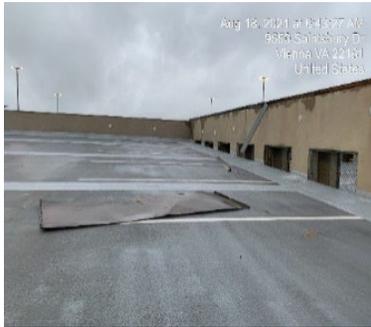
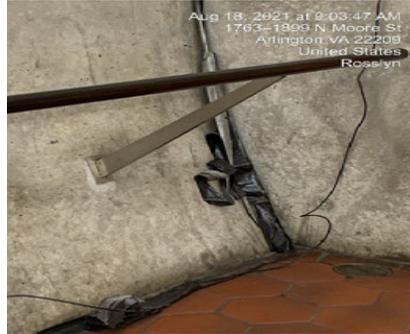
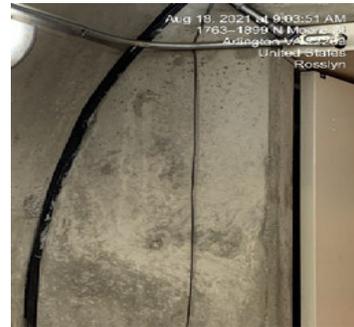
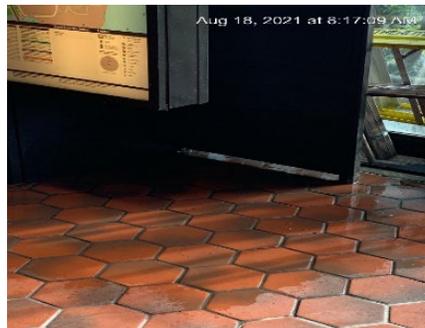
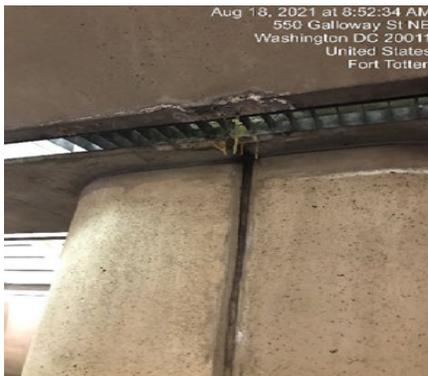
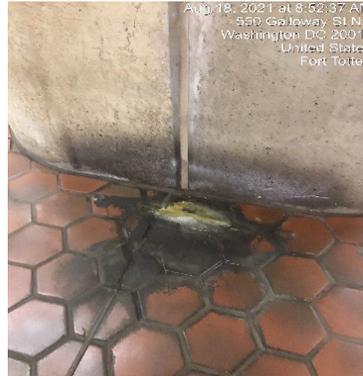
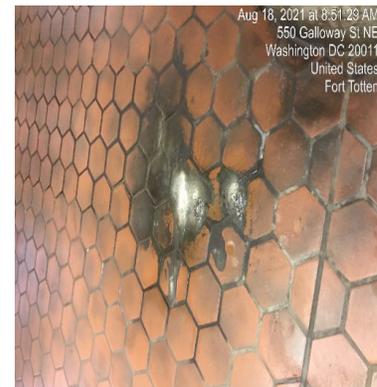
Potential Safety Concerns

- One of two roof leaks created water on the floor and that area was not cordoned off
- Water intrusion from the ceiling near a light fixture
- Electrical wires were found hanging along the wall and on the floor in the station entrance area, visible to customers
- Two large broken metal pieces located in the parking garage floor and wall area
- A cracked window near the garage elevator
- Mineral deposits forming on the ceiling and floor near a support pillar in the platform area
- Missing or faded demarcation lines on escalators, lighting and light direction that may impact customers with low vision

- Large metal pieces on floor and wall of parking garage
- Roof leak – water on floor not cordoned off
- Spalling and exposed rebar – under rails visible from concrete pathway
- Mineral deposit forming on ceiling and bottom of pillar/platform (potential tripping hazard)
- Escalator lighting and yellow markings

Management Response: As previously discussed and consistent with current procedures identified in Metrorail Station Standard Operating Procedure (SOP) Handbook Section 1.5.2.3 (see attachment #4), station Managers are responsible for inspecting the general condition of the station, as well as notifying MOC of any observed issues. MOC in turn generates the appropriate work order to track and resolve the issue. Station Managers will continue to mitigate unsafe conditions and report structural leaks to MOC for repair.

This includes the items OIG noted as potential safety issues. For example, since the time of the audit, the temporary hanging wires were removed, the two large broken metal pieces located in the parking garage floor and wall area were removed, and the cracked window was repaired. However, mineral deposits forming on the ceiling and floor are cosmetic defects and were/will be addressed in the manner described above. Similarly, management will continue to perform repairs on escalators as needed during scheduled preventative maintenance inspections as described above.
