# SPECIAL PROJECT REPORT

May 26, 2022

Station Cleaning Inspection

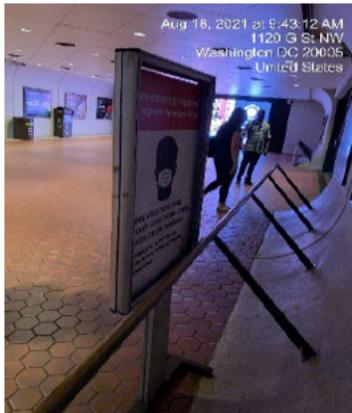
**Metro Center**

Two of the 17 stations inspected lacked the free-standing "wear your mask" signs in direct view of the customer or did not have the mask requirement signage at all entrances. There were isolated instances of mask non-compliance noted with one customer and three employees. One station did not have a hand sanitizer station at all entrances; and five stations had hand sanitizer stations that were either fully or partially inoperable.

- Mask sign turned around not visible to customers
- Not all hand sanitizer stations were fully operational
- Missing hand sanitizer station at station entrance
- Isolated instances of mask non-compliance (1 customer/3 employees)

WMATA will continue to replace missing signs as reported to Maintenance Operation Control (MOC). WMATA also has its system-wide digital mask requirements signage posted in all stations and in the past 12 months, WMATA has distributed 2.7 million face masks to customers, roughly 52,000 face masks a week.

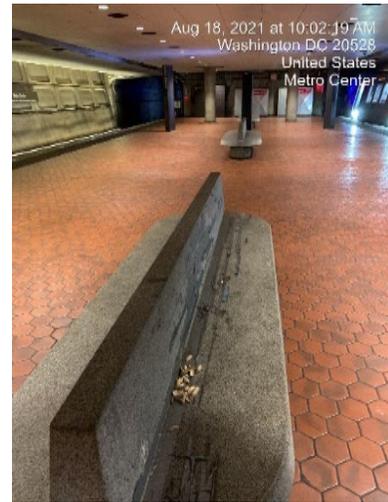
← ← ← **Fort Totten** → → →

Platforms: OIG also noted three stations with cracks or stains on the platform floor/tile, and one bench on the platform needed cleaning.

- Cracked tile, weeds between tile
- Bench in need of cleaning
- Floors in need of cleaning
- Moisture / Mold cement (track)

Consistent with current procedures identified in Metrorail Station Standard Operating Procedure (SOP) Handbook Section 1.5.2.3 (see attachment #4), station managers are responsible for inspecting the general condition of the station, as well as notifying MOC of any observed issues. The MOC in turn generates the appropriate work order to track and resolve the hairline cracks like those noted by OIG; these issues are considered cosmetic repairs. The workflow process of reporting, creating/prioritizing a work order, monitoring the condition, and then correcting the defect is executed on a regular basis. There are many instances, as in this case, where a condition exists but does not demand an immediate response. Conditions are assessed and remediations are scheduled in a timely fashion, as they are reported, however any potential tripping hazards are addressed immediately.
