**September 28, 2023**

## **A REPORT BY THE OFFICE OF INSPECTOR GENERAL**

**OIG 24-001**

# **Review of WMATA's 7000-Series Rail Car Cannibalization for Spare Parts**

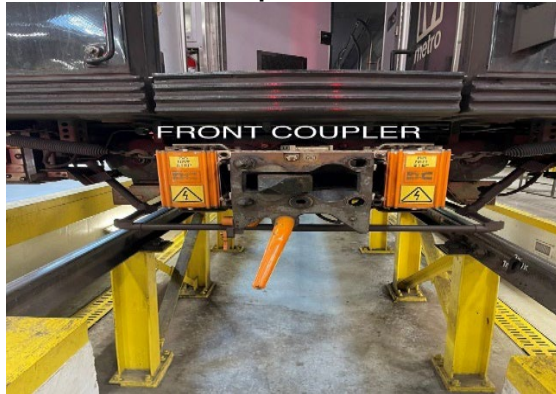
**Picture 2: Front Coupler**

An example of a safety sensitive part is a front coupler. Picture 2<sup>2</sup> shows a coupler on a typical 7000-Series rail car, whereas Picture 3 shows the missing coupler from a cannibalized rail car. Officials designated this part as safety sensitive because it is used to connect one car to another. Rail Car Maintenance officials indicated it would take over 1.5 years for the couplers to be ordered and installed on rail cars 7038 and 7039. However, when OIG checked Maximo, the system of record, there were seven couplers in stock.

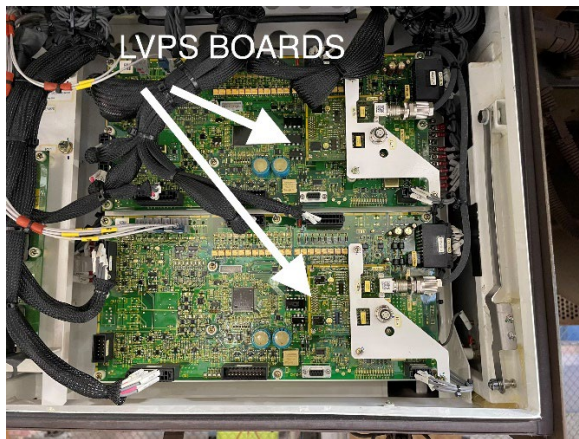
**Picture 4: LVPS Boards**

Another example of an electronic part designated as safety sensitive is a component called a “daughter board” on the low voltage power systems (LVPS) board. Picture 4 shows an LVPS board on a typical 7000-Series rail car, whereas Picture 5 depicts the missing component on the LVPS board from rail car 7039 after cannibalization.

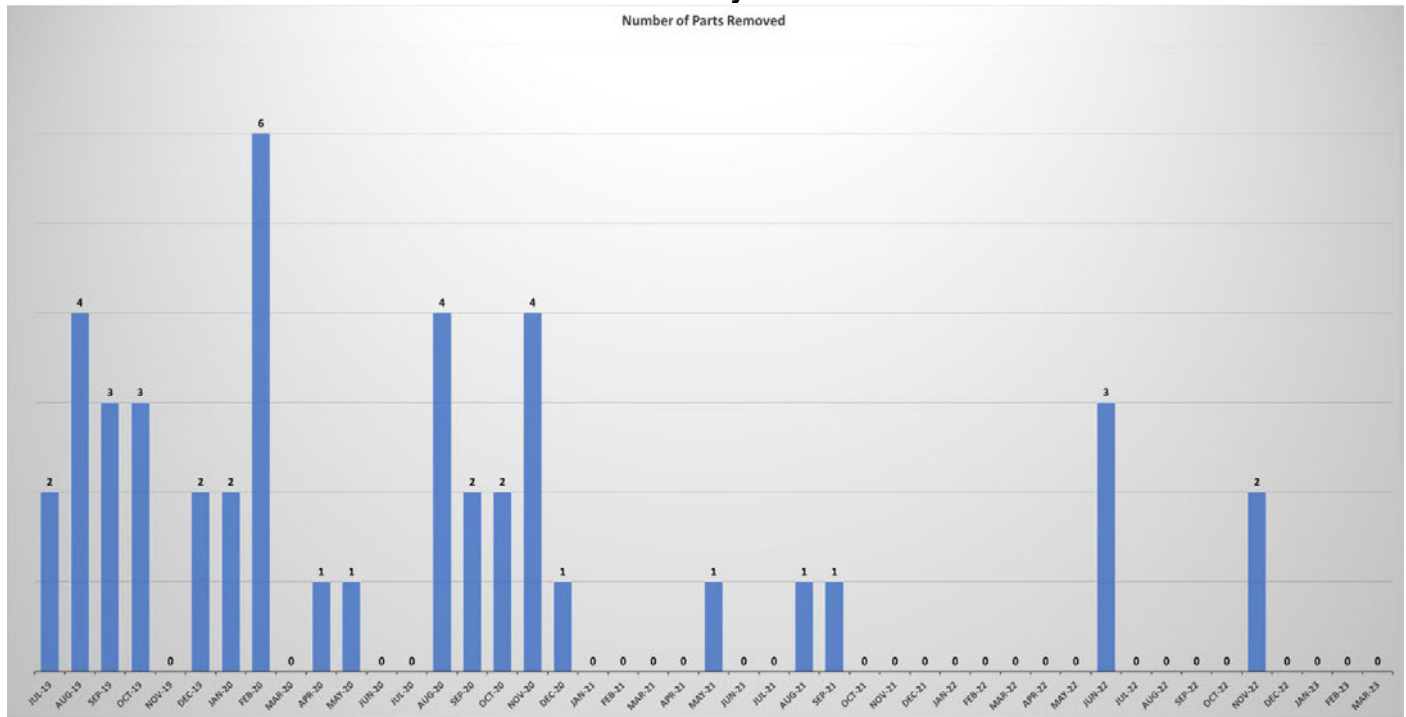
**Chart 1: Parts Removed from the Cannibalized Rail Cars by Month**

Section 6.1.3 of the SOP states, "No active revenue service rail car shall be used as a donor vehicle for longer than 8 months." However, "... an inactive long term out of service rail car may exceed the 8-month limit." Section 6.1.4 further states, "If the requirement for cannibalization exists after 8-months another rail car will be chosen." Thus, cannibalization is meant to be short-term. However, one official stated that some spare parts need purchase lead times of several years, which would render the 8-month time limit too short. In the case of rail cars 7038 and 7039, 37 parts were removed over a period of 1.5 years (from July 2019 to December 2020), and an additional eight parts were removed throughout 2021 and 2022. Chart 1 illustrates the volume of cannibalization by month.

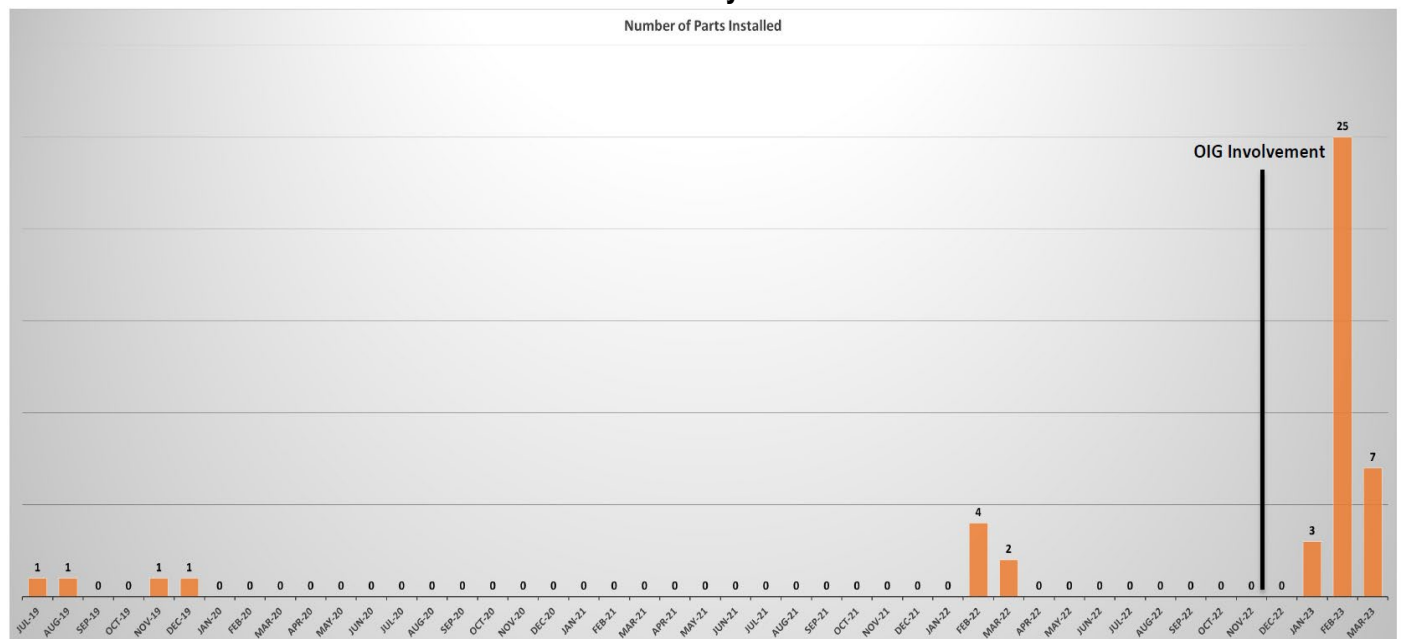
**Chart 2: Parts Reinstalled on the Cannibalized Rail Cars by Month**

The SOP does not address returning the cannibalized rail car(s) back into revenue service, nor does it discuss timeframes for reinstalling parts on the cannibalized rail cars. In the case of rail cars 7038 and 7039, only 10 parts were reinstalled over the 3.5-year period (from July 2019 to December 2022), whereas 35 parts were reinstalled in the first three months of 2023. Chart 2 illustrates the volume of parts reinstallation by month. OIG started its review in November 2022 – denoted by the vertical black line in the Chart.
