SUBJECT: Management Assistance Report
WMATA Crane Purchase
(MAR-23-0001)

DATE PUBLISHED: November 17, 2022

FROM: OIG – Rene Febles [REDACTED]

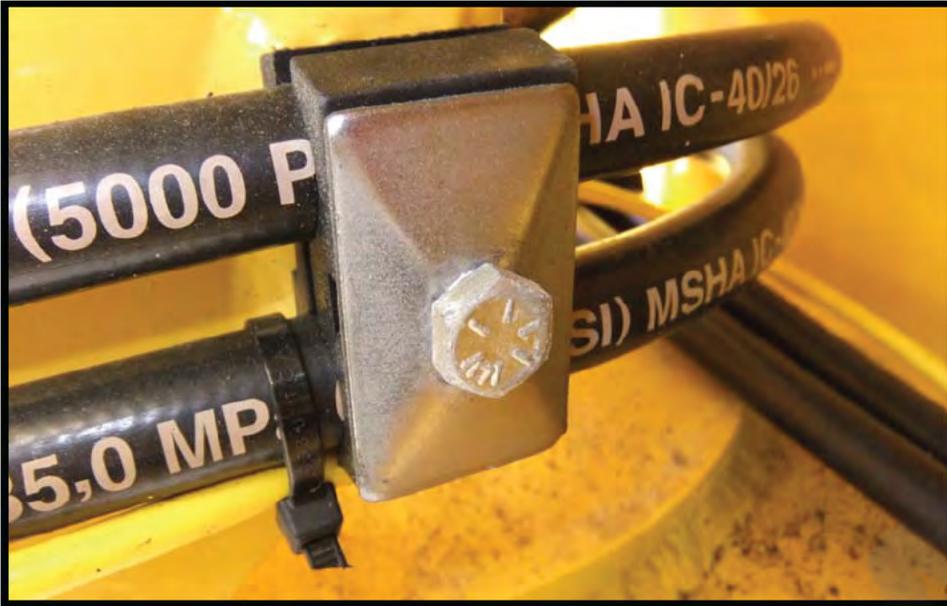
Item No.	Discrepancy	MFR QC <small>(Sign / Initial / Stamp)</small>	Cust Insp. <small>(Sign / Initial / Stamp)</small>
1	At each outrigger (4 places); yellow cable is in hard contact with cylinder and lacks protection rubber. Photo 1		
2	Nearly all tie-wraps exhibit sharp edges and trimming. Photo 2		
3	Multiple hydraulic hose clamps exhibit inconsistent hardware grade 5 and Grade 8 bolts are used throughout these clamps along outriggers the carbody. Photo 3A & 3B		
4	At pivot points where the hoses join the carbody there exists hard contact between the bolt head on the hydraulic clamps and nearby hydraulic hoses. Photo 4		
5	Multiple cases of insufficient thread protrusion on hydraulic hose clamps on hoses at pivot of outrigger. Photo 5		
6	Chafing conditions visible under carbody forward of forward right outrigger. Photo 6		
7	Electrical tape wrapped instead sharp edges of fitting on forward truck, right side, forward of #2. Photo 7

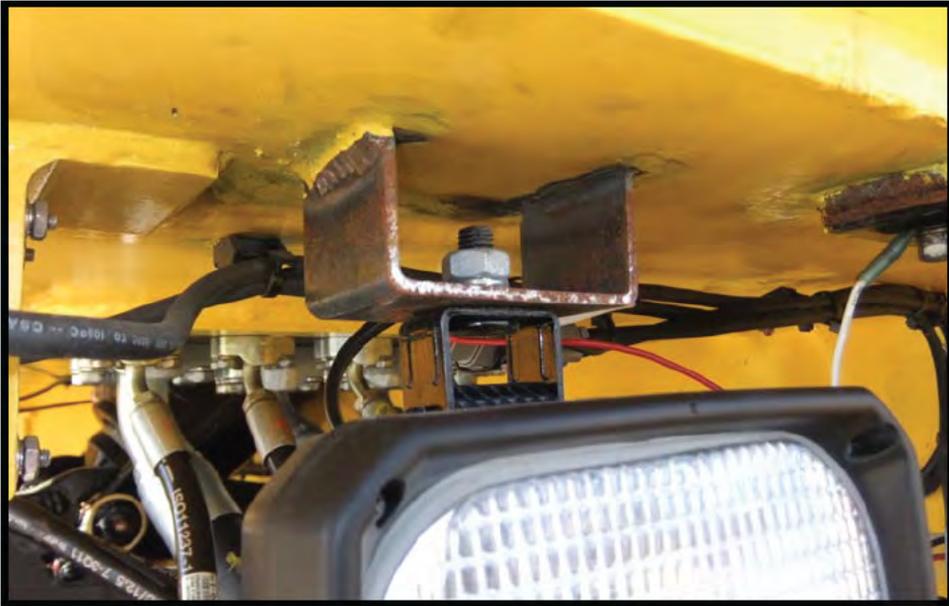
8	P-clamp on cable is not attached to vehicle under carbody near forward right outrigger lock. Photo 8		
9	Compartment cover missing at bottom of radiator compartment. Photo 9		
10	Unpainted rusting mounting bracket at forward right headlight. Photo 10		
11	Unpainted and rusting mounting bracket at forward right red light. Photo 11

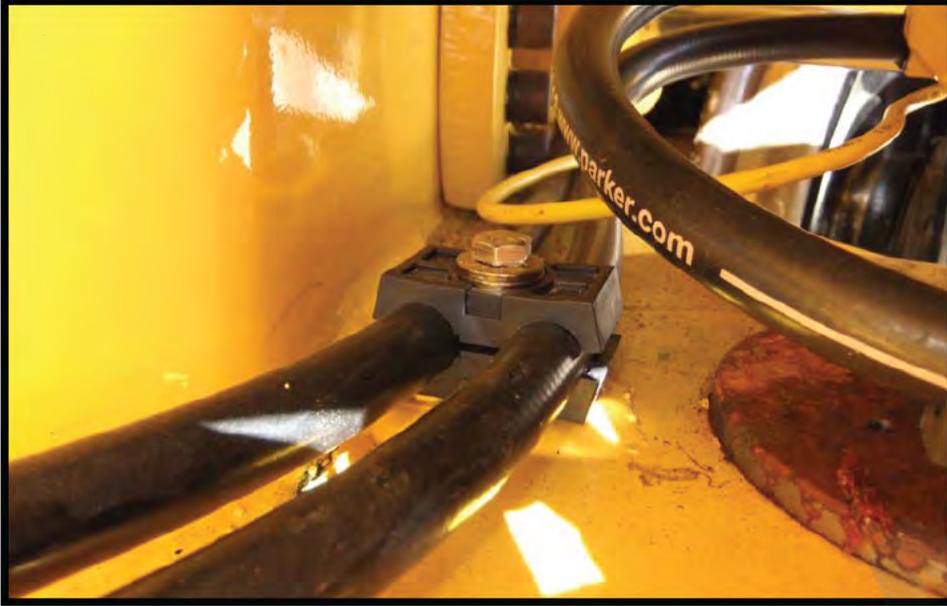
12	Seven of the eight axle keepers are installed upside-down. Photos 12A & 12B		
13	Hydraulic line clamps are missing rectangular metal plates at pivot point of forward right outrigger. Photo 13		
14	Missing lockwasher under head of cap screw at hydraulic flange on right side of carbody (Service Brake Pilot hose). Photo 14		
15	Corrosion/rust on hydraulic flange near leveling cylinder on forward left side of vehicle. Photo 15		
16	Support pipe for manifold attached to leveling cylinder on forward left side of vehicle is rusted. Photo 16		
17	Inconsistent hardware used at forward tow loop weldment. Middle bolt is longer than the two on either side of it on left and right side. Photo 17		
18	Inconsistent hardware used at rear tow loop weldment. Middle bolt is longer than the two on either side of it on left and right side. Photo 17		
19	Electrical tape used to hold black protective conduit on yellow cable harness is unattached from conduit and is unraveled on right side of forward truck. Photo 18

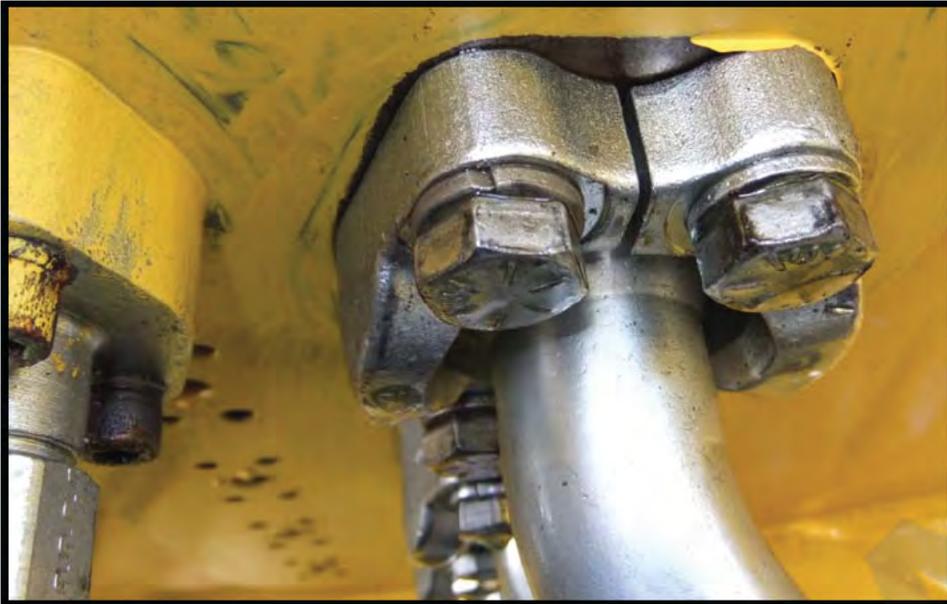
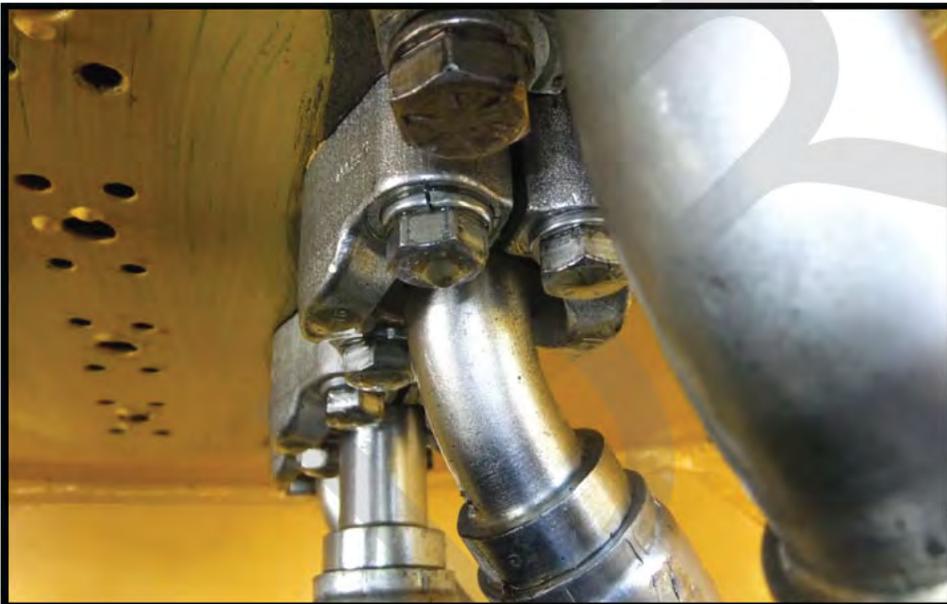
20	Fittings leaking fluid at forward left outrigger cylinder. Photo		
21	Insufficient thread protrusion on P-clamp hardware for sensor cable at #3 stabilizer cylinder on truck. Photo		
22	Fluid leaking from gaskets under carbody aft of left forward outrigger lock. Photo 21A & 21B		
23	Hydraulic lines for #3 stabilizer are not secured to truck frame at forward left area of truck. Photo 22		
24	At rear of vehicle under the deck and above the truck, large bundles of hoses in contact with the weldments for the front and rear tow-loops. Photo 23		
25	Tow-loop mounting hardware at front and rear of vehicle exhibit insufficient thread protrusion. Photo 24		
26	Nearly all of the large cap screws in turret of vehicle exhibit corrosion/rust. Photo 25		
27	Cap washers securing the right and left side outrigger controls have paint in the recess of the hex heads and appear to be marred. Photos 26A & 26B		
28	Hydraulic line clamps are missing rectangular metal plates at left side of carbody. Photo 27

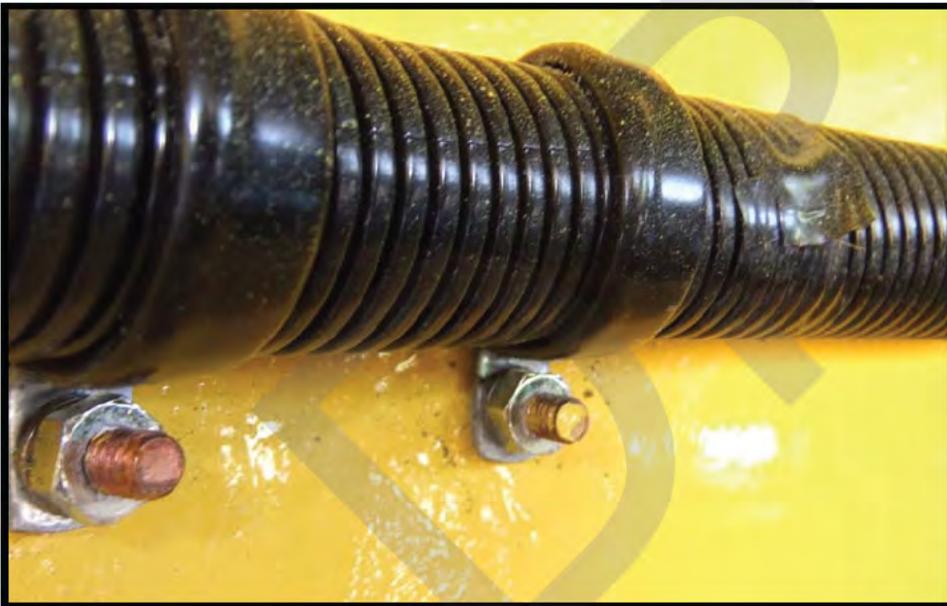
29	Paint in threads of P-clamp studs at left side of carbody, forward of #3 axle. Photo 28		
30	Large bundle of hydraulic lines chafe against white wear pad on deck of vehicle at rear left side. Photo 29		
31	Fluid leaking from flange at rear left of vehicle under deck. Photo 30		
32	Hard contact and damage has occurred between the suction hose and pony mot mounting brackets. Photo 31		
33	Inconsistent cap screws found on block on right rear leveling device – insufficient thread protrusion. Photo 32		
34	Loose nut on P-clamp stud at rear left side of carbody above axle. Photo 33		
35	Hose connection plates welded to deck aft of cab area are untested and tested. Photos 34A & 34B		
36	Insufficient thread protrusion on P-clamp studs on carbody, right side, above #3 axle. Photo 35		
37	Fluid leaking from flanges under deck, above axle, right side. Photo 36		
38	Cable lying on #3 axle, right side. Photo 37

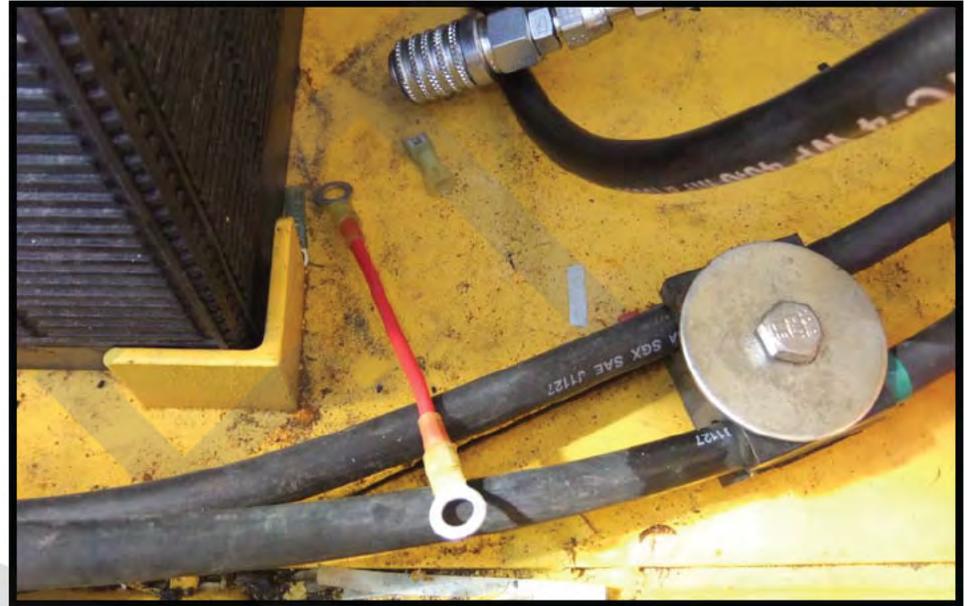
46	Terminals, wire and tie-wraps laying on the floor of the electrical compartment. Photos 45A & 45B		
47	Bolt laying on floor of radiator compartment. Photo 46		
48	In several areas, the hydraulic hose clamps pinch the hoses. Photo 47		
49	Unterminated wires at the terminal strip in the electrical compartment are not properly capped. Photo 48		
50	Fins on the surface of the radiator are bent/damaged at top. Photo 49		
51	Nearly all glass panels in the cab area lack rubber seals/glazing. Photo 50A, 50B, 50C, 50D, 50E, 50F & 50G		
52	Bottom cab windshield wiper is misaligned with the windshield and falls below the glass. Photo 51		
53	Cotter pin installed incorrectly on large pin securing stacked sheet steel rights at rear of vehicle. Photo 52		
54	Several fluid leaks exist directly below the cab area of the vehicle. Photo 53A & 53B		
55	Battery cable is in hard contact with threads of connector in turret of the vehicle. Photo 54

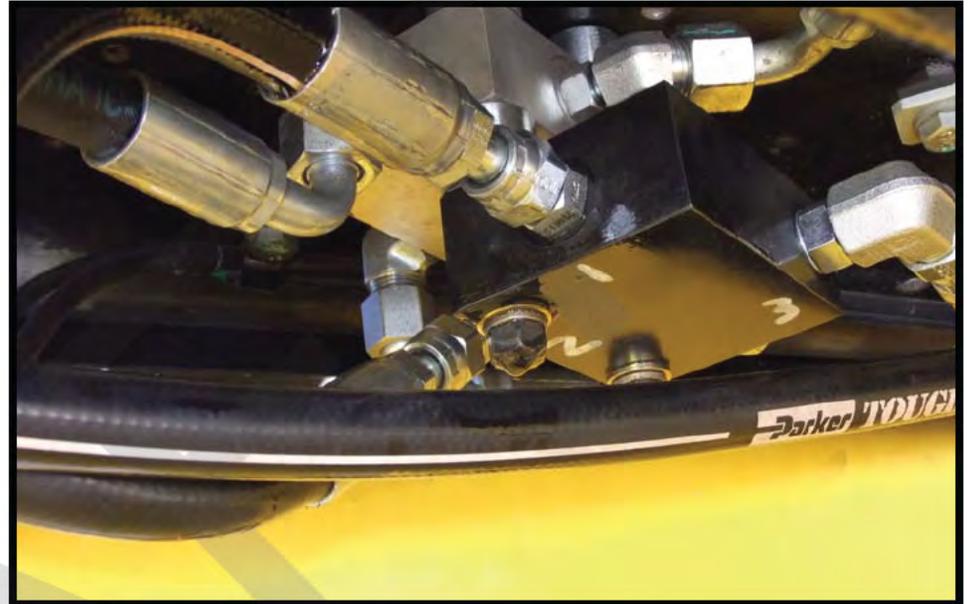
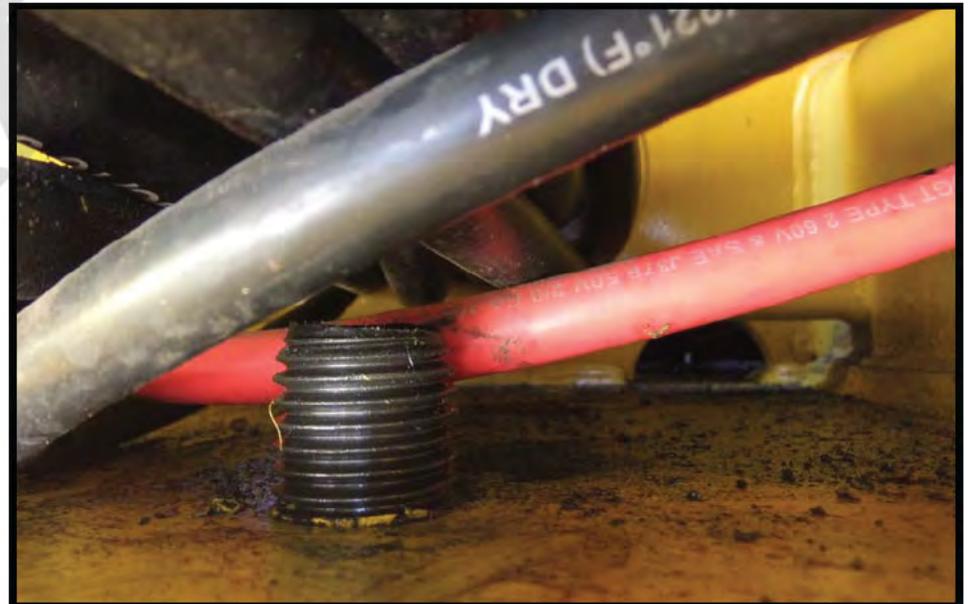
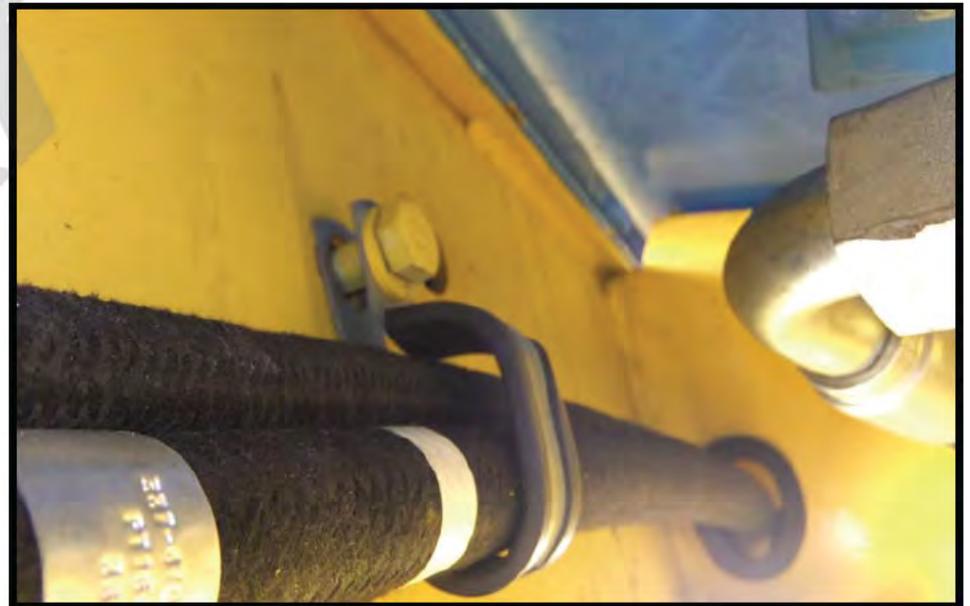
Photo 55A

56	Wiring in electrical compartment lacks labels and is poorly routed in general. Photos 55A, 55B & 55C		
57	Hardware on P-clip above pivot point of outrigger is loose. Photo 56		
58	Sheet metal connected to forward exterior side of the fuel tank has two P-clamps on it yet is not secured to anything. Photo 57		
59	"RC-01" labels are missing from the vehicle.

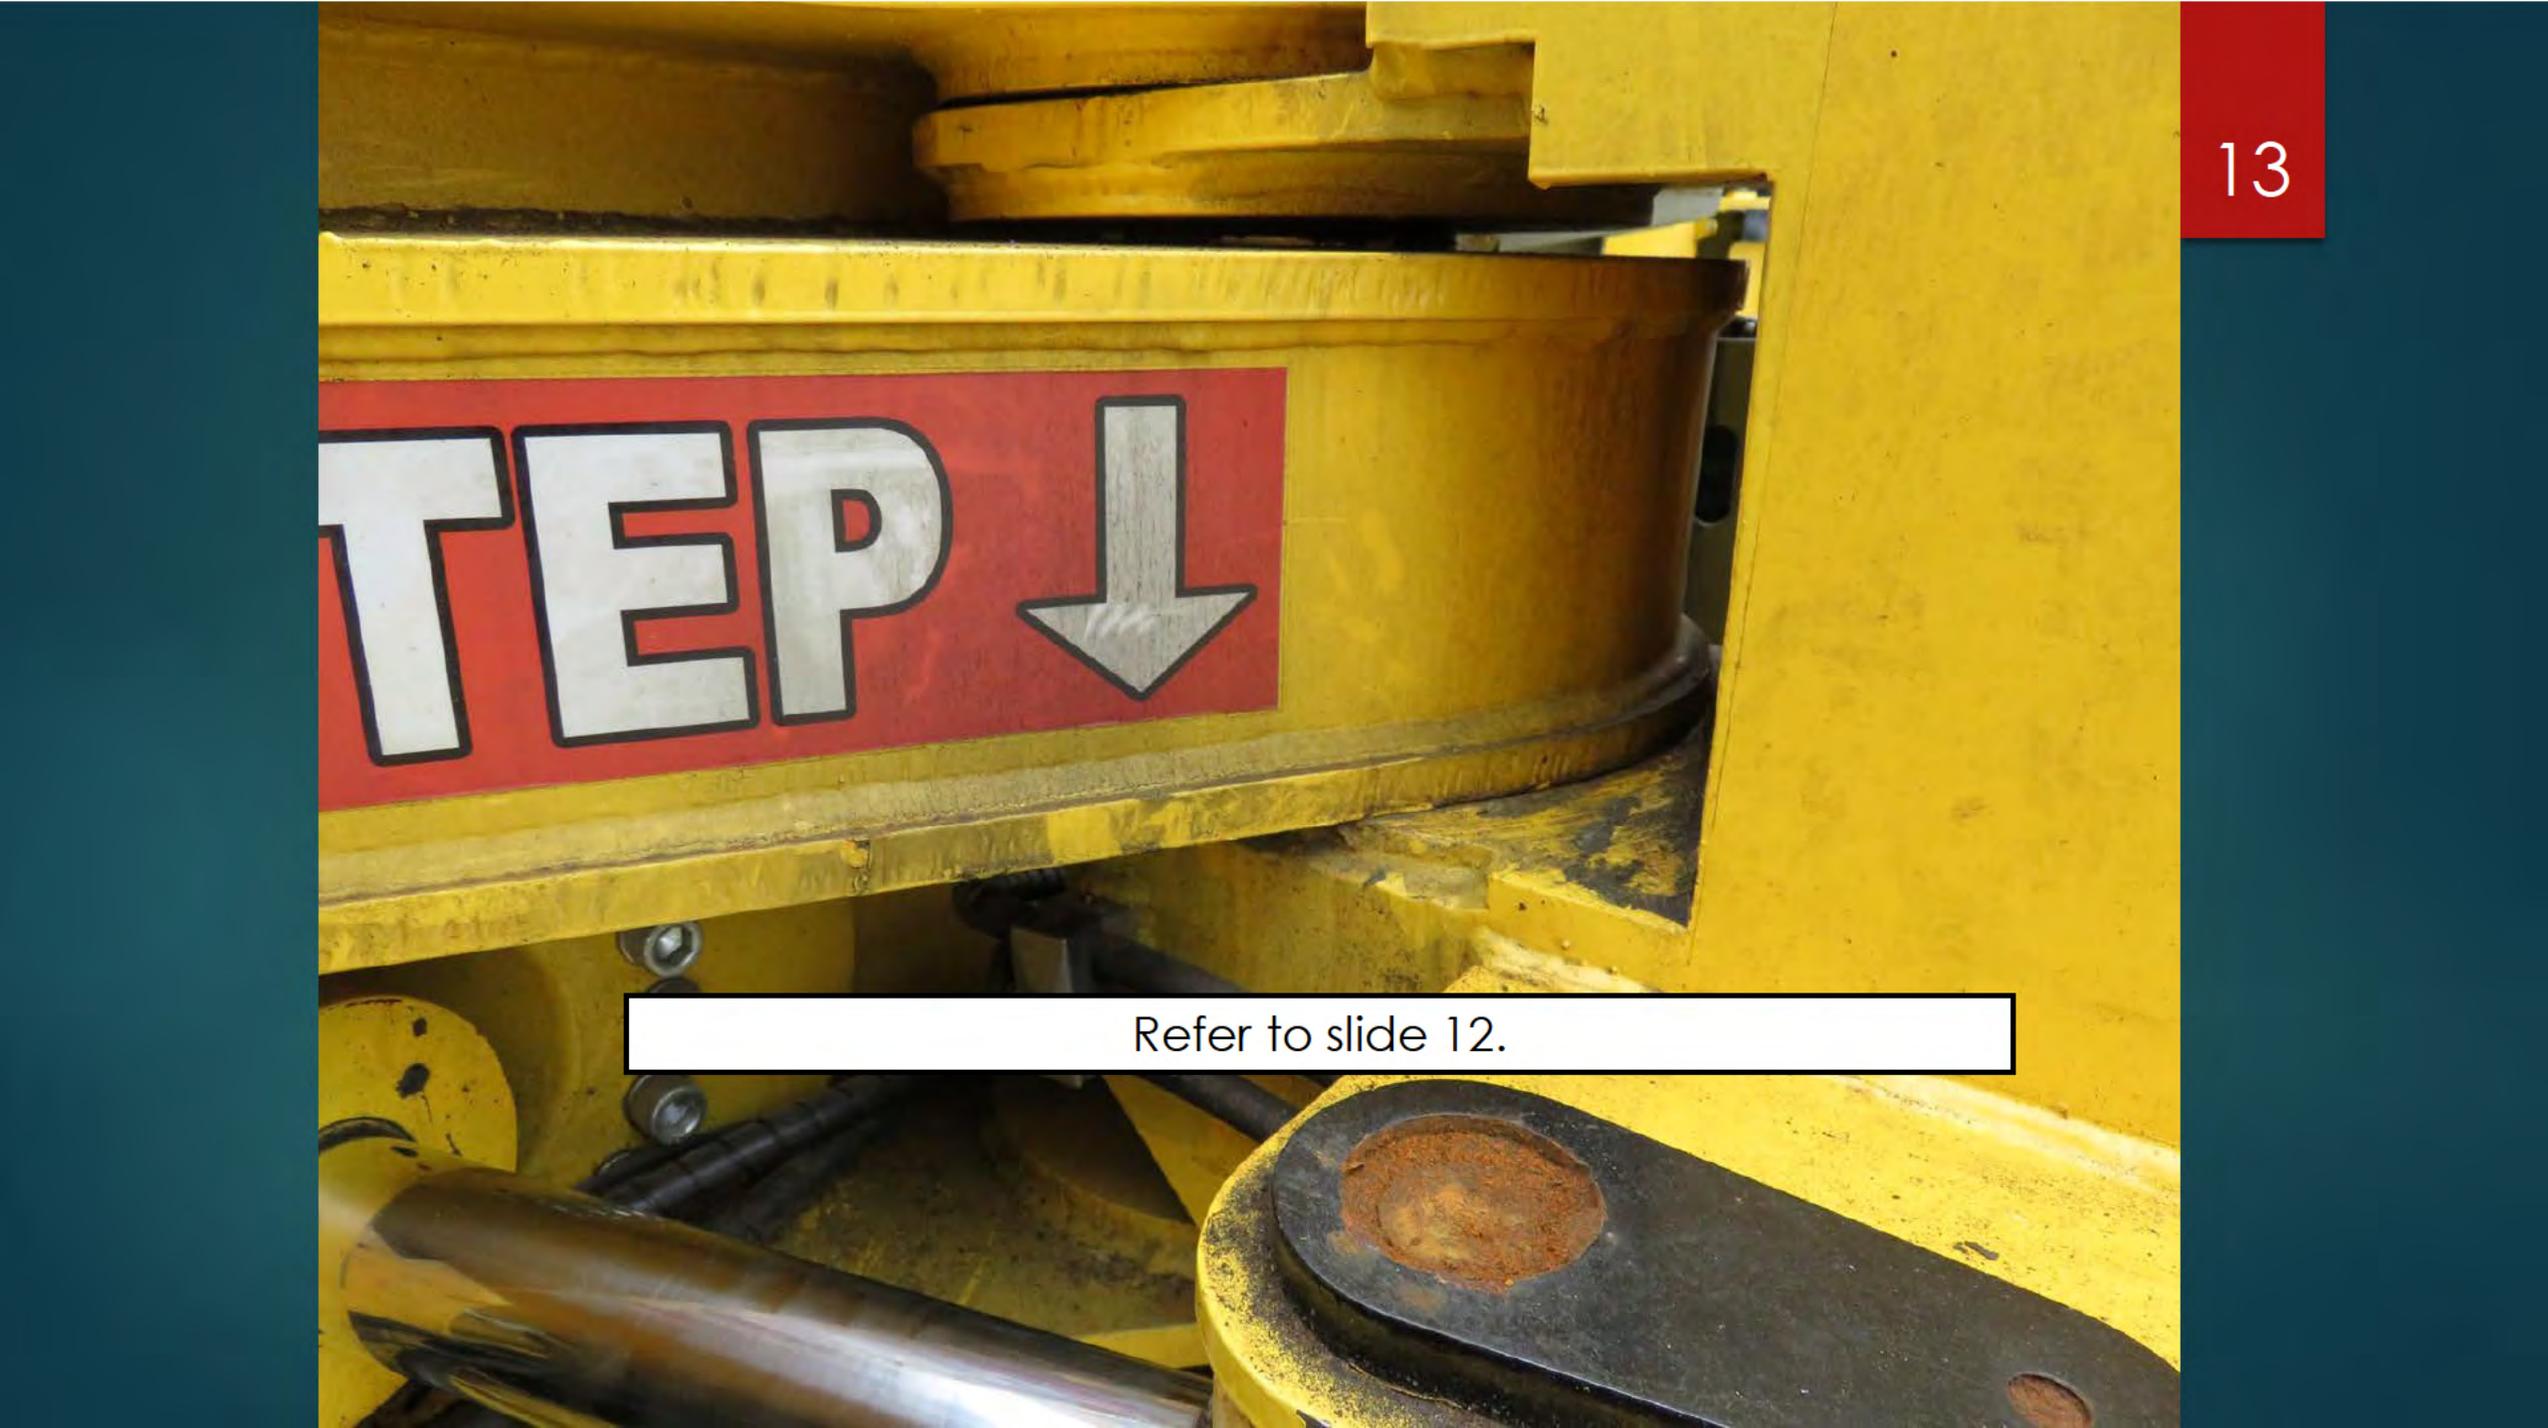
Questioned wear area: CraneMaster Rep. explained this is not an issue.

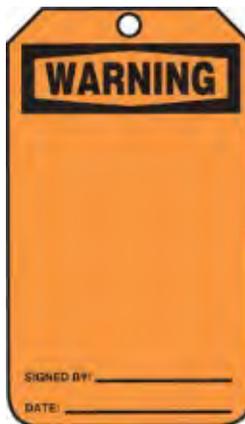
Warning Tag

- A “Warning” tag will be applied to the operator’s console listing the defective component and any usage restrictions. This alerts the operator of ancillary equipment concerns that may affect the machines functionality. This tag does not remove a unit from service, only the component listed is out of service.
